# Historic Libertyville

BEGINNING STREET NUMBER	108
END STREET NUMBER	-
STREET # SUFFIX	-
STREET NAME	First Street
PIN	
<b><u>LOCAL</u></b>	
WITHIN LOCAL DISTRICT?	No
LOCAL DIST CONTRIB/NON-CONTRIB?	C
LOCAL LANDMARK?	No
YEAR	-
LOCAL LANDMARK ELIGIBLE?	No
CRITERIA	-

Downtown Libertyville

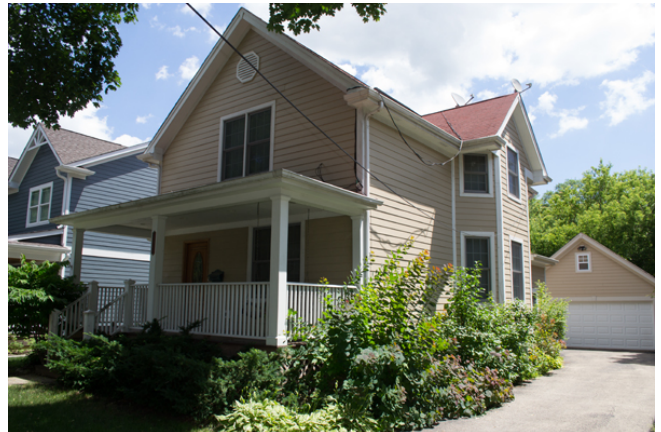
Photo Id: FirstSt108(3)

<b>CATEGORY</b>	<b>HISTORIC USE</b>
Building	Domestic - single dwelling
<b>CONDITION</b>	<b>SECONDARY STRUCTURE</b>
Good	Detached garage
<b>INTEGRITY</b>	<b>NR SECOND</b>
Moderate Alterations	NC
<b>CURRENT USE</b>	
Domestic - single dwelling

Front gable roof; three-sided, full-height gable bay on south facade; rectangular massing; hipped-roof front porch structure

Replacement windows in original openings; replacement siding; replacement columns, railing, and base on front porch (2001); rear porch addition (2003)
