# Historic Libertyville

BEGINNING STREET NUMBER	117
END STREET NUMBER	-
STREET # SUFFIX	-
STREET NAME	First Street
PIN	
<b><u>LOCAL</u></b>	
WITHIN LOCAL DISTRICT?	No
LOCAL DIST CONTRIB/NON-CONTRIB?	C
LOCAL LANDMARK?	No
YEAR	-
LOCAL LANDMARK ELIGIBLE?	No
CRITERIA	-

Photo Id: FirstSt117(1)

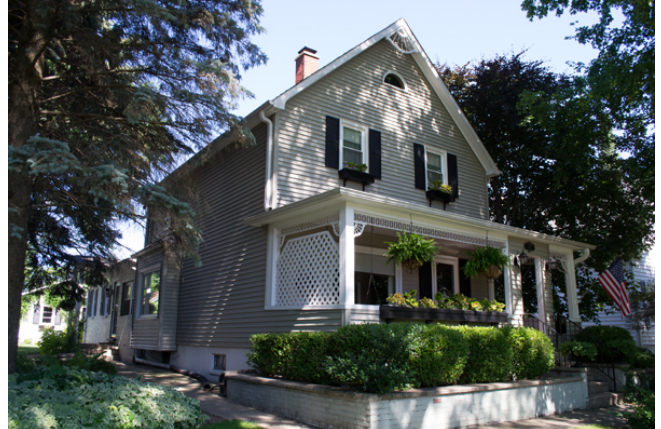
<b>CATEGORY</b>	<b>HISTORIC USE</b>
Building	Domestic - single dwelling
<b>CONDITION</b>	<b>SECONDARY STRUCTURE</b>
Good	Detached garage
<b>INTEGRITY</b>	<b>NR SECOND</b>
Minor alterations and additions	NC
<b>CURRENT USE</b>	
Domestic - single dwelling

Replacement siding (1963); replacement windows in original openings (2010); one-story rear addition (1973); alterations to front porch--enclosure around entry; verge board at gable and spindle work on porch are not historic
