# Historic Libertyville

BEGINNING STREET NUMBER	518
END STREET NUMBER	-
STREET # SUFFIX	-
STREET NAME	First Street
PIN	
<b><u>LOCAL</u></b>	
WITHIN LOCAL DISTRICT?	No
LOCAL DIST CONTRIB/NON-CONTRIB?	C
LOCAL LANDMARK?	No
YEAR	-
LOCAL LANDMARK ELIGIBLE?	Potentially Eligible
CRITERIA	A

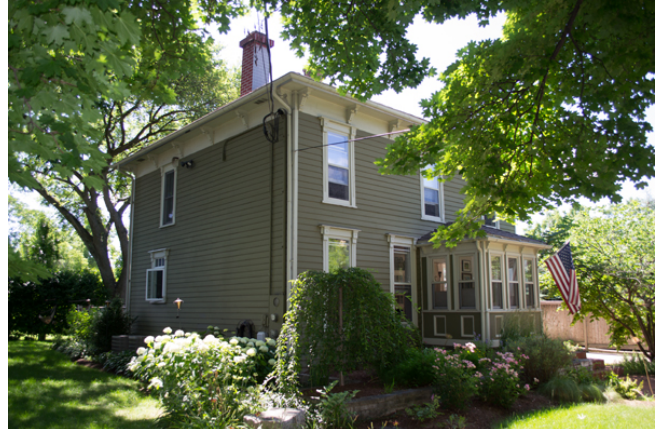
Photo Id: FirstSt518(2)

<b>CATEGORY</b>	<b>HISTORIC USE</b>
Building	Domestic - single dwelling
<b>CONDITION</b>	<b>SECONDARY STRUCTURE</b>
Good	Detached garage
<b>INTEGRITY</b>	<b>NR SECOND</b>
Minor alterations and additions	NC
<b>CURRENT USE</b>	
Domestic - single dwelling

Fine example Italianate residential architecture in the village, with characteristic bracketed cornice and classical wood window surrounds. The enclosed front porch and open entry porch on the north facade are non-historic alterations.

Front porch addition (not historic); original north side sun porch removed and replaced with small entry porch (not historic)
