# Historic Libertyville

BEGINNING STREET NUMBER	624
END STREET NUMBER	-
STREET # SUFFIX	-
STREET NAME	First Street
PIN	
<b><u>LOCAL</u></b>	
WITHIN LOCAL DISTRICT?	No
LOCAL DIST CONTRIB/NON-CONTRIB?	NC
LOCAL LANDMARK?	No
YEAR	-
LOCAL LANDMARK ELIGIBLE?	No
CRITERIA	-

Ramsey Historic Consultants

May-June 2016

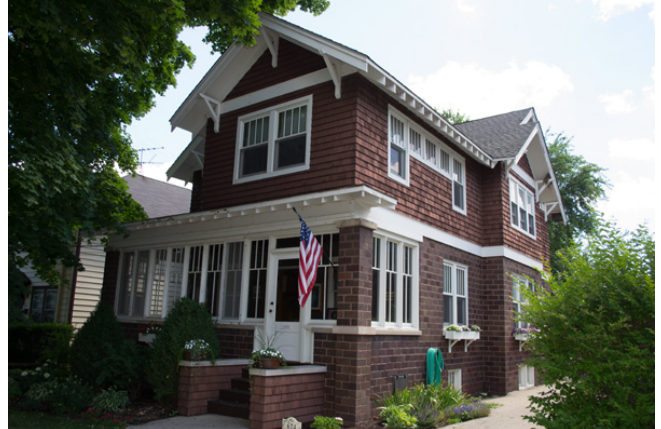
Photo Id: FirstSt624(1)

First floor of building was originally part of 1-story bungalow--oversized brick first story; inset front porch with square brick piers on solid brick knee walls (porch enclosed with historic 5-light storm windows

Historic structure obscured by second story addition (2004); replacement windows in original openings on all facades (except on porch); first story window on south facade bricked in
