Historic Libertyville

BEGINNING STREET NUMBER	113
END STREET NUMBER	-
STREET # SUFFIX	-
STREET NAME	First Street
PIN	
<u>LOCAL</u>	
WITHIN LOCAL DISTRICT?	No
LOCAL DIST CONTRIB/NON-CONTRIB?	NC
LOCAL LANDMARK?	No
YEAR	-
LOCAL LANDMARK ELIGIBLE?	No
CRITERIA	-

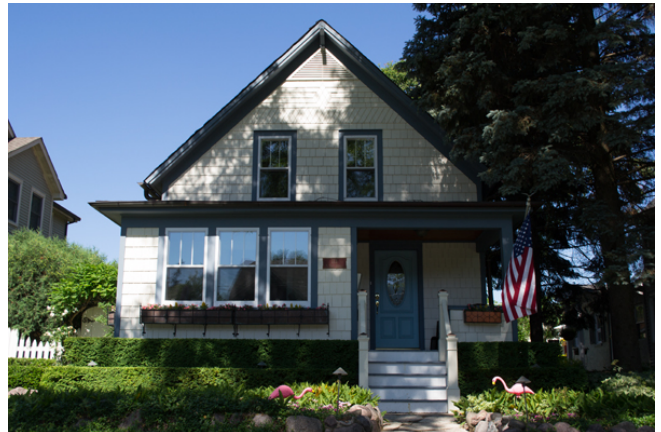
Photo Id: FirstSt113(2)

CATEGORY	HISTORIC USE
Building	Domestic - single dwelling
CONDITION	SECONDARY STRUCTURE
Good	Detached garage
INTEGRITY	NR SECOND
Major alterations and additions	C
CURRENT USE	
Domestic - single dwelling

Front gable roof; hipped roof full-front porch structure (partially enclosed c. 1920); historic (but not original) 3/1 double hung windows on front facade

Large 2-story rear addition that is taller than original house (1997); wood shingles on front facade (1951); front porch partially enclosed c. 1920; entry porch steps and railing are more recent

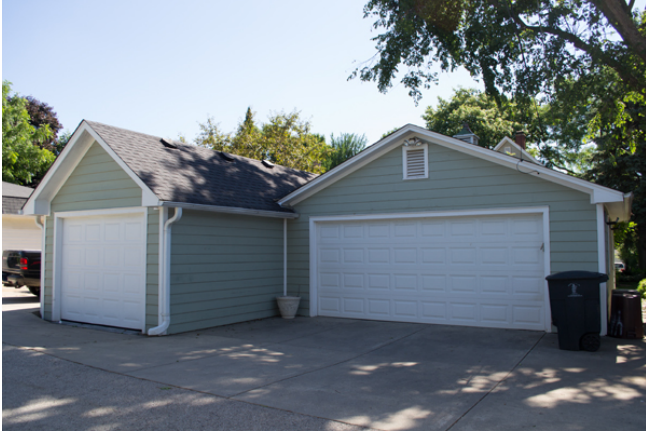
Photo Id: FirstSt117(1)

CATEGORY	HISTORIC USE
Building	Domestic - single dwelling
CONDITION	SECONDARY STRUCTURE
Good	Detached garage
INTEGRITY	NR SECOND
Minor alterations and additions	NC
CURRENT USE	
Domestic - single dwelling

Front gable roof and rectangular massing; full-front hipped-roof porch structure

Replacement siding (1963); replacement windows in original openings (2010); one-story rear addition (1973); alterations to front porch--enclosure around entry; verge board at gable and spindle work on porch are not historic

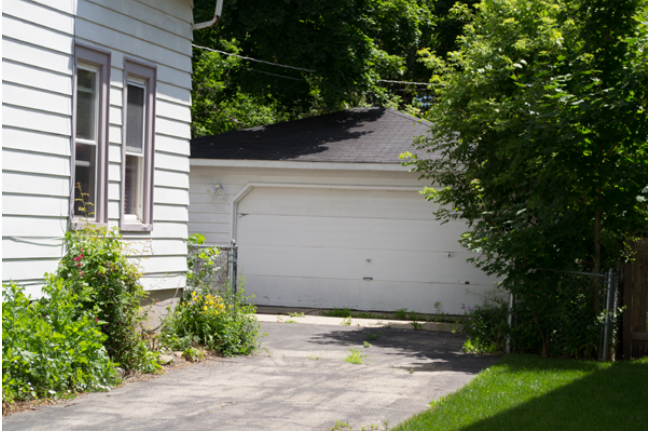
Photo Id: FirstSt118(2)

CATEGORY	HISTORIC USE
Building	Domestic - single dwelling
CONDITION	SECONDARY STRUCTURE
Good	Detached garage
INTEGRITY	NR SECOND
Minor alterations	NC
CURRENT USE	
Domestic - single dwelling

Front gable roof with cornice returns; north and south gable through-the-cornice dormers with cornice returns; hipped roof front porch structure (enclosed)

Replacement windows in original openings; front porch enclosed, wood entry stoop at porch entrance; replacement siding; fixed shutters on front facade

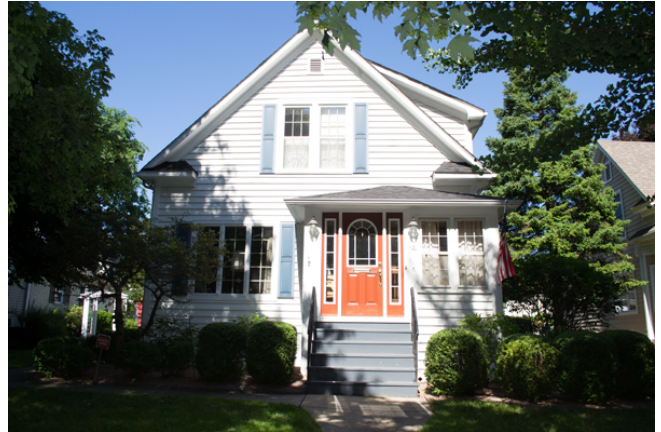
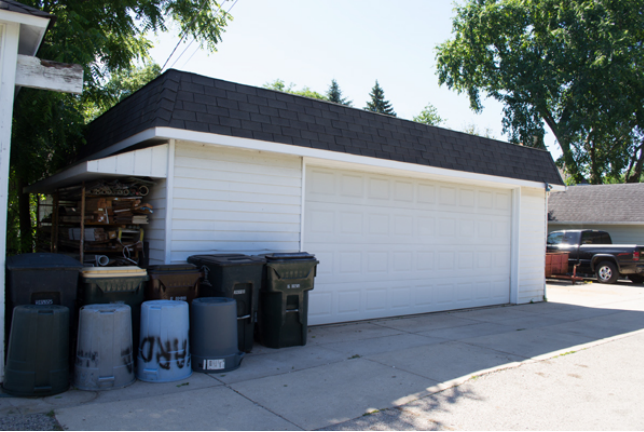
Photo Id: FirstSt121(1)

CATEGORY	HISTORIC USE
Building	Domestic - single dwelling
CONDITION	SECONDARY STRUCTURE
Good	Detached garage
INTEGRITY	NR SECOND
Minor alterations and additions	NC
CURRENT USE	
Domestic - single dwelling

Front gable roof with cornice returns; south side gable through-the-cornice dormer; three-sided first story window bay on south facade; historic 6/6 wood windows

Front entry porch is historic addition (1924-1933) that was enclosed some time after 1948; replacement siding; replacement casement windows in front window bay; north side shed-roof dormer addition (1974)

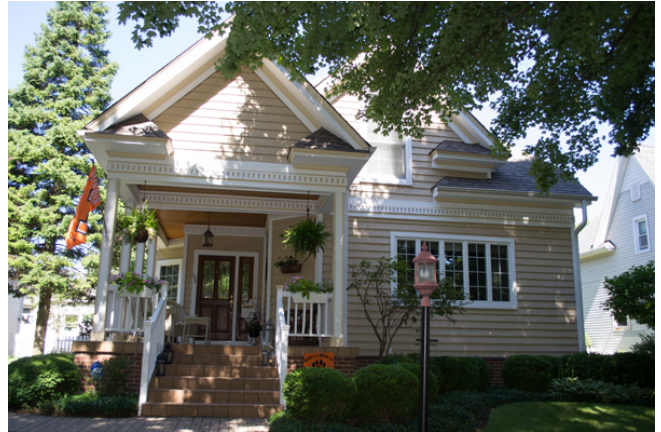
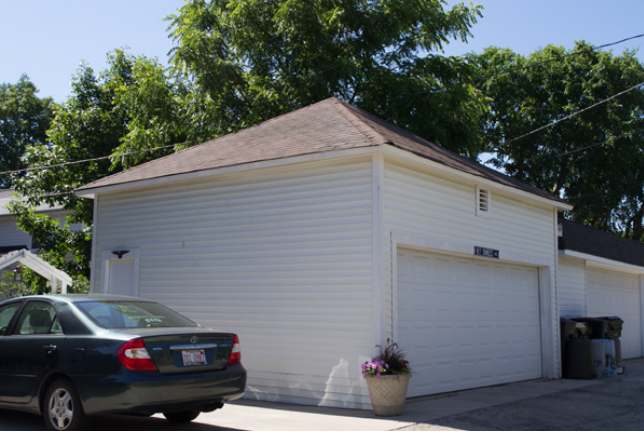
Photo Id: FirstSt125(2)

CATEGORY	HISTORIC USE
Building	Domestic - single dwelling
CONDITION	SECONDARY STRUCTURE
Good	Detached garage
INTEGRITY	NR SECOND
Moderate alterations	NC
CURRENT USE	
Domestic - single dwelling

Steeply pitched hipped main roof; rectangular massing

Sanborn maps indicate that a polygonal front bay just north of the corner entry porch on the front facade was leveled off some time between 1924 and 1933; replacement front porch (2004); replacement siding; front gable through-the-wall dormer with round-arch window; replacement windows in original openings

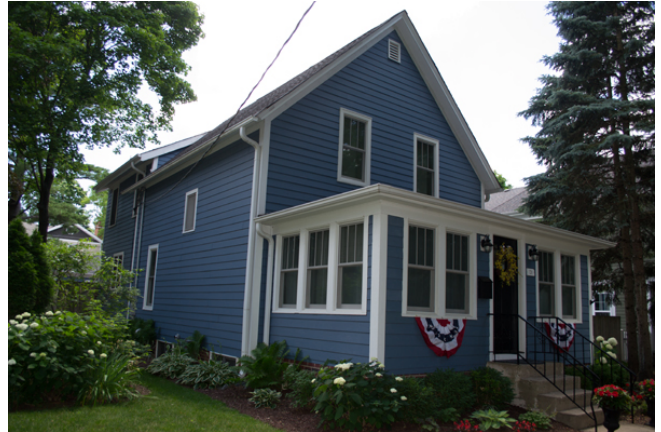
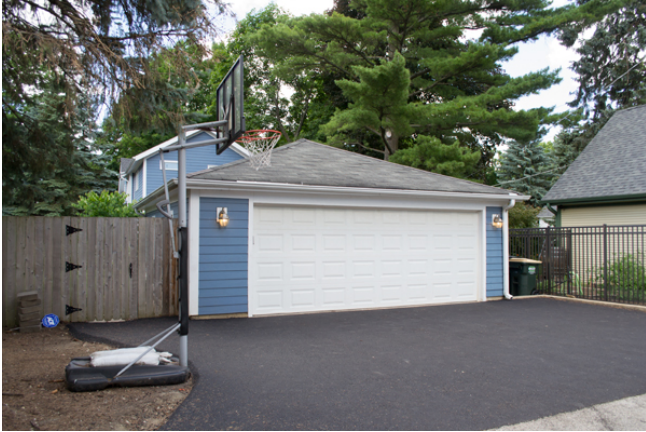
Photo Id: FirstSt128(2)

CATEGORY	HISTORIC USE
Building	Domestic - single dwelling
CONDITION	SECONDARY STRUCTURE
Good	Detached garage
INTEGRITY	NR SECOND
Minor alterations	C
CURRENT USE	
Domestic - single dwelling

Front gable roof; south side gable dormer and three-sided first story window bay; hipped front porch structure (enclosed)

Replacement siding; front porch enclosed; 2-story rear addition (2005); replacement windows in original openings

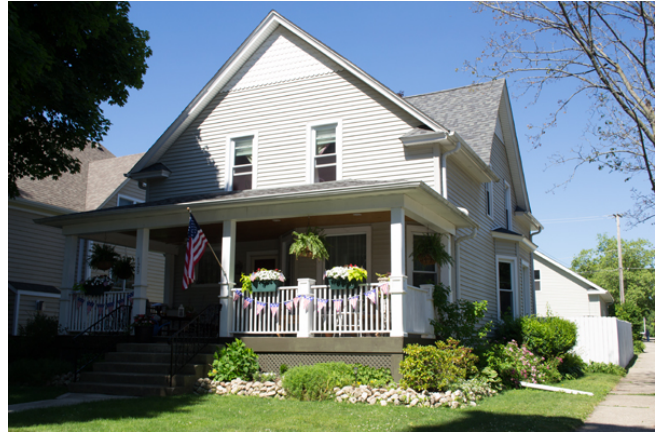
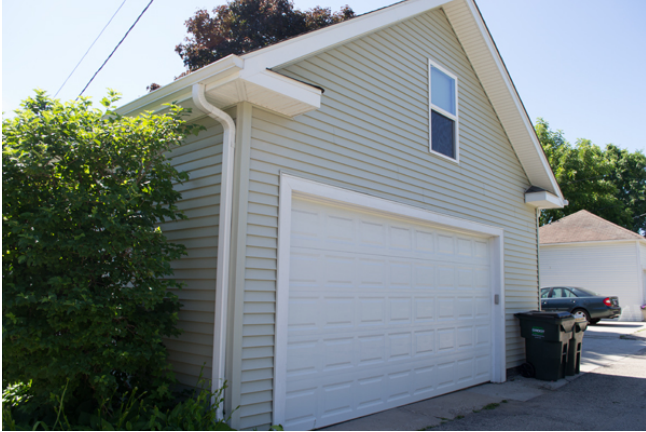
Photo Id: FirstSt129(1)

CATEGORY	HISTORIC USE
Building	Domestic - single dwelling
CONDITION	SECONDARY STRUCTURE
Good	Detached garage
INTEGRITY	NR SECOND
Moderate alterations and additions	NC
CURRENT USE	
Domestic - single dwelling

Replacement siding; replacement windows in original openings; porch knee wall and columns are non-historic replacements

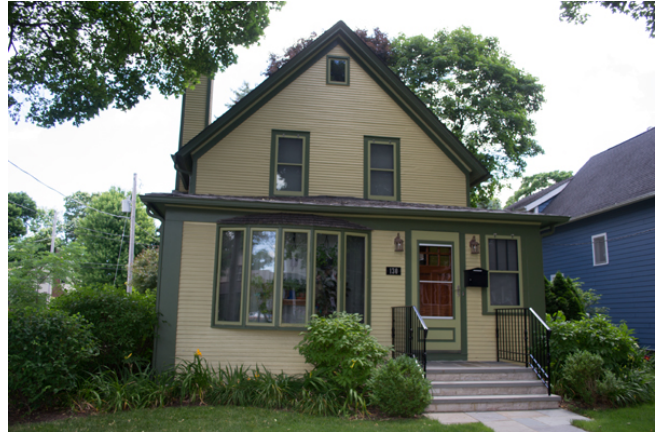
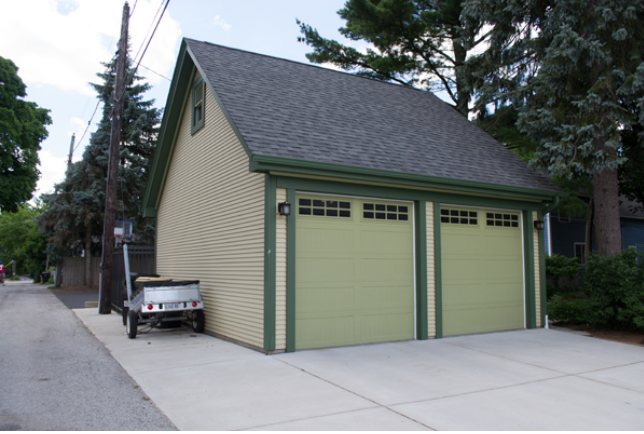
Photo Id: FirstSt130(2)

CATEGORY	HISTORIC USE
Building	Domestic - single dwelling
CONDITION	SECONDARY STRUCTURE
Good	Detached garage
INTEGRITY	NR SECOND
Minor alterations	C
CURRENT USE	
Domestic - single dwelling

Front porch enclosed (c. 1920); chimney added to north elevation; curving bay window on front wall of porch (not historic); rear deck addition

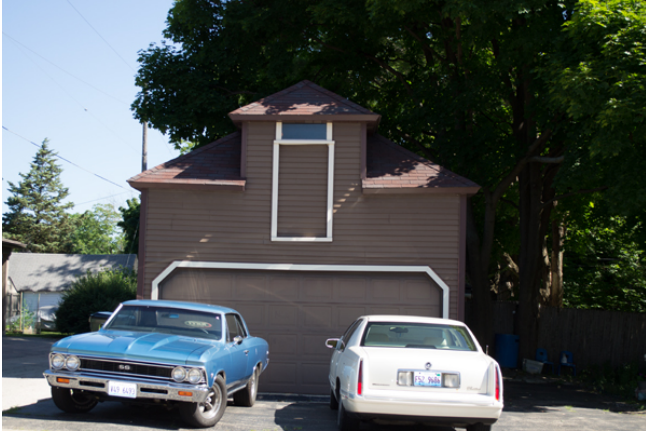
Photo Id: FirstSt203(1)

CATEGORY	HISTORIC USE
Building	Domestic - single dwelling
CONDITION	SECONDARY STRUCTURE
Good	Detached garage
INTEGRITY	NR SECOND
Minor alterations	NC
CURRENT USE	
Domestic - single dwelling

Front porch enclosed (post-1948); wood and concrete front stoop is replacement; skylight
