Historic Libertyville

BEGINNING STREET NUMBER	525
END STREET NUMBER	-
STREET # SUFFIX	-
STREET NAME	First Street
PIN	
<u>LOCAL</u>	
WITHIN LOCAL DISTRICT?	No
LOCAL DIST CONTRIB/NON-CONTRIB?	NC
LOCAL LANDMARK?	No
YEAR	-
LOCAL LANDMARK ELIGIBLE?	No
CRITERIA	-

Ramsey Historic Consultants

Downtown Libertyville

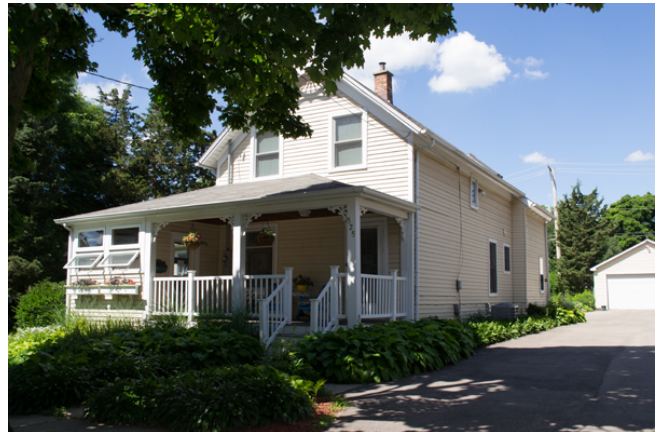
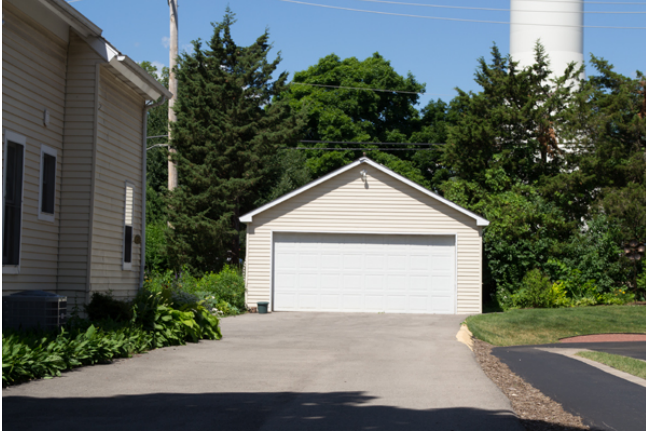
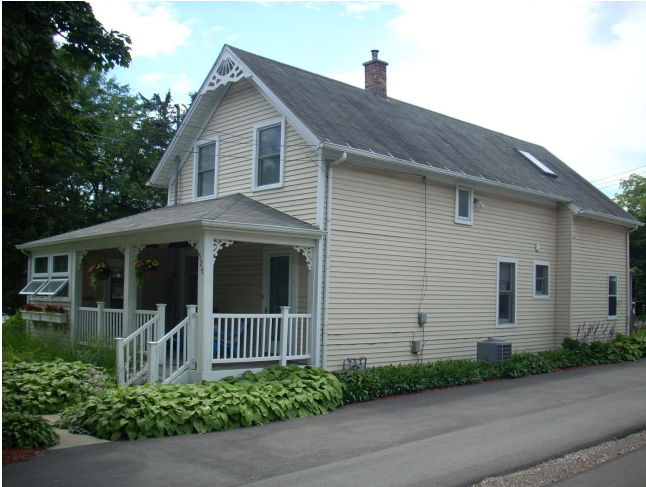
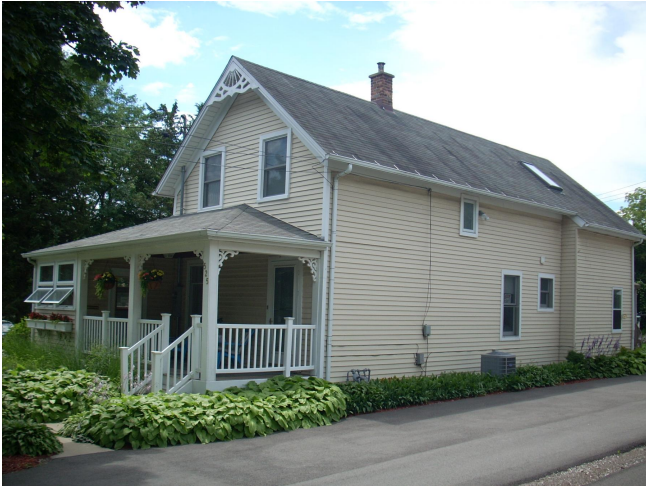
Photo Id: FirstSt525(3)

CATEGORY	HISTORIC USE
Building	Domestic - single dwelling
CONDITION	SECONDARY STRUCTURE
Good	Detached garage
INTEGRITY	NR SECOND
Major alterations and additions	NC
CURRENT USE	
Domestic - single dwelling

Front gable roof; some historic wood windows on first story

Original house obscured by multiple additions and alterations--2-story south side addition; 2-story rear addition (1992); front porch replaced (1997); replacement siding (1983); replacement windows in original openings; skylight

93-158 (4/26/1983)--replace siding and roofing; 92-253 (5/15/1992)--2nd story addition over existing first story (single-family dwelling); 97-760 (9/30/1997)--1-story frame addition and frame porch

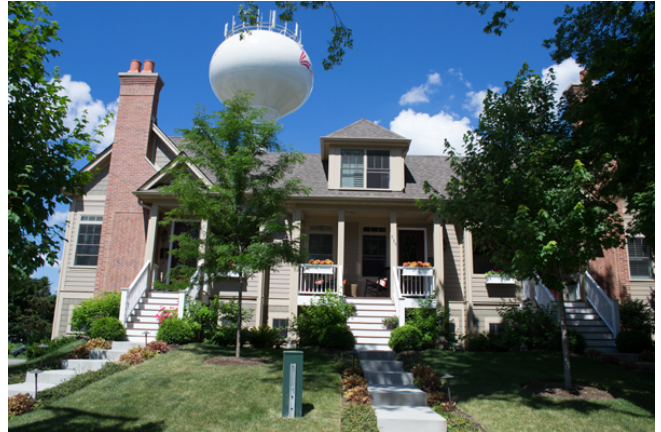
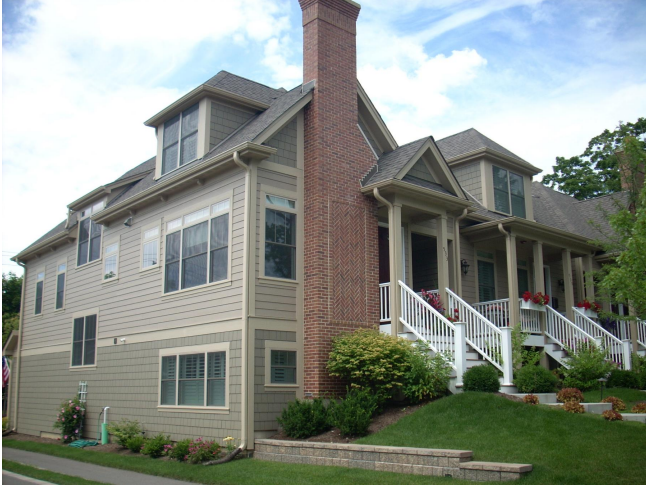
Photo Id: FirstSt533-537(2)

CATEGORY	HISTORIC USE
Building	Domestic - multiple dwelling
CONDITION	SECONDARY STRUCTURE
Excellent	-
INTEGRITY	NR SECOND
Not altered	-
CURRENT USE	
Domestic - multiple dwelling

New Traditional

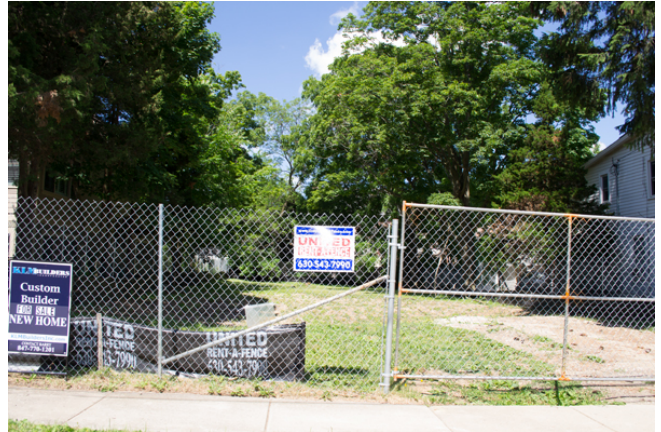
Photo Id: FirstSt605

BUILDING NAME	ZONING
-	R-7
GROUND FLOOR USE	NUMBER OF STORIES
Vacant Lot	1
UPPER FLOOR USE	PROPERTY INDEX NUMBER
N/A	1116405049
CURRENT OCCUPANT	
-

CATEGORY	HISTORIC USE
site	Landscape - unoccupied land
CONDITION	SECONDARY STRUCTURE
N/A	-
INTEGRITY	NR SECOND
-	-
CURRENT USE	
Landscape - unoccupied land

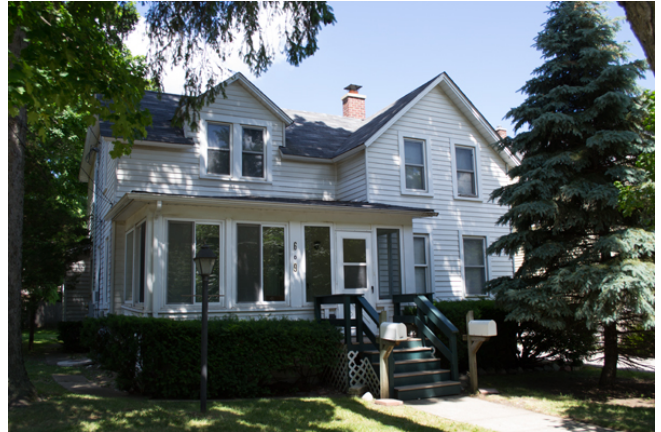
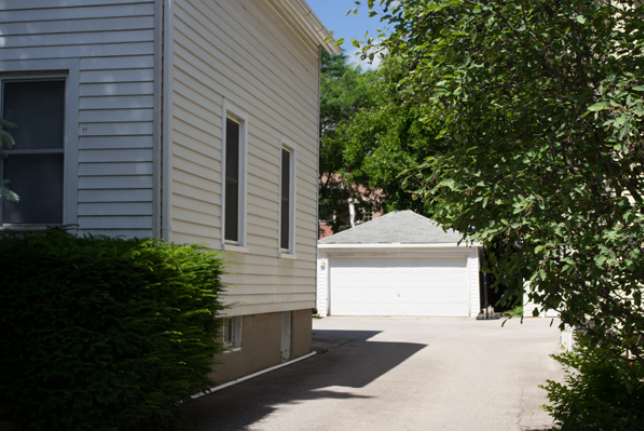
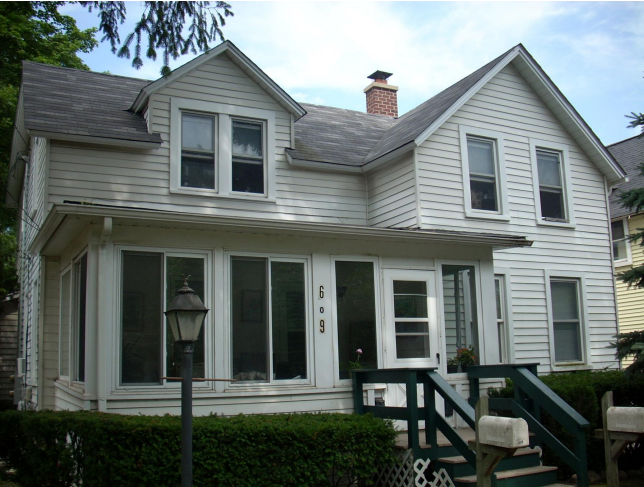
Photo Id: FirstSt609(1)

CATEGORY	HISTORIC USE
Building	Domestic - single dwelling
CONDITION	SECONDARY STRUCTURE
Good	Detached garage
INTEGRITY	NR SECOND
Moderate alterations	NC
CURRENT USE	
Domestic - single dwelling

1.5-story north-end front gable bay intersected by 1.5-story south side gable wing; front porch structure is historic, but may not be original

One story rear additions are very early (pre-1924--see Sanborn map); aluminum siding (1990); front porch enclosed (1960); front through-the cornice dormer addition (no date); non-historic replacement windows in original openings

1569 (8/23/1956)--reside house with insulated siding; 3977 (8/4/1966)--new doors on garage; 2762 (1960)--enclose front porch with glass windows; 90-584 (1990)--aluminum siding, fascia, and soffit

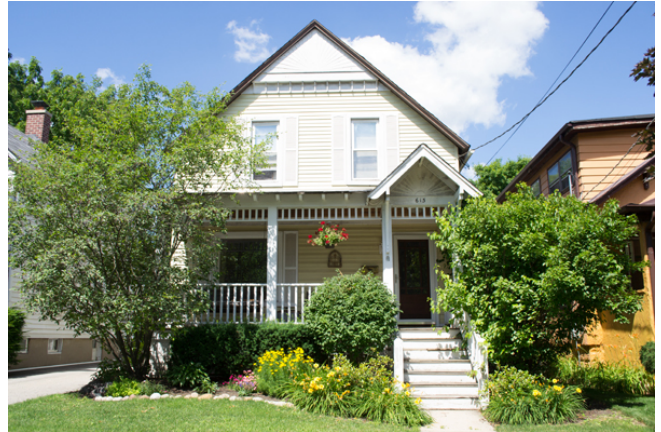
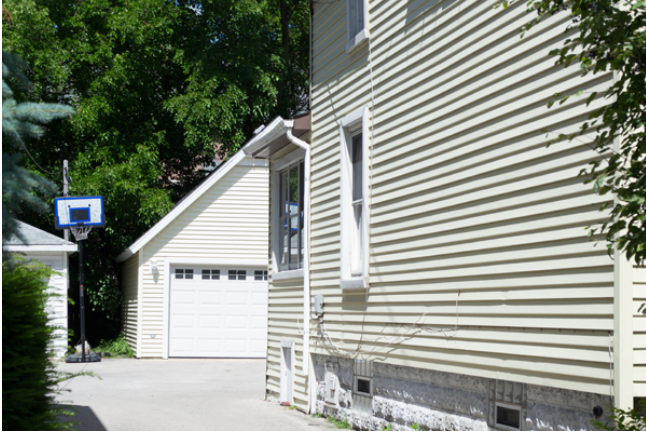
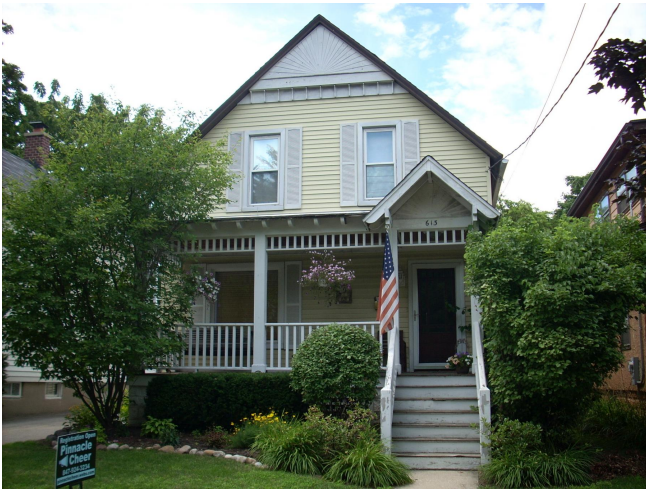
Photo Id: FirstSt613(1)

CATEGORY	HISTORIC USE
Building	Domestic - single dwelling
CONDITION	SECONDARY STRUCTURE
Good	Detached garage
INTEGRITY	NR SECOND
Major alterations	NC
CURRENT USE	
Domestic - single dwelling

Front gable roof; sunburst motif under gable

Replacement siding; replacement windows in original openings; replacement front porch (2001); fixed shutters

JRAB-01-0034 (2003)--detached garage; 85-373 (1985)--repairs after fire; zoning appeals agenda (9/2001)--replacement front porch and garage (see JRAB-01-0034)

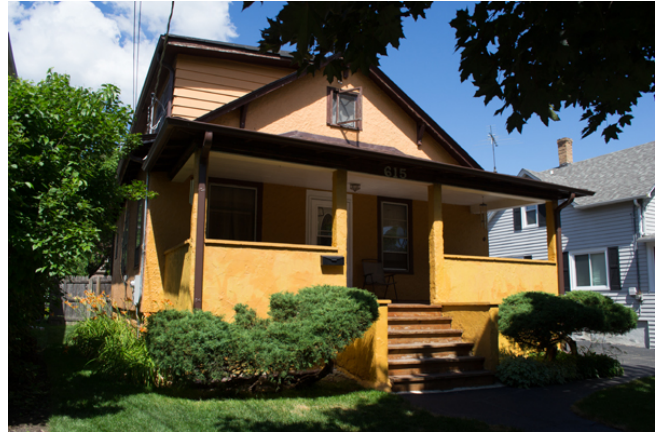
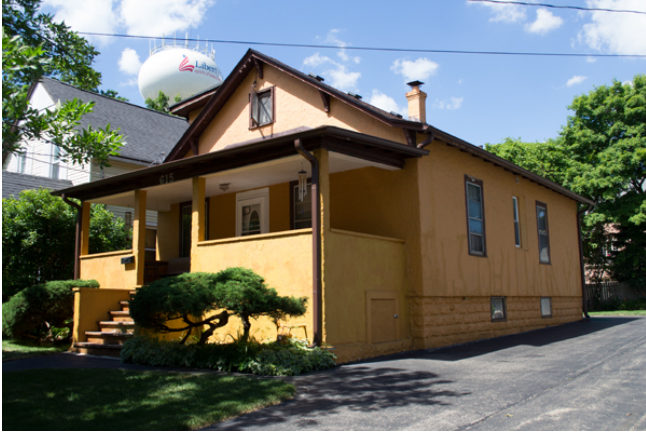
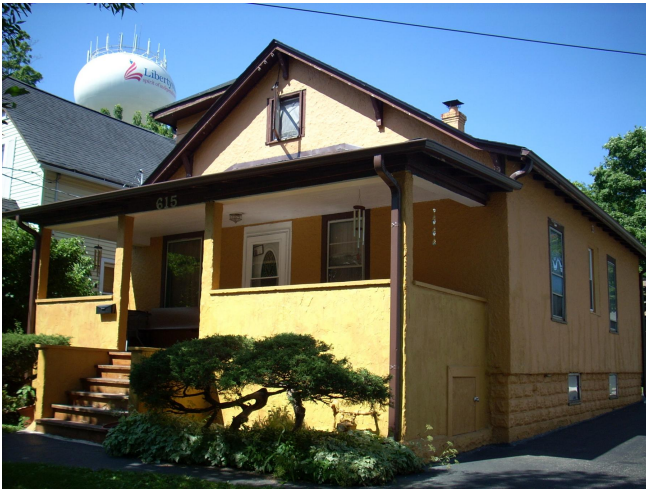
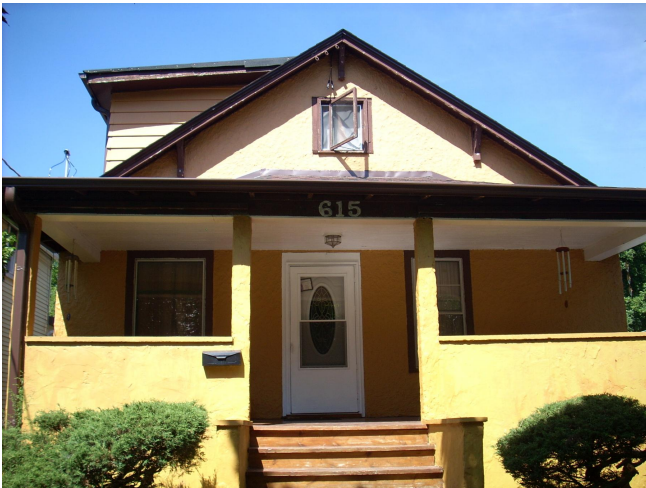
Photo Id: FirstSt615(1)

CATEGORY	HISTORIC USE
Building	Domestic - single dwelling
CONDITION	SECONDARY STRUCTURE
Good	-
INTEGRITY	NR SECOND
Minor alterations and additions	-
CURRENT USE	
Domestic - single dwelling

Broad front gable roof with overhanging eaves and exposed rafter tails; full front porch with hipped roof, square piers on solid knee walls; historic 1/1 wood windows

Shed roof front porch on south facade (1960); replacement front door; replacement front porch steps; shed roof dormer addition (1963)

3185 (1/11/1963)--dormer addition

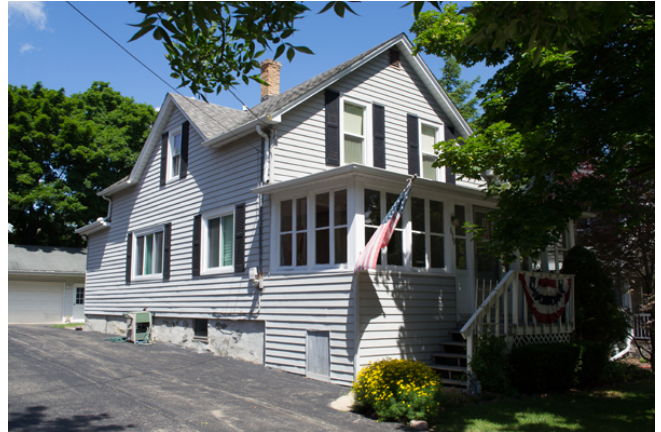
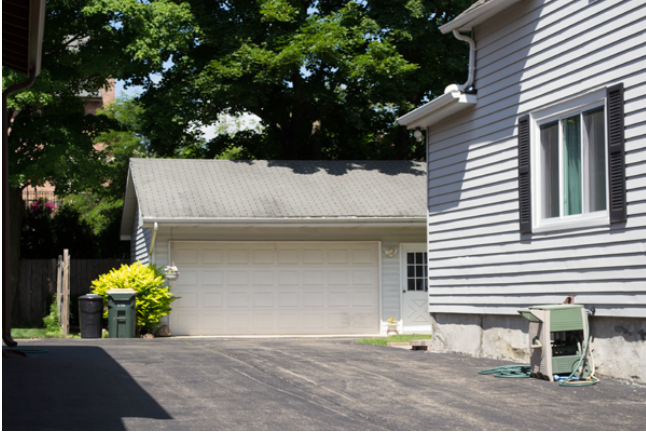
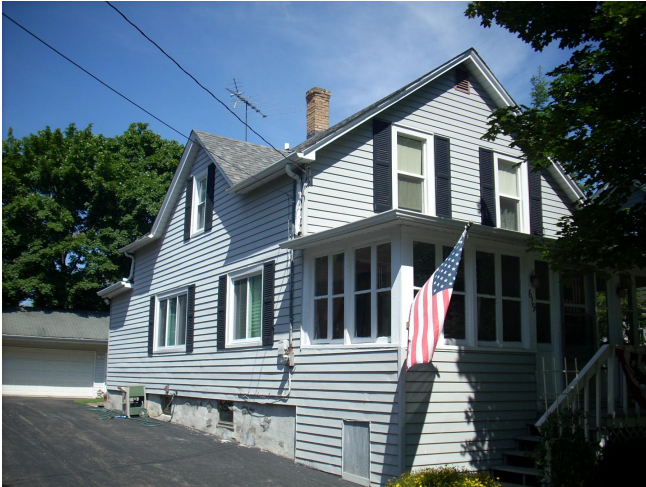
Photo Id: FirstSt619(1)

CATEGORY	HISTORIC USE
Building	Domestic - single dwelling
CONDITION	SECONDARY STRUCTURE
Good	Detached garage
INTEGRITY	NR SECOND
Moderate alterations	NC
CURRENT USE	
Domestic - single dwelling

Front gable roof; rectangular massing; hipped roof full-front porch (enclosed before 1933); north and south gable dormers

Replacement windows in original openings (some casement windows, not historically appropriate, 2011); wood steps to front porch entrance

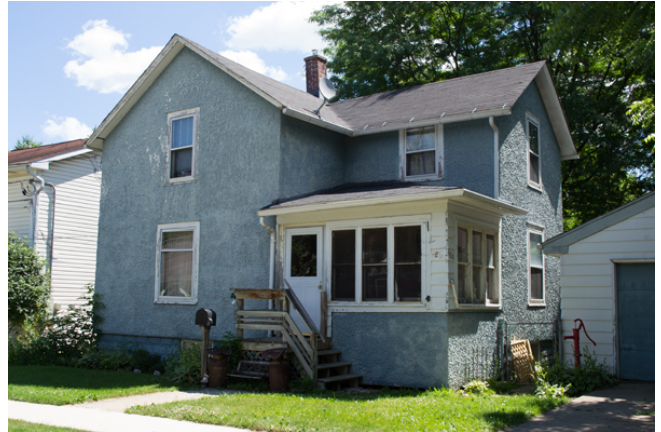
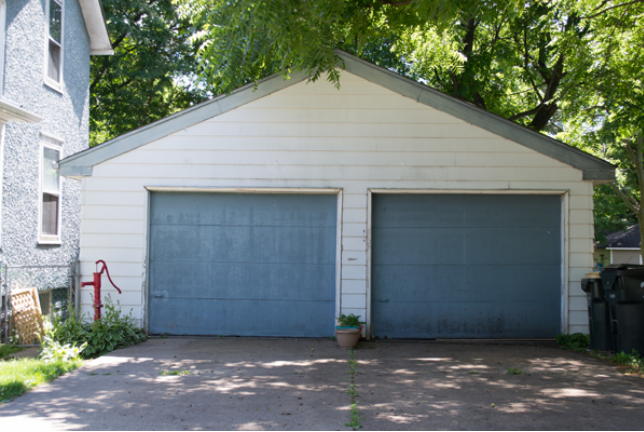
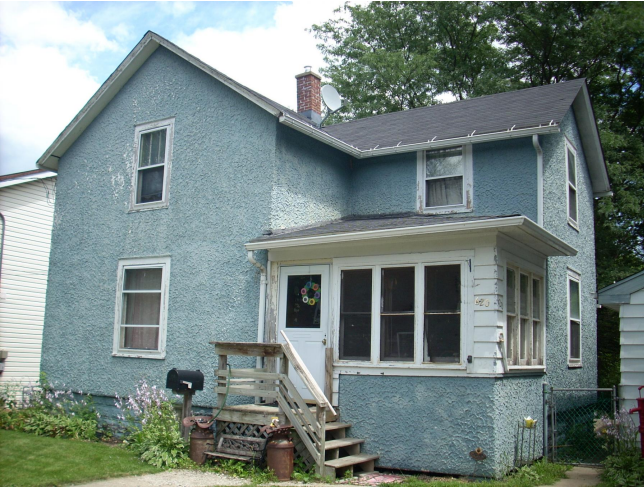
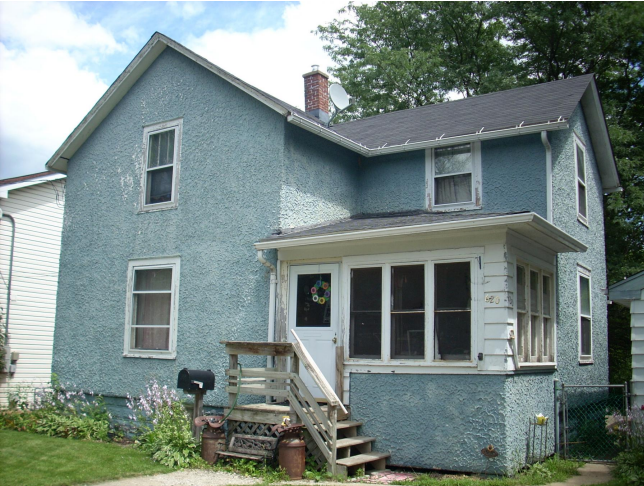
Photo Id: FirstSt620(1)

CATEGORY	HISTORIC USE
Building	Domestic - single dwelling
CONDITION	SECONDARY STRUCTURE
Fair	Detached garage
INTEGRITY	NR SECOND
Moderate alterations	NC
CURRENT USE	
Domestic - single dwelling

Stucco cladding; front porch enclosed; wood stairs to porch
entry; wood windows appear historic, but not original

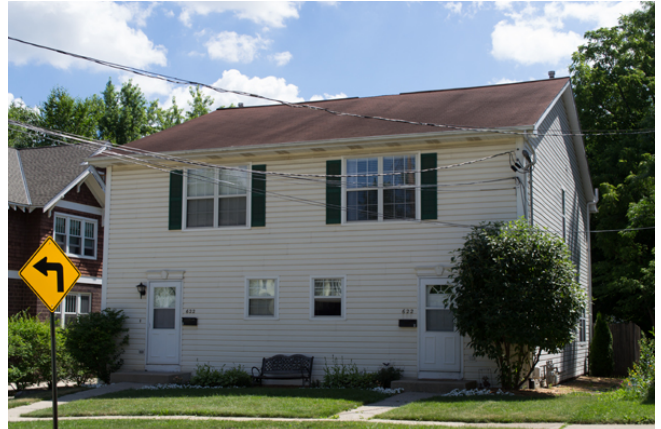
Photo Id: FirstSt622(1)

CATEGORY	HISTORIC USE
Building	Domestic - multiple dwelling
CONDITION	SECONDARY STRUCTURE
Good	Detached garage
INTEGRITY	NR SECOND
Minor alterations	NC
CURRENT USE	
Domestic - multiple dwelling

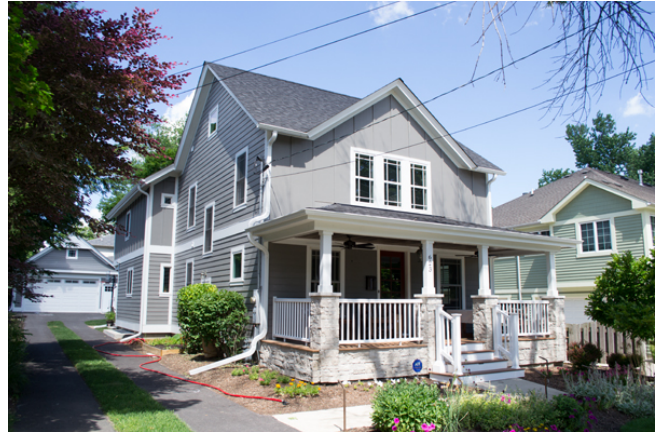
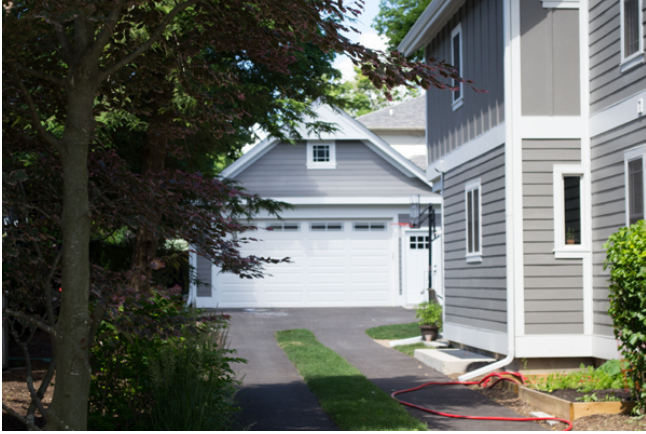
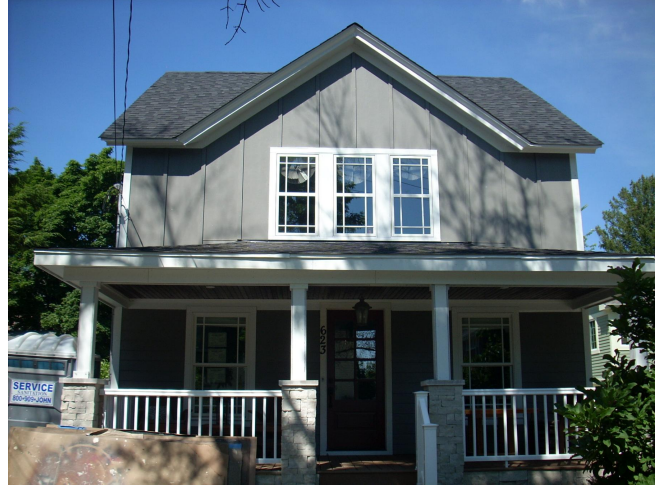
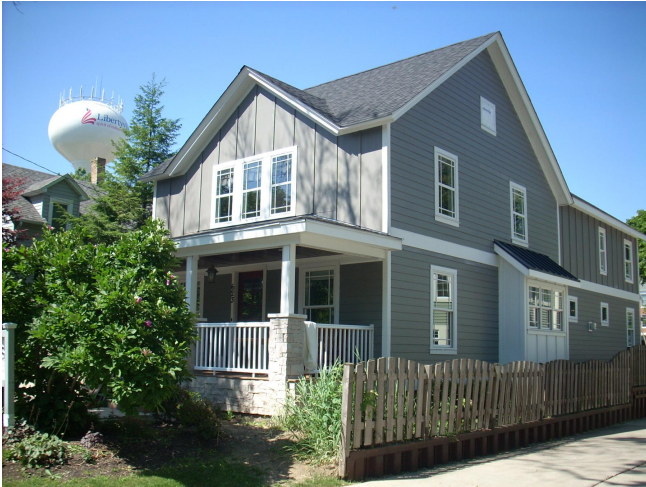
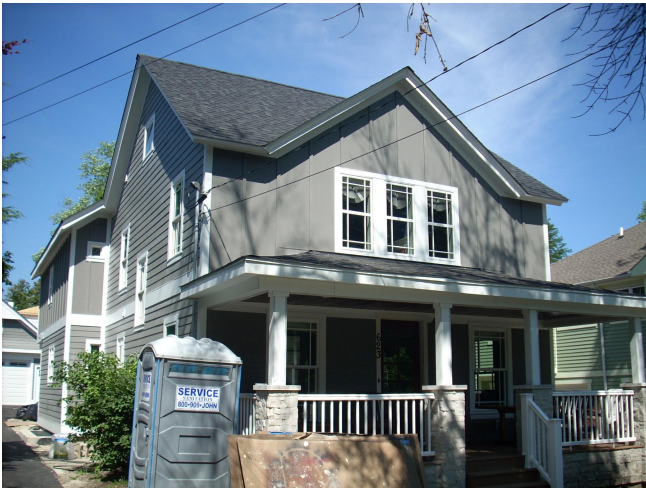
Photo Id: FirstSt623(1)

CATEGORY	HISTORIC USE
Building	Domestic - single dwelling
CONDITION	SECONDARY STRUCTURE
Excellent	Detached garage
INTEGRITY	NR SECOND
Major alterations and additions	NC
CURRENT USE	
Domestic - single dwelling

Replacement siding (2014); replacement windows in original openings (2014); replacement front door (2014); replacement front porch (1993); 2-story rear addition (2015)

93-309 (1993)--rebuilt existing porch; JLC-11-0152 (2011)--remove rear deck and replace with patio; JRE-14-0058 (2014)--repair porch, replace door, windows and siding; JRA-14-0029 (2015)--addition and remodel, detached garage
