Historic Libertyville

Ramsey Historic Consultants

Downtown Libertyville

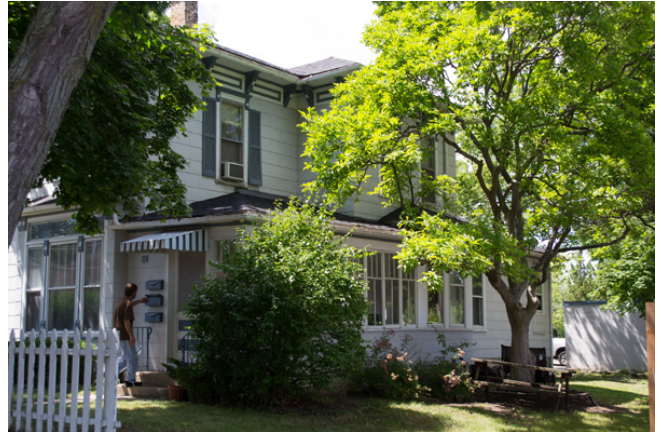
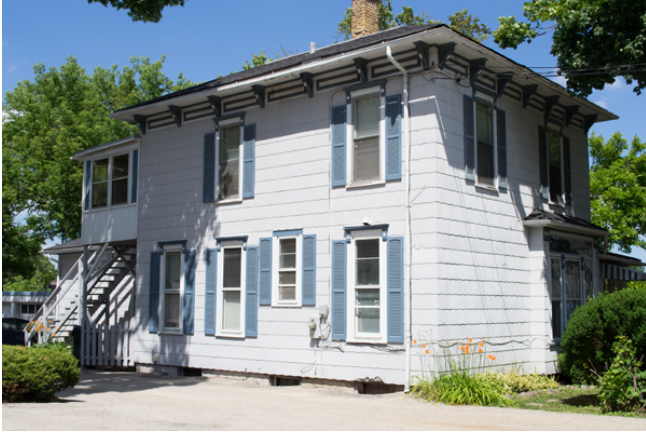
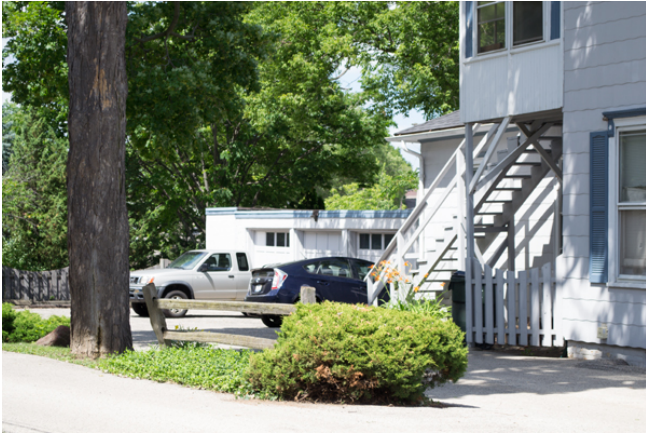
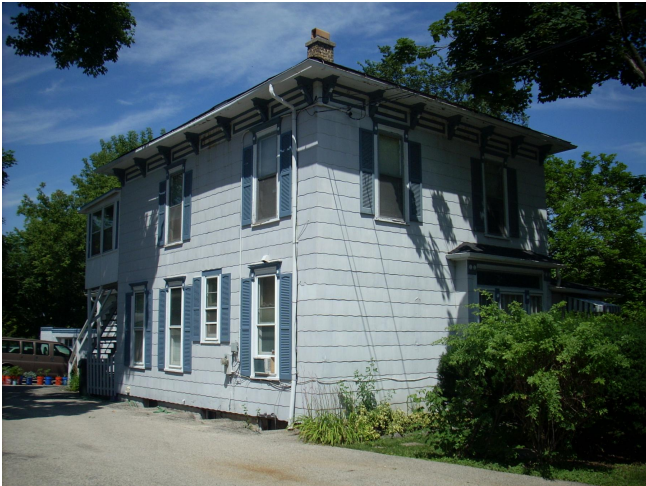
Photo Id: LakeSt126(2)

CATEGORY	HISTORIC USE
Building	Domestic - single dwelling
CONDITION	SECONDARY STRUCTURE
Good	Detached garage
INTEGRITY	NR SECOND
Moderate alterations	C
CURRENT USE	
Domestic - multiple dwelling

Shallow hipped roof; wood cornice with paneled frieze and scrolled brackets; classical lintels above window openings; southeast corner porch structure (enclosed); square oriel bay window on front facade; east side oriel window

Replacement windows in original openings (replacement windows in front bay are historic, dating from the 1920s or 30s); corner entry porch enclosed (historic alteration--c. 1920s-30s); 2-story rear/northwest addition; exterior staircase (1952)

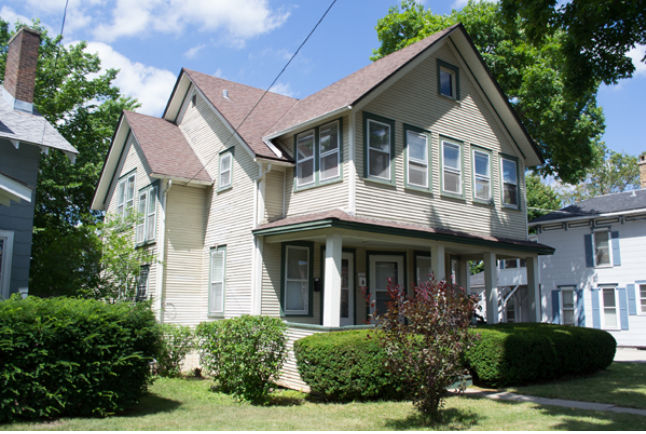
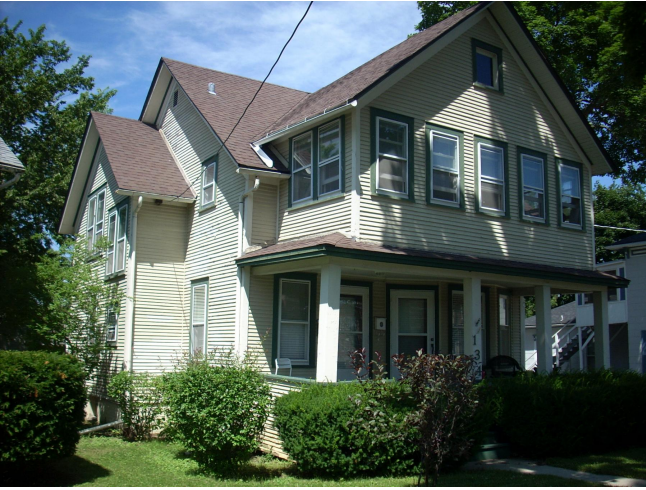
Photo Id: LakeSt134(2)

CATEGORY	HISTORIC USE
Building	Domestic - single dwelling
CONDITION	SECONDARY STRUCTURE
Good	Detached garage
INTEGRITY	NR SECOND
Minor alterations and additions	NC
CURRENT USE	
Domestic - multiple dwelling

Broad side gable roof crossed with front gable roof; recessed entry porch under front gable bay; 2-story west side gable bay; three-sided 1st-story window bay on east facade

Replacement wood windows; second entrance set within three-sided window bay under porch (building converted to multifamily some time between 1924 and 1933)

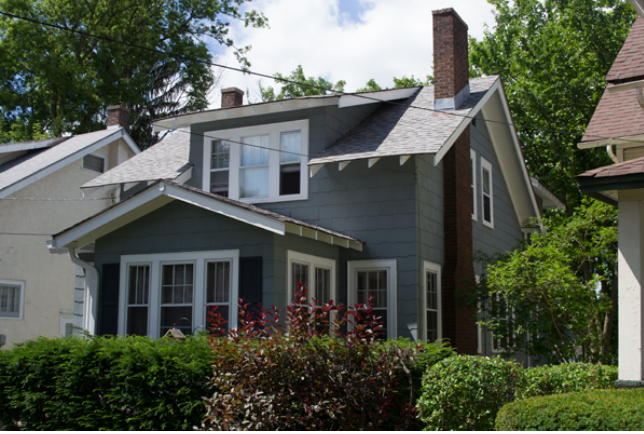
Photo Id: LakeSt138(1)

CATEGORY	HISTORIC USE
Building	Domestic - single dwelling
CONDITION	SECONDARY STRUCTURE
Fair	Detached garage
INTEGRITY	NR SECOND
Minor alterations	C
CURRENT USE	
Domestic - single dwelling

Charming Craftsman Bungalow with a very high degree of architectural integrity.

Side gable roof with overhanging eaves; shed-roof through-the-cornice dormer on front facade; projecting 1-story center gable bay on front facade, with attached west end, shed-roof entry bay; historic wood windows; historic front door

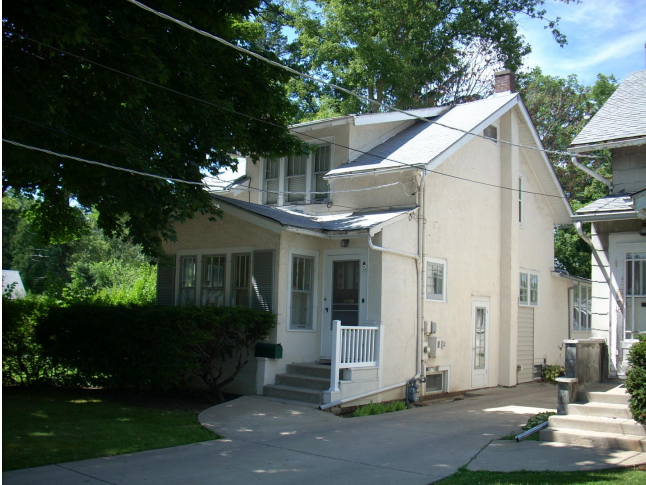
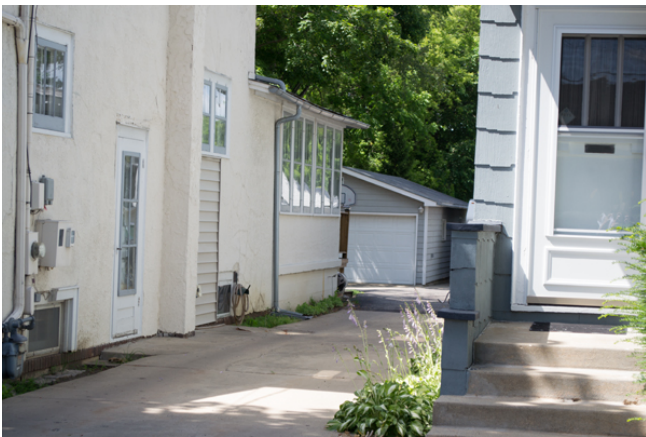
Photo Id: LakeSt140(1)

CATEGORY	HISTORIC USE
Building	Domestic - single dwelling
CONDITION	SECONDARY STRUCTURE
Fair	Detached garage
INTEGRITY	NR SECOND
Minor alterations	NC
CURRENT USE	
Domestic - single dwelling

Side gable roof with overhanging eaves; shed-roof, through-the-cornice dormer on front facade; 1-story front gable center bay with attached east end shed-roof entry bay; historic wood double hung windows; historic front door

Aluminum siding on a portion of the east facade; replacement railing at front entry stoop; rear second-story addition; rear deck addition (1996)

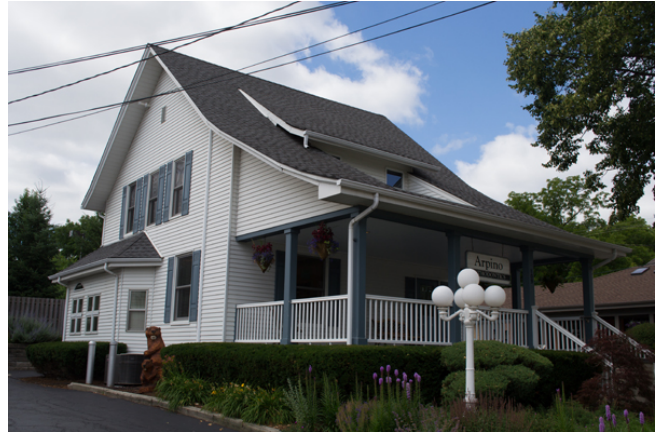
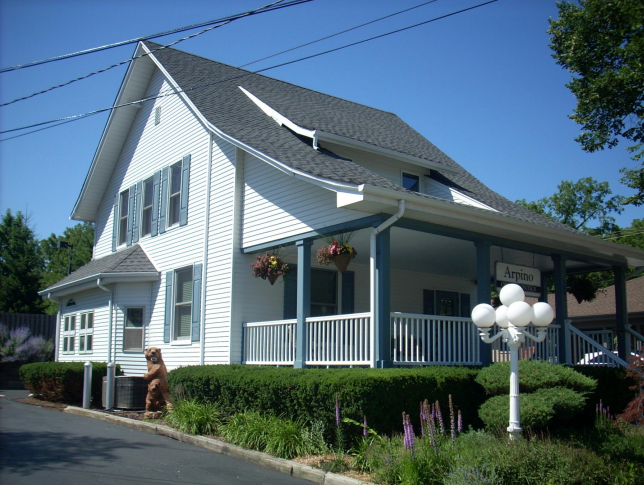
Photo Id: MapleAveW109(2)

CATEGORY	Building	HISTORIC USE	Domestic - single dwelling
CONDITION	Good	SECONDARY STRUCTURE	-
INTEGRITY	Major alterations and/or additions	NR SECOND	-
CURRENT USE	Commerce/trade - office

Replacement siding; replacement windows in original openings; shutters; replacement front porch (1983)

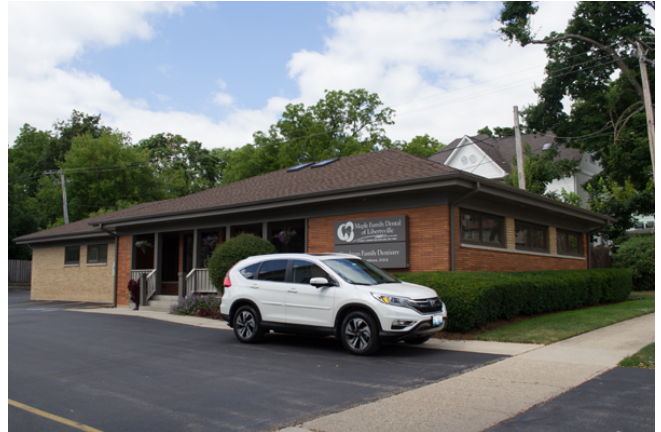
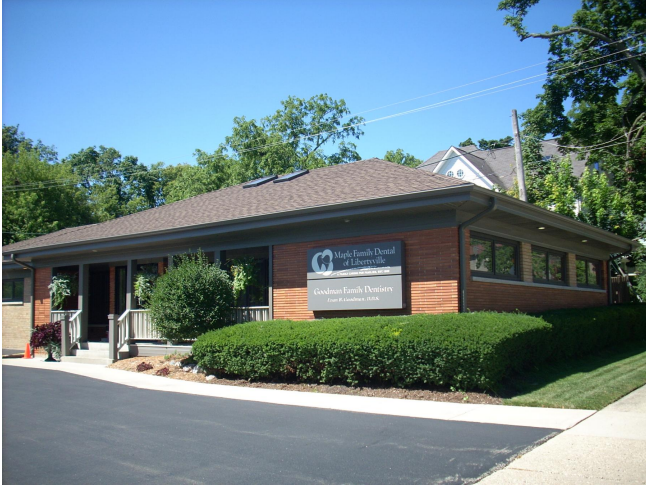
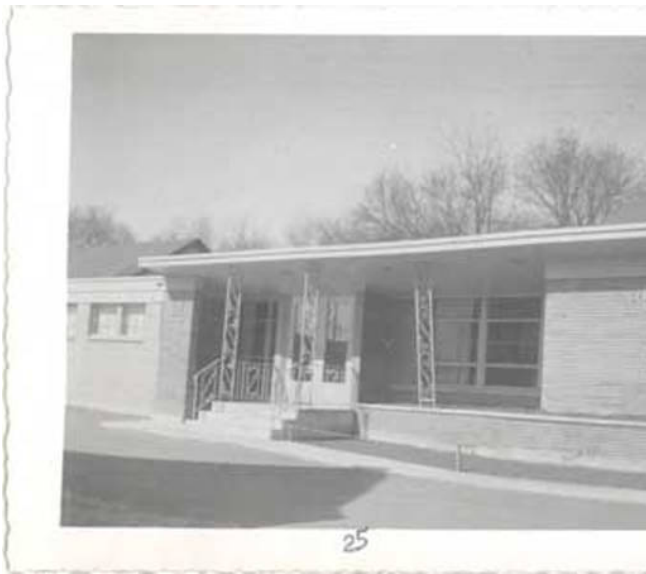
Photo Id: MapleAveW115

CATEGORY	HISTORIC USE
Building	Commerce/trade - office
CONDITION	SECONDARY STRUCTURE
Good	-
INTEGRITY	NR SECOND
Minor alterations	-
CURRENT USE	
Commerce/trade - office

Original flat roof changed to hipped; replacement front porch columns and railing; replacement windows in original openings; replacement front door; signage on east facade

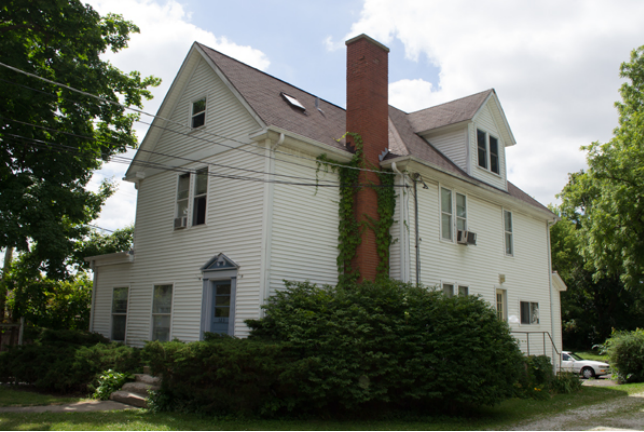
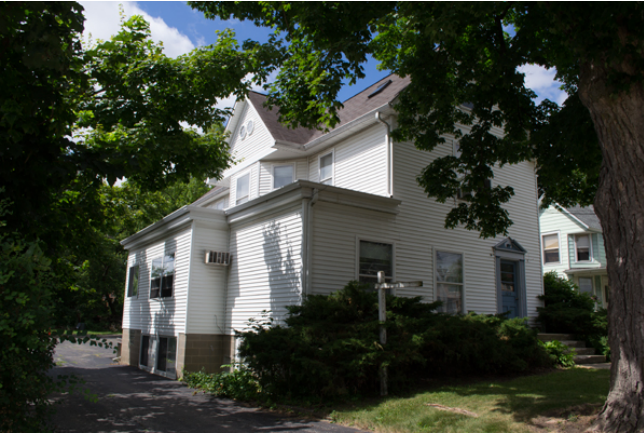
Photo Id: maple123

CATEGORY	HISTORIC USE
Building	Domestic - single dwelling
CONDITION	SECONDARY STRUCTURE
Good	-
INTEGRITY	NR SECOND
Major alterations and additions	-
CURRENT USE	
Domestic - multiple dwelling

Replacement siding; original wraparound porch removed (post-1948); 1-story east side addition (may have originally been part of porch that was enclosed); replacement windows, most in original openings; 1st story front window in altered opening; replacement front door and surround, concrete stoop (1950s); concrete stoop and door at west elevation
