Historic Libertyville

BEGINNING STREET NUMBER	308
END STREET NUMBER	-
STREET # SUFFIX	-
STREET NAME	W. Maple Avenue
PIN	
<u>LOCAL</u>	
WITHIN LOCAL DISTRICT?	No
LOCAL DIST CONTRIB/NON-CONTRIB?	C
LOCAL LANDMARK?	No
YEAR	-
LOCAL LANDMARK ELIGIBLE?	No
CRITERIA	-

Ramsey Historic Consultants

May-June 2016

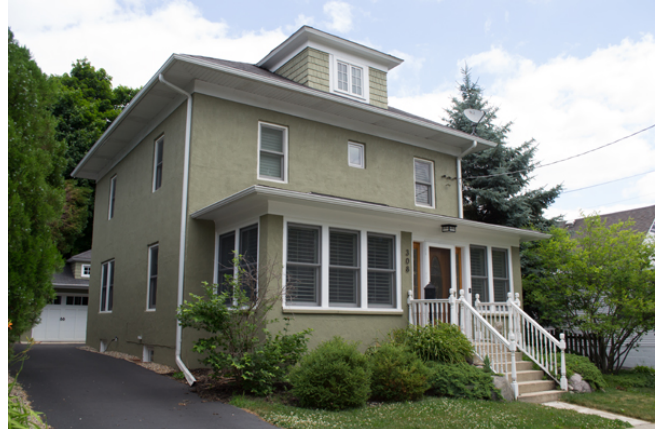
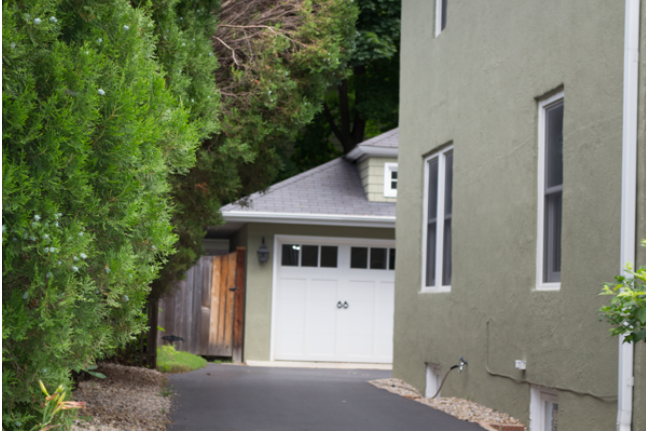
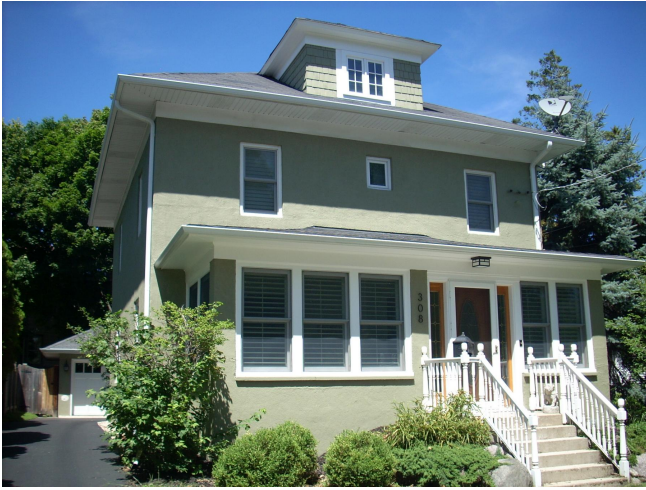
Photo Id: MapleAveW308(1)

CATEGORY	HISTORIC USE
Building	Domestic - single dwelling
CONDITION	SECONDARY STRUCTURE
Good	Detached garage
INTEGRITY	NR SECOND
Moderate alterations	NC
CURRENT USE	
Domestic - single dwelling

American Foursquare

Hipped roof and rectangular massing; hipped roof front gable; hipped-roof full front porch structure

Stucco siding (post-1948); front porch enclosed with 1/1 windows, new door and sidelights; replacement windows in original openings; replacement front door; concrete front steps with wood railing

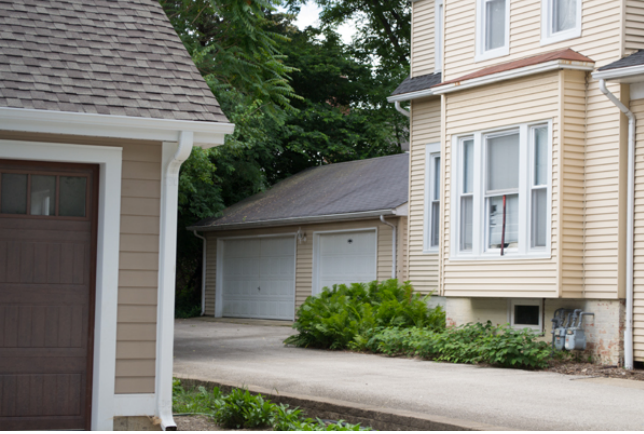
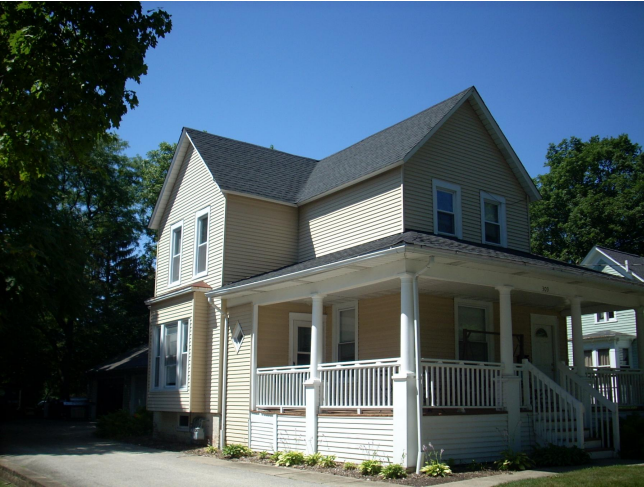
Photo Id: MapleAveW309(3)

CATEGORY	HISTORIC USE
Building	Domestic - single dwelling
CONDITION	SECONDARY STRUCTURE
Good	Detached garage
INTEGRITY	NR SECOND
Minor alterations and additions	NC
CURRENT USE	
Domestic - single dwelling

Gabled Ell

Front gable bay intersected by east-side two-story gable ell; wraparound porch structure with hipped roof, supported by classical columns set on square piers; first-story three-sided west window bay; square oriel window bay on east facade

Replacement siding; replacement windows in original openings; alterations to front porch--replacement railings, ceiling; southeast corner porch enclosed, 2nd story addition added above (post-1948)

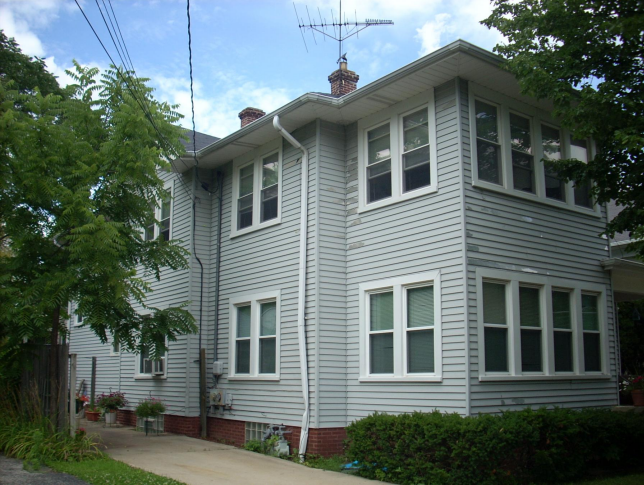
Photo Id: Maple312

CATEGORY	HISTORIC USE
Building	Domestic - multiple dwelling
CONDITION	SECONDARY STRUCTURE
Good	Detached garage
INTEGRITY	NR SECOND
Minor alterations	NC
CURRENT USE	
Domestic - multiple dwelling

Craftsman

Low pitched front hipped roof with overhanging eaves; north (rear) section of house features side gable roof; southeast corner entry porch with hipped roof and battered square column on brick pier; historic wood entry doors

Replacement siding (1955--permit indicates that house was originally stucco); replacement windows in original openings (1/1 on first and second stories, glass block in basement)

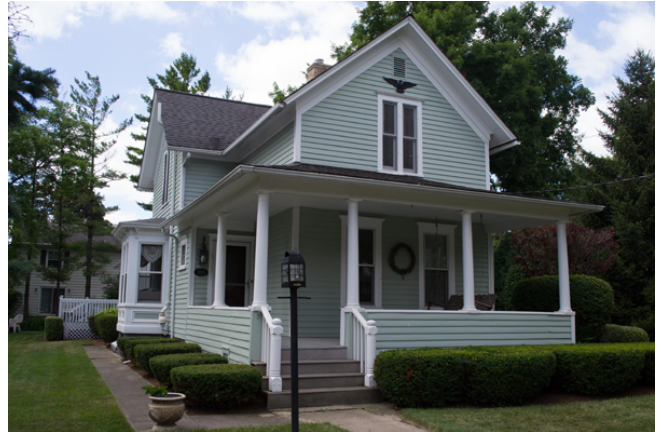
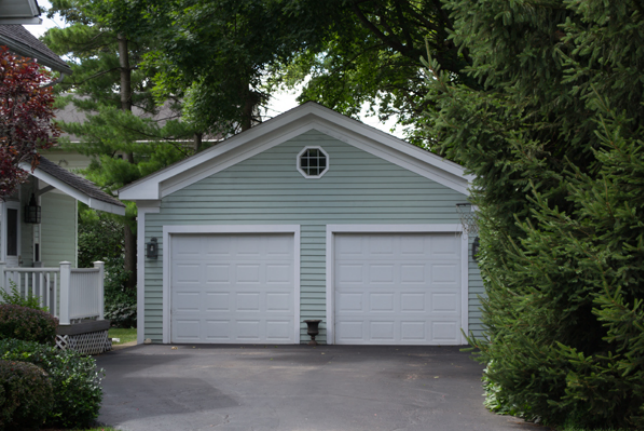
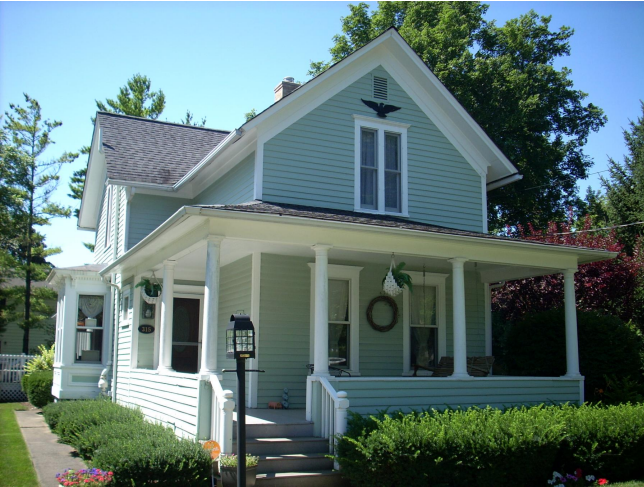
Photo Id: MapleAveW315(1)

CATEGORY	HISTORIC USE
Building	Domestic - single dwelling
CONDITION	SECONDARY STRUCTURE
Good	Detached garage
INTEGRITY	NR SECOND
Minor alterations	NC
CURRENT USE	
Domestic - single dwelling

Even with alterations to east porch and replacement windows, this Cross Form residence with Queen Anne and Italianate detailing may be eligible for local landmark designation.

Cross gable roofline, with 2-story front gable bay intersected by east and west projecting gable bays; wraparound front porch (likely an historic alteration from early 20th century); 1-story east window bay with classical cornice

Replacement windows in original openings; rear and southeast porches enclosed and connected (1982)

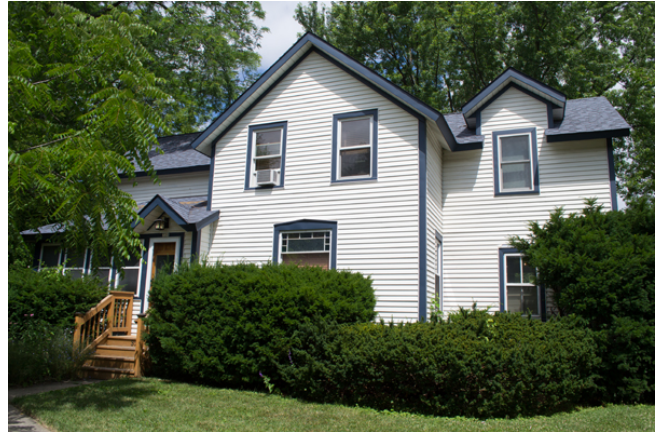
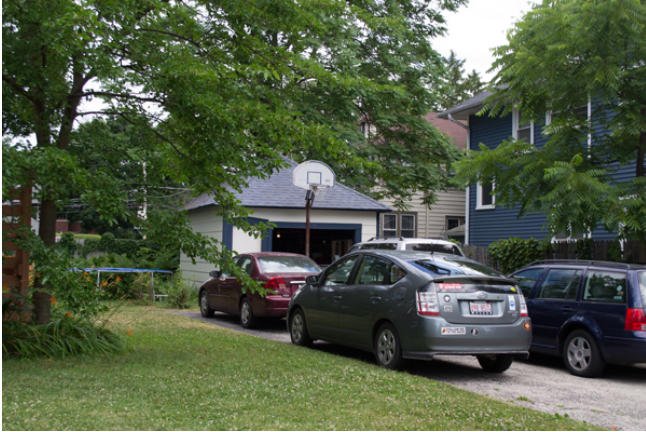
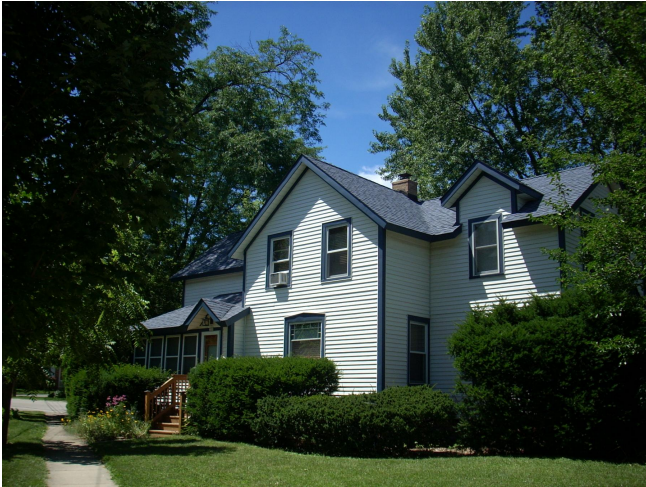
Photo Id: MapleAveW320(2)

CATEGORY	Building	HISTORIC USE	Domestic - single dwelling
CONDITION	Good	SECONDARY STRUCTURE	Detached garage
INTEGRITY	Moderate alterations	NR SECOND	C
CURRENT USE	Domestic - single dwelling

L-Form

Two-story south-facing gable bay intersected by two-story west side wing; historic window with multi-light upper sash on first story of south-facing bay

1/1 replacement windows in original openings; replacement front porch (later enclosed); 2nd story east addition (2007)

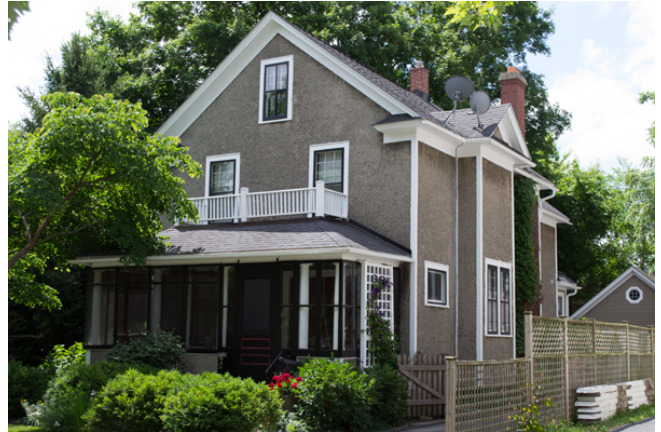
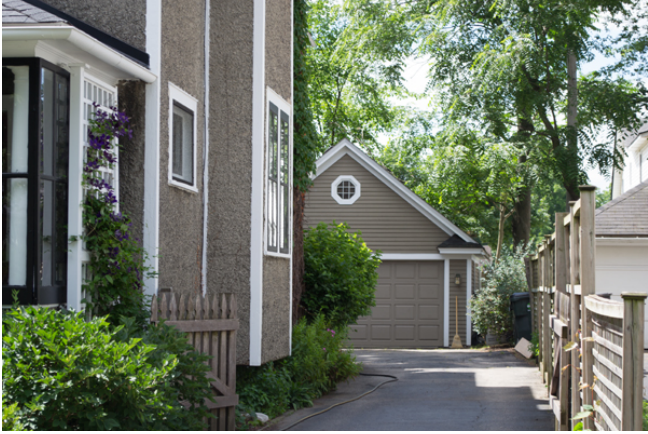
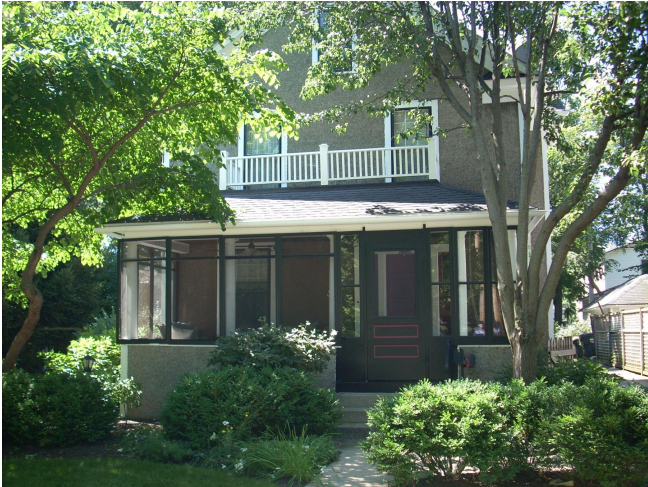
Photo Id: MapleAveW323(1)

CATEGORY	HISTORIC USE
Building	Domestic - single dwelling
CONDITION	SECONDARY STRUCTURE
Good	Detached garage
INTEGRITY	NR SECOND
Minor alterations and additions	NC
CURRENT USE	
Domestic - single dwelling

Well-preserved Gable Front residence with Colonial Revival detailing.

Front gable roof with cornice returns; 2-story west side projecting bay; hipped-roof front porch with classical columns on stucco knee wall; historic front door and sidelights; historic wood windows

Replacement railings at roof of front porch; rear addition (2000)

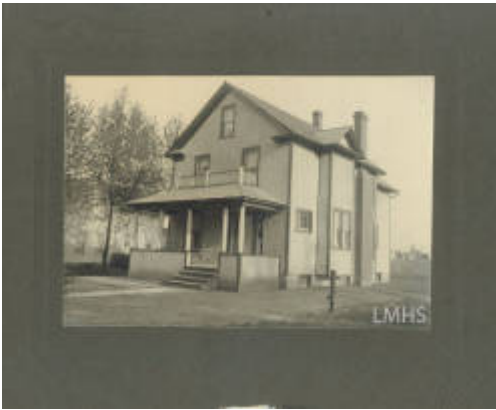
MapleAveW323

Replacement windows in front porch

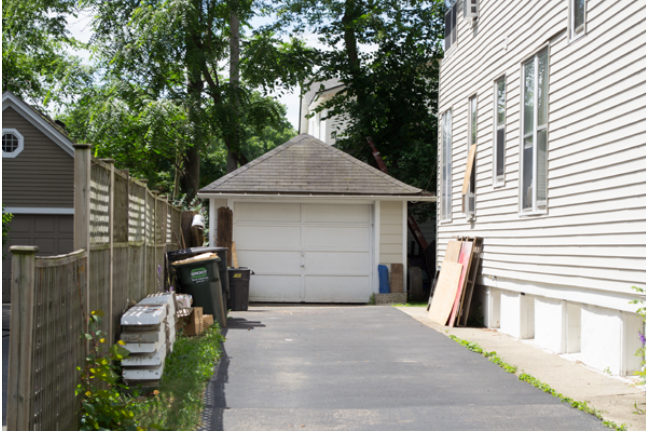
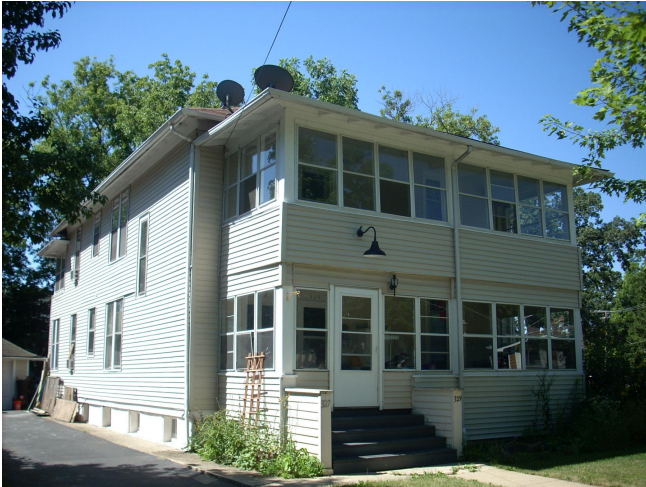
Photo Id: MapleAveW327-329(1)

CATEGORY	HISTORIC USE
Building	Domestic - multiple dwelling
CONDITION	SECONDARY STRUCTURE
Good	Detached garage
INTEGRITY	NR SECOND
Moderate alterations	C
CURRENT USE	
Domestic - multiple dwelling

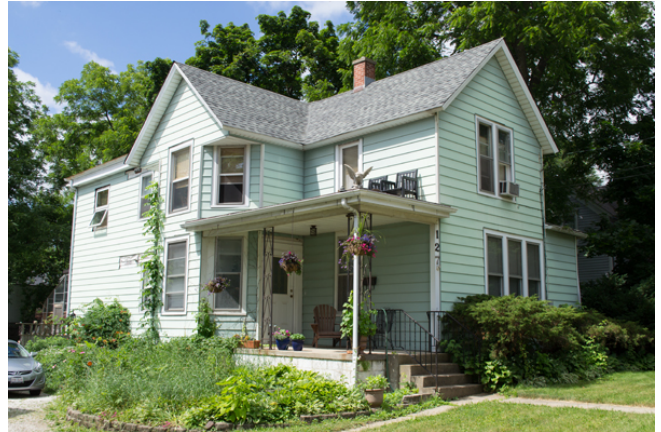
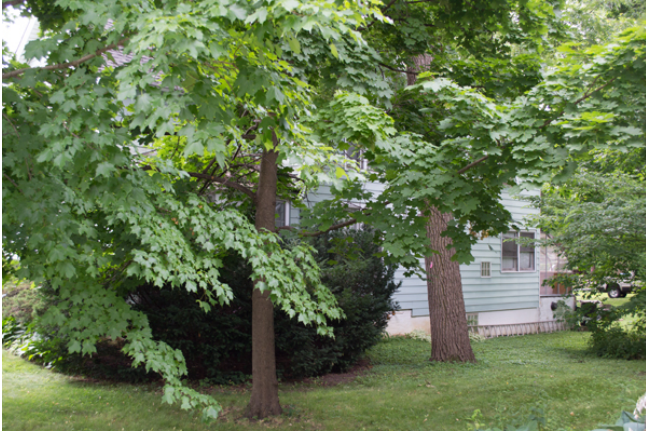
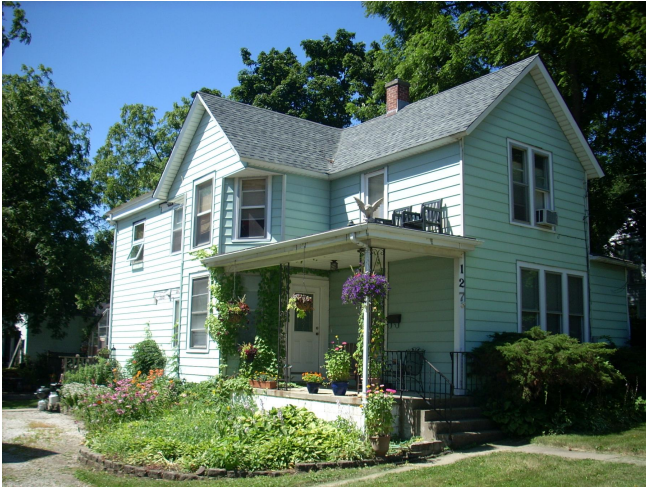
Photo Id: MapleAveW127(1)

CATEGORY	Building	HISTORIC USE	Domestic - single dwelling
CONDITION	Good	SECONDARY STRUCTURE	-
INTEGRITY	Minor alterations and additions	NR SECOND	-
CURRENT USE	Domestic - single dwelling

Replacement front porch; replacement siding (2003); 2-story rear addition; 1-story west side addition; replacement windows, most in original openings; three-part window at first story of front facade

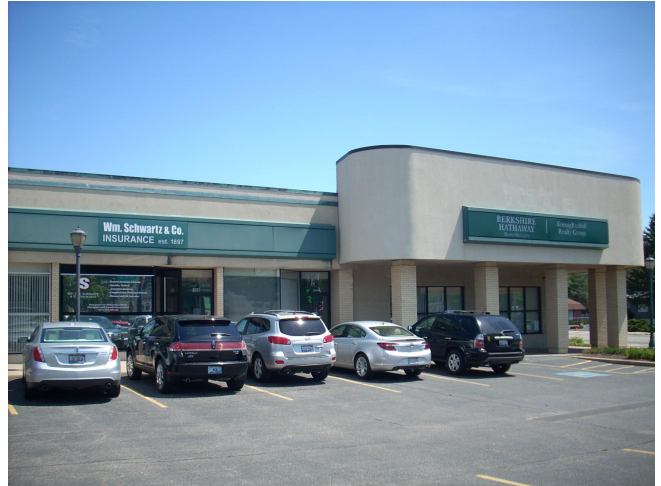
Photo Id: NMil100108

CATEGORY	HISTORIC USE
Building	Commerce/Trade
CONDITION	SECONDARY STRUCTURE
Good	-
INTEGRITY	NR SECOND
Minor alterations	-
CURRENT USE	
Commerce/Trade
