Historic Libertyville

BEGINNING STREET NUMBER	315
END STREET NUMBER	-
STREET # SUFFIX	-
STREET NAME	W. Park Avenue
PIN	
<u>LOCAL</u>	
WITHIN LOCAL DISTRICT?	No
LOCAL DIST CONTRIB/NON-CONTRIB?	C
LOCAL LANDMARK?	No
YEAR	-
LOCAL LANDMARK ELIGIBLE?	No
CRITERIA	-

Downtown Libertyville

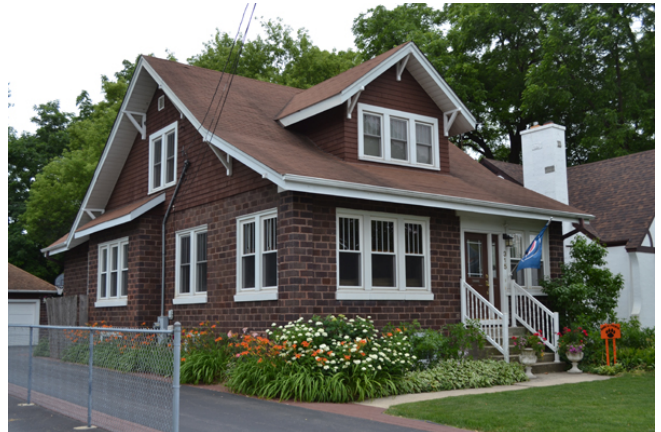
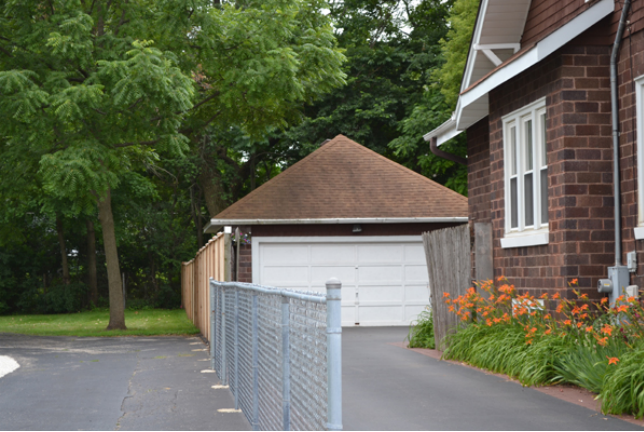
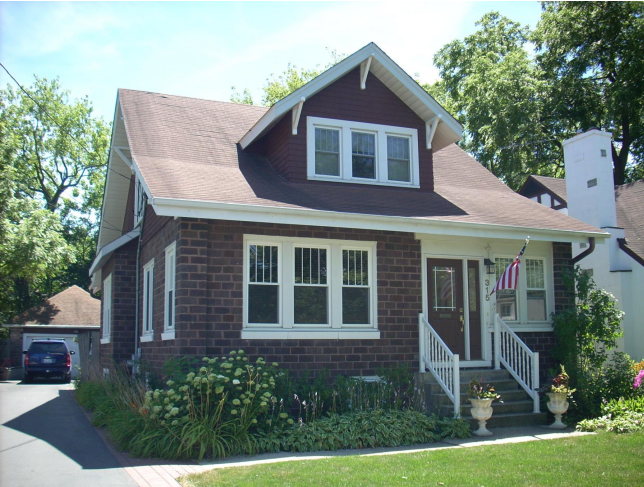
Photo Id: ParkAveW315(2)

CATEGORY	HISTORIC USE
Building	Domestic - single dwelling
CONDITION	SECONDARY STRUCTURE
Good	Detached garage
INTEGRITY	NR SECOND
Minor alterations	C
CURRENT USE	
Domestic - single dwelling

Craftsman Bungalow

Side gable roof with overhanging eaves and L brackets; gable front dormer; inset corner entry porch with brick pier and knee walls; she-roof square window bay on east facade; oversized brick and wood shingle exterior

Replacement windows in original openings; front porch enclosed

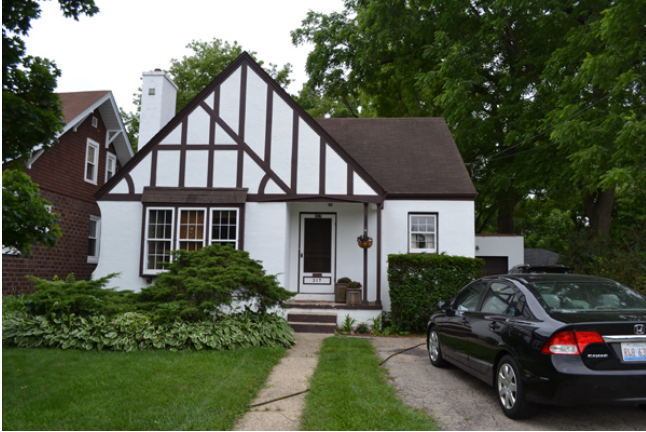
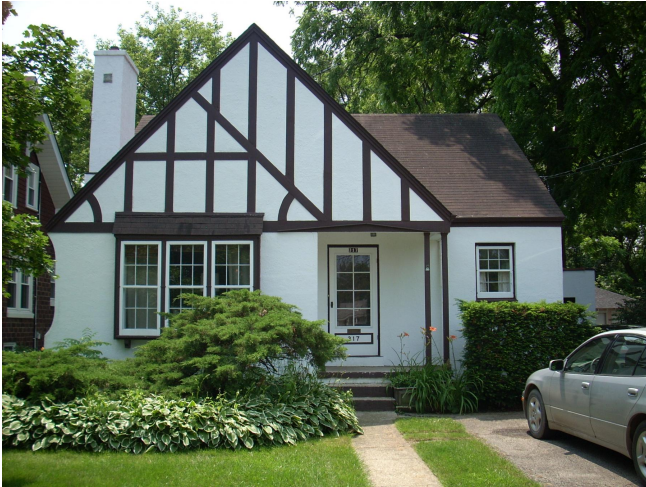
Photo Id: ParkAveW317(2)

CATEGORY	HISTORIC USE
Building	Domestic - single dwelling
CONDITION	SECONDARY STRUCTURE
Good	[attached garage]
INTEGRITY	NR SECOND
Minor alterations	-
CURRENT USE	
Domestic - single dwelling

Tudor Revival

Modest but nicely detailed Tudor Revival cottage from the early post-war period.

Side gable roof; broad front gable bay with decorative half timbering; inset corner entry porch with square wood supports; east end chimney; three-sided oriel bay on east facade; historic wood plank door; wood windows; garage bay at west facade

Replacement front steps to west side entry

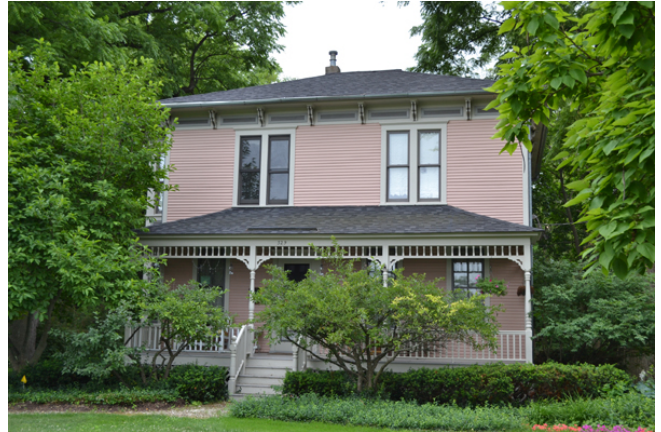
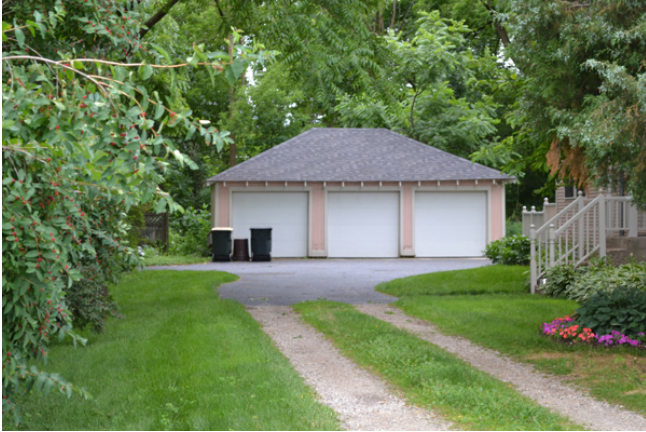
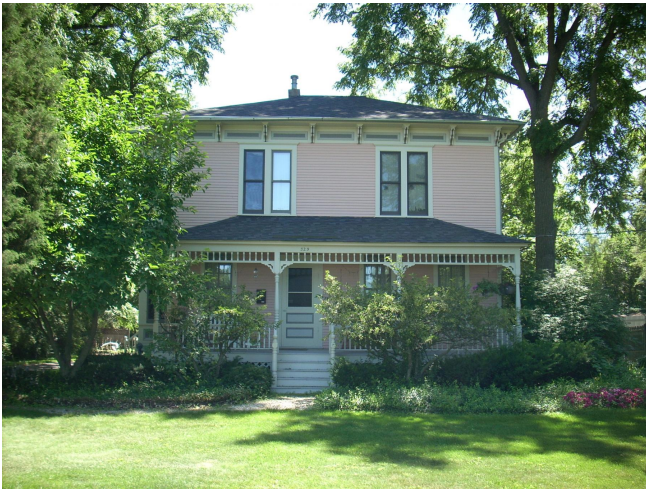
Photo Id: ParkAveW329(1)

CATEGORY	Building	HISTORIC USE	Domestic - single dwelling
CONDITION	Good	SECONDARY STRUCTURE	Detached garage
INTEGRITY	Minor alterations	NR SECOND	C
CURRENT USE	Domestic - single dwelling

Folk Victorian

Handsome Folk Victorian residence from the late 19th century. Notable features include cornice with paneled frieze and scrolled brackets, hipped-roof front porch, and two-story east side bay.

Hipped roof; cornice with paneled frieze and brackets; hipped roof porch with turned porch columns and railings and spindlework frieze (may be early alteration from the 1890s); two-story, three-sided bay on east facade; some windows on first floor appear to be historic wood double hung windows

Second-story windows are wood replacement; rear deck addition (1996)

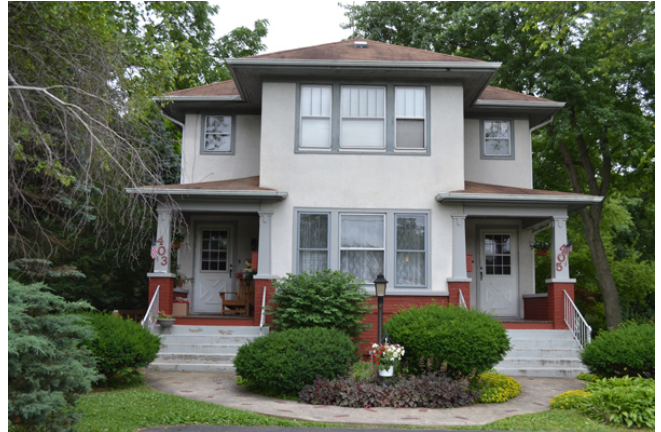
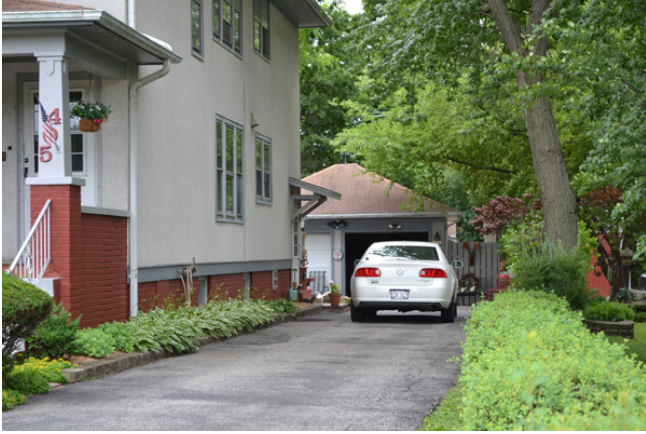
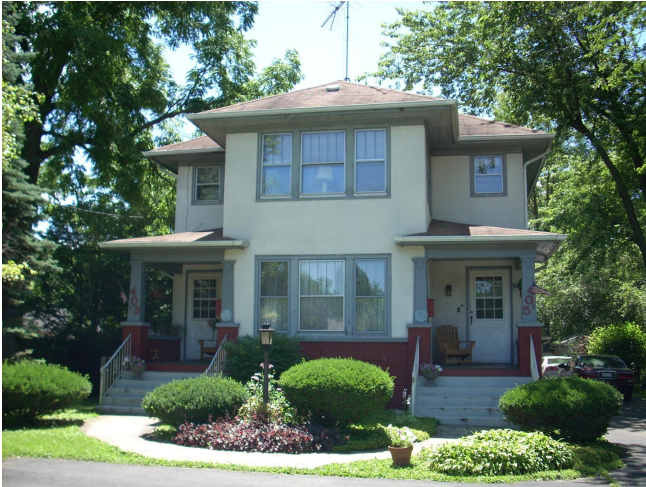
Photo Id: ParkAveW403-405(1)

CATEGORY	HISTORIC USE
Building	Domestic - multiple dwelling
CONDITION	SECONDARY STRUCTURE
Good	Detached garage
INTEGRITY	NR SECOND
Minor alterations	C
CURRENT USE	
Domestic - multiple dwelling

Craftsman

Fine Craftsman duplex with mirror-image entry porches on either side of a central hipped-roof bay.

Two-story hipped front bay flanked by matching entry porches (porches feature brick knee walls, battered piers, hipped roof); overhanging eaves; stucco cladding; west secondary entrance with shed canopy; historic wood windows

Replacement railings on front steps

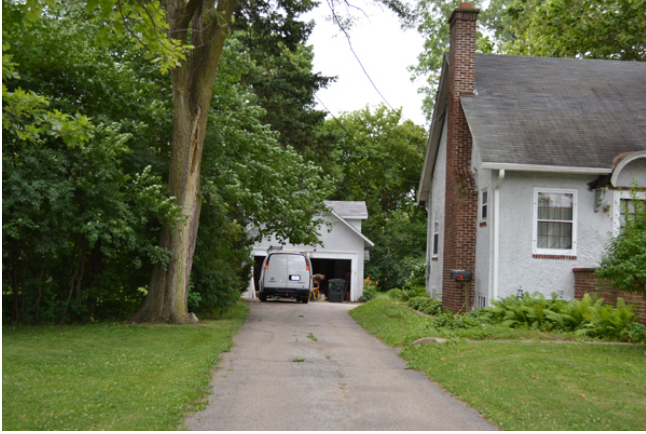
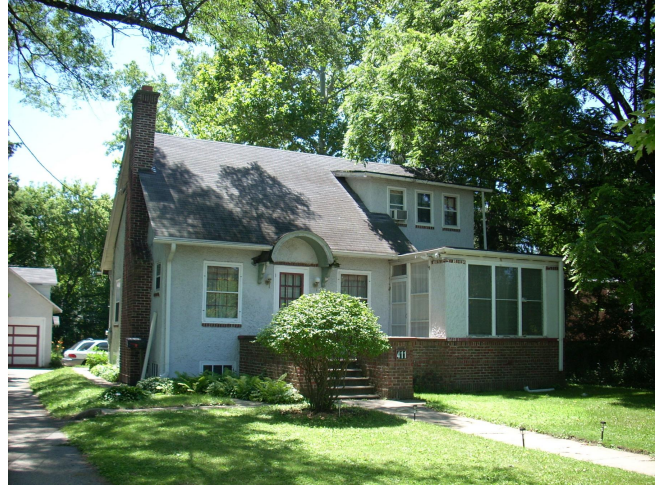
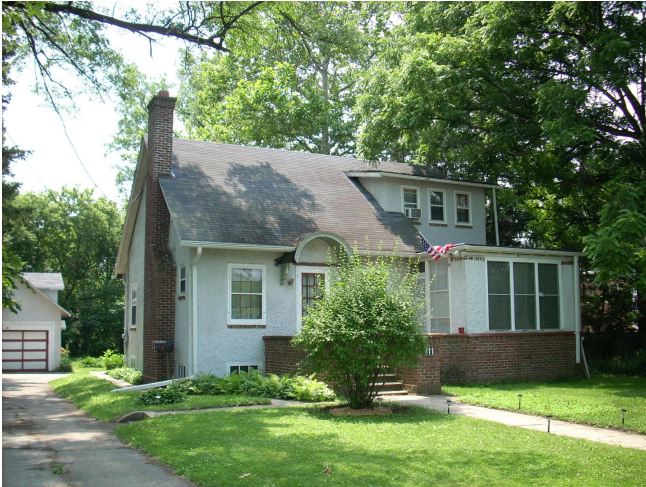
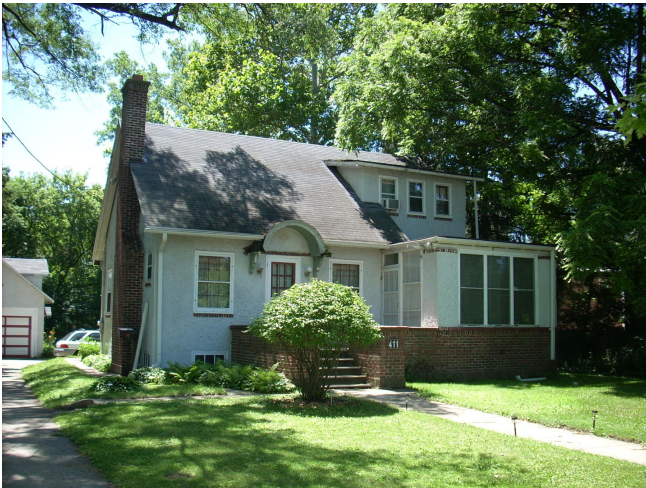
Photo Id: ParkAveW411(1)

CATEGORY	HISTORIC USE
Building	Domestic - single dwelling
CONDITION	SECONDARY STRUCTURE
Good	Detached garage
INTEGRITY	NR SECOND
Minor alterations	C
CURRENT USE	
Domestic - single dwelling

Craftsman Bungalow

Side gable roof with overhanging eaves; shed-roof, through-the-cornice dormer; brick knee walls surrounding front terrace; west end sun porch; historic front door with barrel arch canopy; historic wood windows; brick rowlock sills; east side brick chimney

Jalousie windows in sun porch; exterior re-stuccoed

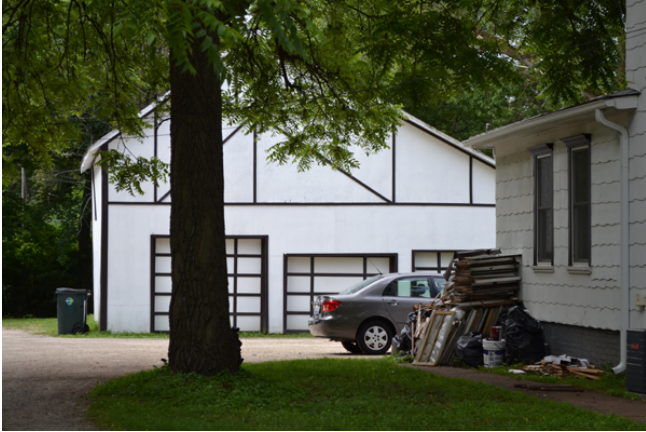
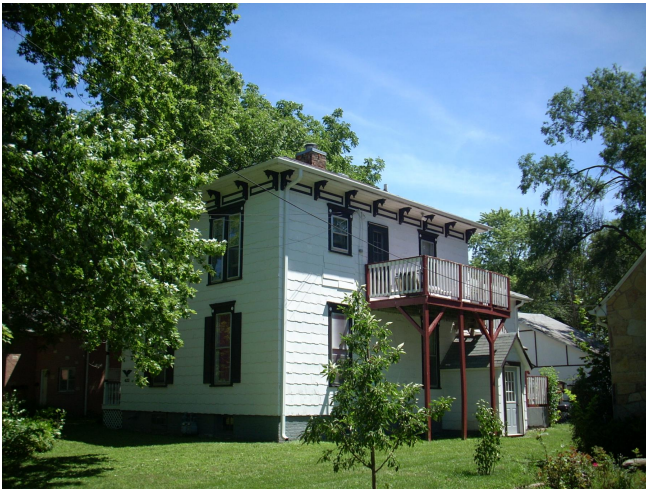
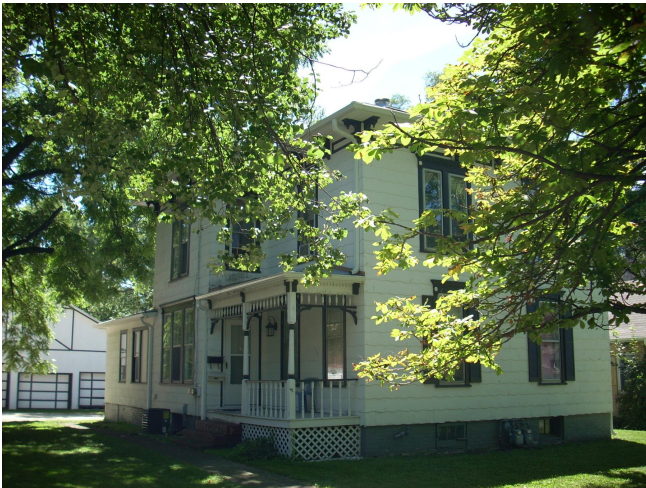
Photo Id: ParkAveW423(1)

CATEGORY	HISTORIC USE
Building	Domestic - single dwelling
CONDITION	SECONDARY STRUCTURE
Good	Barn
INTEGRITY	NR SECOND
Minor alterations and additions	C
CURRENT USE	
Domestic - multiple dwelling

Replacement siding; some 1/1 replacement windows in original openings; replacement railing and deck on porch; replacement front door; rear east porch enclosed; fixed shutters; one-story west addition; west side stair addition

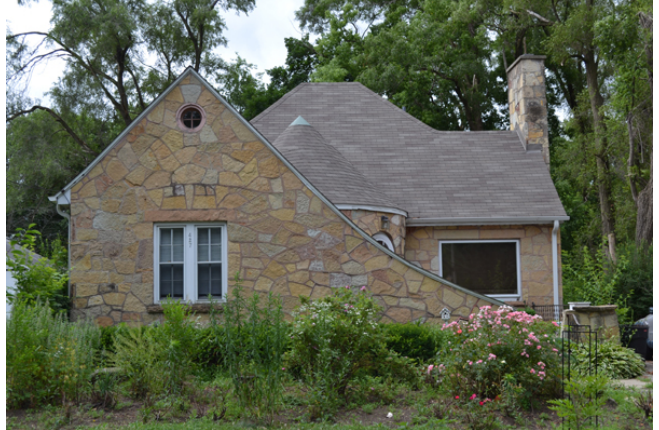
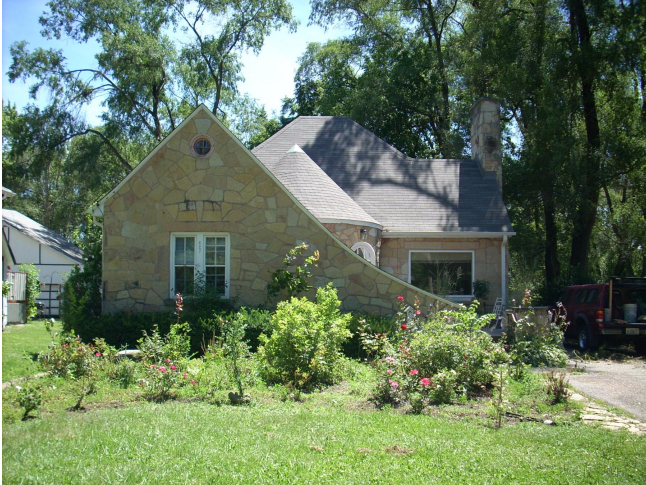
Photo Id: ParkAveW427(1)

CATEGORY	HISTORIC USE
Building	Domestic - single dwelling
CONDITION	SECONDARY STRUCTURE
Good	Detached garage
INTEGRITY	NR SECOND
Minor alterations and additions	NC
CURRENT USE	
Domestic - single dwelling

Aluminum on east side shed-roof dormer and under eaves

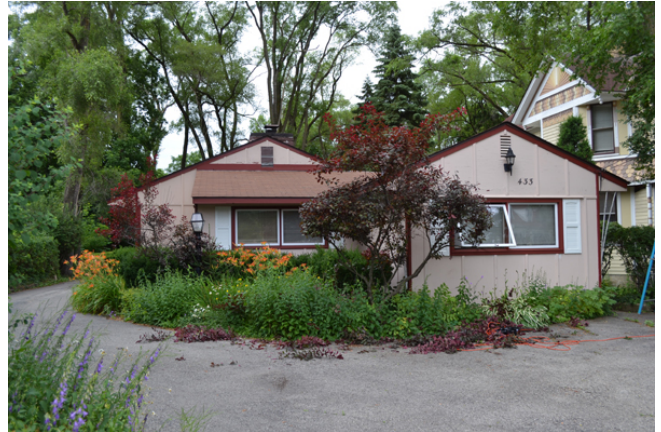
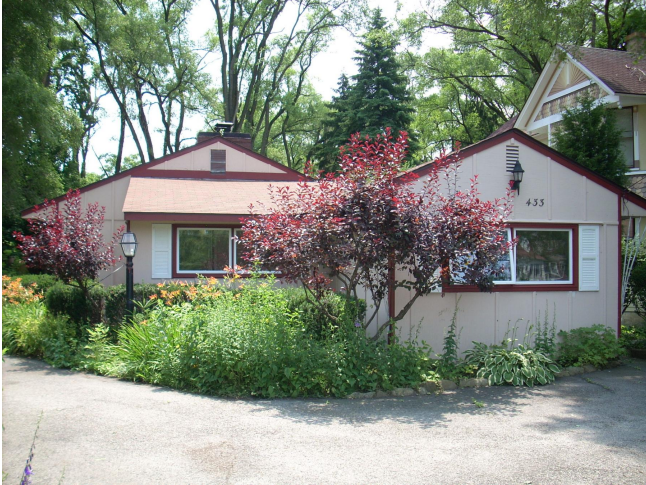
Photo Id: ParkAveW433

CATEGORY	HISTORIC USE
Building	Domestic - single dwelling
CONDITION	SECONDARY STRUCTURE
Good	Detached garage
INTEGRITY	NR SECOND
Moderate alterations and additions	NC
CURRENT USE	
Domestic - single dwelling

One-story shed-roof front addition (1970)
