Historic Libertyville

BEGINNING STREET NUMBER	121
END STREET NUMBER	-
STREET # SUFFIX	-
STREET NAME	First Street
PIN	
<u>LOCAL</u>	
WITHIN LOCAL DISTRICT?	No
LOCAL DIST CONTRIB/NON-CONTRIB?	C
LOCAL LANDMARK?	No
YEAR	-
LOCAL LANDMARK ELIGIBLE?	No
CRITERIA	-

Ramsey Historic Consultants

Downtown Libertyville

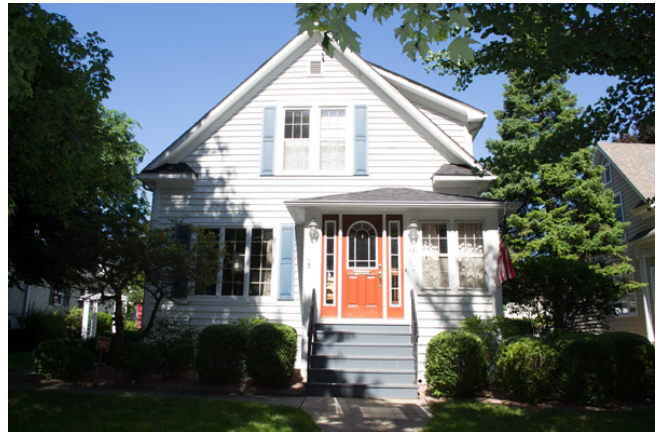
Photo Id: FirstSt121(1)

CATEGORY	HISTORIC USE
Building	Domestic - single dwelling
CONDITION	SECONDARY STRUCTURE
Good	Detached garage
INTEGRITY	NR SECOND
Minor alterations and additions	NC
CURRENT USE	
Domestic - single dwelling

Front gable roof with cornice returns; south side gable through-the-cornice dormer; three-sided first story window bay on south facade; historic 6/6 wood windows

Front entry porch is historic addition (1924-1933) that was enclosed some time after 1948; replacement siding; replacement casement windows in front window bay; north side shed-roof dormer addition (1974)
