Historic Libertyville

| STREET NAME | First Street |

BUILDING DETAILS

ARCHITECTURAL DESCRIPTION

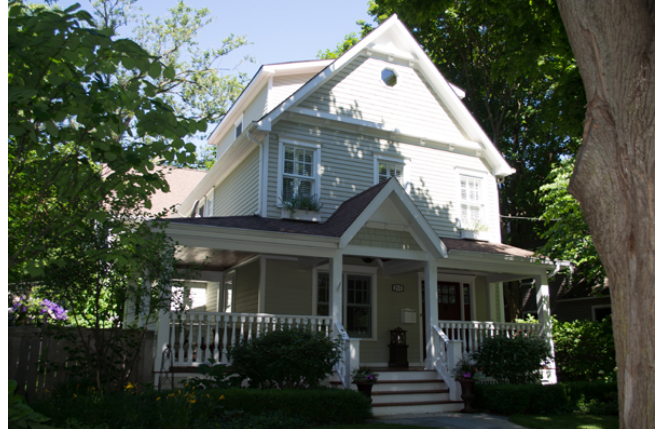
Photo Id: FirstSt213(1)

New Traditional - Queen Anne (altered)

Original house obscured by multiple alterations and additions, most of which date from 2012--wraparound front porch; multiple dormer additions on north and south side of roof (1962, later); large 2-story rear addition; replacement siding; replacement windows in original openings
