Historic Libertyville

BEGINNING STREET NUMBER	207
END STREET NUMBER	-
STREET # SUFFIX	-
STREET NAME	E. Park Avenue
PIN	
<u>LOCAL</u>	
WITHIN LOCAL DISTRICT?	No
LOCAL DIST CONTRIB/NON-CONTRIB?	C
LOCAL LANDMARK?	No
YEAR	-
LOCAL LANDMARK ELIGIBLE?	No
CRITERIA	-

Gable Front Cottage

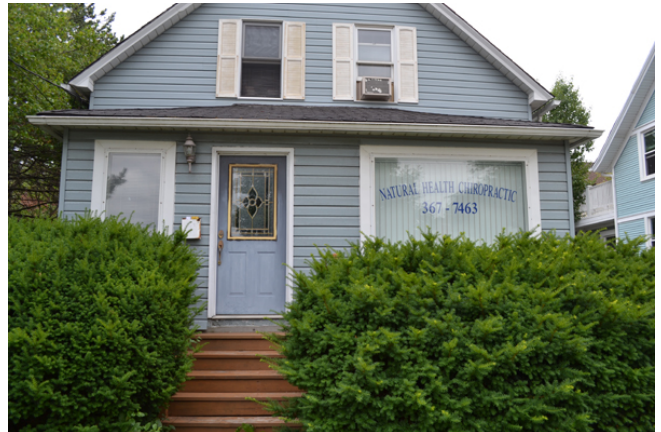
Photo Id: ParkAveE207(4)

Front gable roof and rectangular massing; hipped-roof full-front porch structure (enclosed)

Replacement siding (1994); replacement windows in original openings; front porch enclosed (two door openings, one picture window); fixed shutters
