Historic Libertyville

BEGINNING STREET NUMBER	208
END STREET NUMBER	-
STREET # SUFFIX	-
STREET NAME	W. Park Avenue
PIN	
<u>LOCAL</u>	
WITHIN LOCAL DISTRICT?	No
LOCAL DIST CONTRIB/NON-CONTRIB?	C
LOCAL LANDMARK?	No
YEAR	-
LOCAL LANDMARK ELIGIBLE?	Potentially Eligible
CRITERIA	A

BUILDING NAME	Waldo, A. W. House	ZONING	R-8
GROUND FLOOR USE	Residential	NUMBER OF STORIES	3
UPPER FLOOR USE	Residential	PROPERTY INDEX NUMBER	1121100008
CURRENT OCCUPANT	-

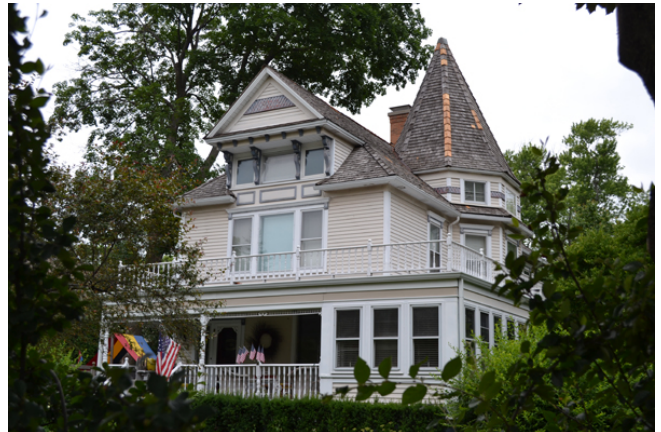
Photo Id: ParkAveW208(1)

Hipped main roof with projecting front-gable through-the-cornice dormer on south facade (dormer features overhang supported by scrolled brackets); 2.5-story east side polygonal tower with pointed roof; wraparound front porch structure (not original, but historic--dates from between 1924 and 1933; partially enclosed)

Replacement siding (1991); wood-shingle roofing; east end of wraparound porch enclosed (post-1948); replacement railings on porch; one-story rear addition; replacement windows in original openings

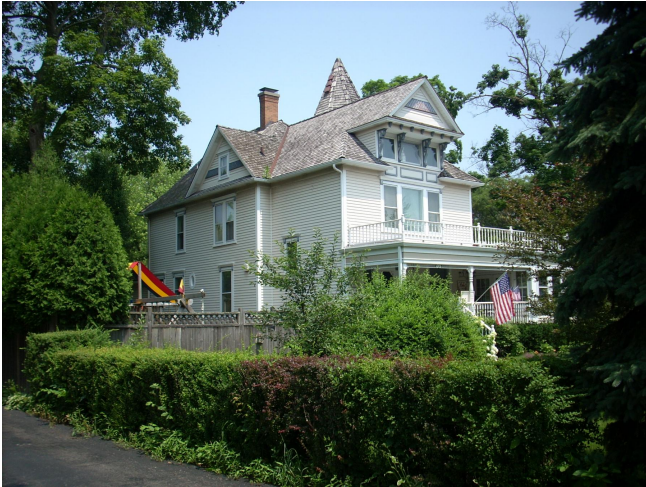
Photo Id: Park208W

Photograph of house on p. 15 of LIBERTYVILLE ILLUSTRATED: Abner W. Waldo "was born in central Vermont in 1830, and removed to the great Northwest while yet a young man, settling in Wisconsin in 1855. After the war, during the latter portion of which he served his country in the First Wisconsin heaving Artillery, he disposed of his farm and removed to Chicago, where he was employed as a bookkeeper for some six years. He then, in 1871, engaged in the lumber business in quite an extensive way. In 1883 he purchased a large improved farm near Libertyville, which he sold in 1896. In that year he retired from business in Chicago and removed to Libertyville, where he erected a fine residence, surrounded by choice trees. Mr. Waldo is a public-spirited man, a splendid example of what New England has done for the Great West."
