# Historic Libertyville

BEGINNING STREET NUMBER	123
END STREET NUMBER	-
STREET # SUFFIX	-
STREET NAME	W. Maple Avenue
PIN	
<b><u>LOCAL</u></b>	
WITHIN LOCAL DISTRICT?	No
LOCAL DIST CONTRIB/NON-CONTRIB?	NC
LOCAL LANDMARK?	No
YEAR	-
LOCAL LANDMARK ELIGIBLE?	No
CRITERIA	-

Photo Id: maple123

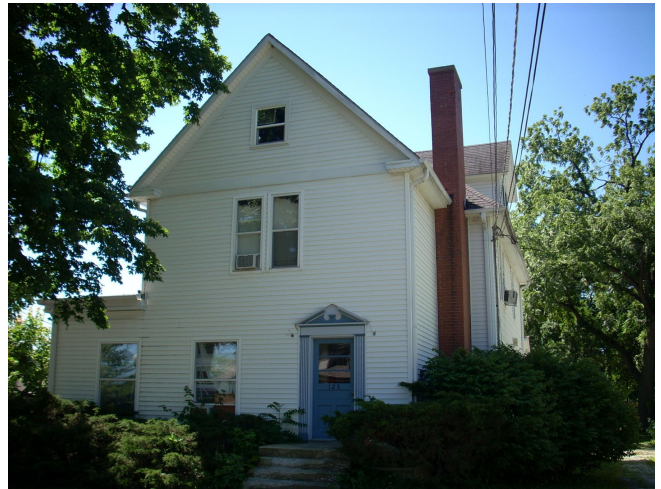
<b>CATEGORY</b>	<b>HISTORIC USE</b>
Building	Domestic - single dwelling
<b>CONDITION</b>	<b>SECONDARY STRUCTURE</b>
Good	-
<b>INTEGRITY</b>	<b>NR SECOND</b>
Major alterations and additions	-
<b>CURRENT USE</b>	
Domestic - multiple dwelling

Hipped main roof; large 2-story front gable bay at north end; 2-story east bay with cutaway corners; west side gable dormer window

Replacement siding; original wraparound porch removed (post-1948); 1-story east side addition (may have originally been part of porch that was enclosed); replacement windows, most in original openings; 1st story front window in altered opening; replacement front door and surround, concrete stoop (1950s); concrete stoop and door at west elevation
