# Historic Libertyville

BEGINNING STREET NUMBER	133
END STREET NUMBER	-
STREET # SUFFIX	-
STREET NAME	W. Maple Avenue
PIN	
<b><u>LOCAL</u></b>	
WITHIN LOCAL DISTRICT?	No
LOCAL DIST CONTRIB/NON-CONTRIB?	C
LOCAL LANDMARK?	No
YEAR	-
LOCAL LANDMARK ELIGIBLE?	No
CRITERIA	-

Photo Id: MapleAveW133(1)

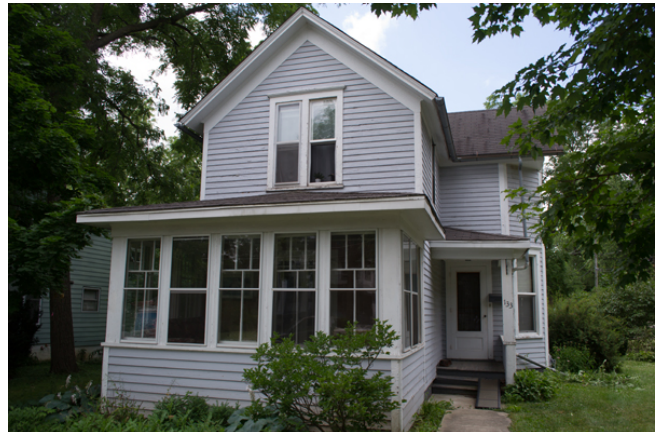
<b>CATEGORY</b>	<b>HISTORIC USE</b>
Building	Domestic - single dwelling
<b>CONDITION</b>	<b>SECONDARY STRUCTURE</b>
Good	Detached garage
<b>INTEGRITY</b>	<b>NR SECOND</b>
Minor alterations	C
<b>CURRENT USE</b>	
Domestic - single dwelling

Front gable bay intersected by west-side gable ell; with cutaway corners and sunburst ornament under gable; 2-story square gable bay on east facade; historic wood surrounds and lintels on window openings

Hipped roof front entry porch and front sun porch are historic alterations (replaced original wraparound front porch some time between 1924 and 1933); 1/1 replacement windows in original openings (not historic)
