Historic Libertyville

BEGINNING STREET NUMBER	315
END STREET NUMBER	-
STREET # SUFFIX	-
STREET NAME	W. Maple Avenue
PIN	
<u>LOCAL</u>	
WITHIN LOCAL DISTRICT?	No
LOCAL DIST CONTRIB/NON-CONTRIB?	C
LOCAL LANDMARK?	No
YEAR	-
LOCAL LANDMARK ELIGIBLE?	Potentially Eligible
CRITERIA	A

Photo Id: MapleAveW315(1)

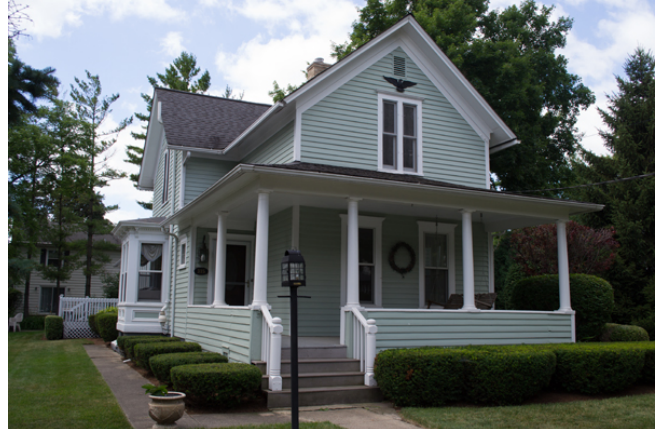
CATEGORY	HISTORIC USE
Building	Domestic - single dwelling
CONDITION	SECONDARY STRUCTURE
Good	Detached garage
INTEGRITY	NR SECOND
Minor alterations	NC
CURRENT USE	
Domestic - single dwelling

Even with alterations to east porch and replacement windows, this Cross Form residence with Queen Anne and Italianate detailing may be eligible for local landmark designation.

Cross gable roofline, with 2-story front gable bay intersected by east and west projecting gable bays; wraparound front porch (likely an historic alteration from early 20th century); 1-story east window bay with classical cornice

Replacement windows in original openings; rear and southeast porches enclosed and connected (1982)
