Historic Libertyville

BEGINNING STREET NUMBER	135
END STREET NUMBER	-
STREET # SUFFIX	-
STREET NAME	W. Church Street
PIN	
<u>LOCAL</u>	
WITHIN LOCAL DISTRICT?	No
LOCAL DIST CONTRIB/NON-CONTRIB?	C
LOCAL LANDMARK?	No
YEAR	-
LOCAL LANDMARK ELIGIBLE?	Potentially Eligible
CRITERIA	A, H

BUILDING NAME	Libertyville Post Office	ZONING	I-B
GROUND FLOOR USE	Civic	NUMBER OF STORIES	1
UPPER FLOOR USE	N/A	PROPERTY INDEX NUMBER	1116300095
CURRENT OCCUPANT	Libertyville Civic Center

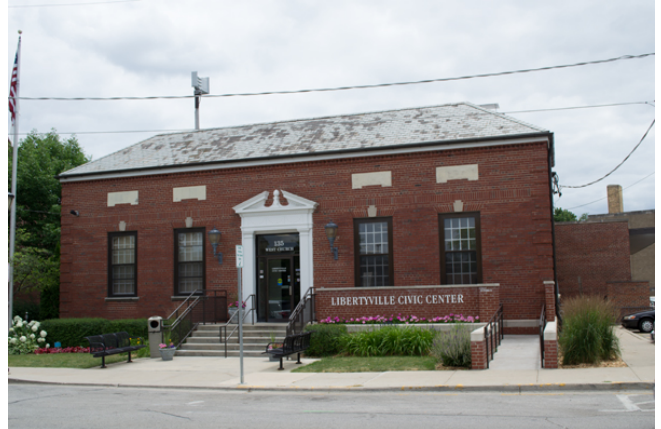
Photo Id: ChurchStW135(1)

Low-pitched hipped roof and rectangular massing; symmetrical front facade with center entry; classical entry surround with broken pediment; center keystone window lintels; decorative stone panels above window openings

1-story rear addition; 1-story west loading dock addition; replacement windows in original openings; replacement front door; some windows on side elevations bricked in
