Historic Libertyville

BEGINNING STREET NUMBER 322-334 **END STREET NUMBER** STREET # SUFFIX STREET NAME N. Milwaukee Avenue PIN **LOCAL** WITHIN LOCAL DISTRICT? No LOCAL DIST CONTRIB/NON-CONTRIB? **LOCAL LANDMARK? YEAR** Photo Id: MilwaukeeAveN322-334(1) LOCAL LANDMARK ELIGIBLE? Potentially Eligible **CRITERIA BUILDING DETAILS BUILDING NAME** ZONING C-1 **Batholomay Building** NUMBER OF STORIES **GROUND FLOOR USE** Commercial UPPER FLOOR USE PROPERTY INDEX NUMBER Commercial/Office 1116414009 (322/324/326/334), 1116400055 (330/332/334) **CURRENT OCCUPANT** Buss Flower Shop (322), Christine Anne Couture (324), How Impressive (326), Full Disclothesure (330), Awards and Engraving (332), Vito Anthony Salon (334) **NATIONAL REGISTER** NR DISTRICT CONTRIB/NON-CONTRIB NR ELIGIBLE? WITHIN DISTRICT? **CRITERIA** NR LANDMARK? **ALTERNATE ADDRESS?** No YEAR **GENERAL INFORMATION CATEGORY HISTORIC USE** Building Commerce/Trade CONDITION SECONDARY STRUCTURE Good NR SECOND INTEGRITY Minor alterations

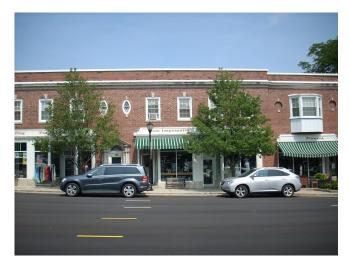
Fine Two-Part Commercial Block with Colonial Revival detailing. Although storefront and 2nd story windows have been replaced, the type and configuration are historically accurate.

Rectangular massing and flat roof with brick parapet and metal cornice below; north and south bays are recessed slightly; historic multi-light oval windows on 2nd story; flat brick arches with center keystones above 2nd-story double hung windows; 2nd story oriel windows at north and south bays; center 2nd-story entry with fanlight and stone/concrete classical surround; storefront configurations are historic, with recessed entries and single storefronts

Replacement materials (windows and doors) on storefronts; replacement double hung windows in original openings on 2nd story facade
