Historic Libertyville

| STREET NAME | N. Milwaukee Avenue |

Two Part Commercial Block

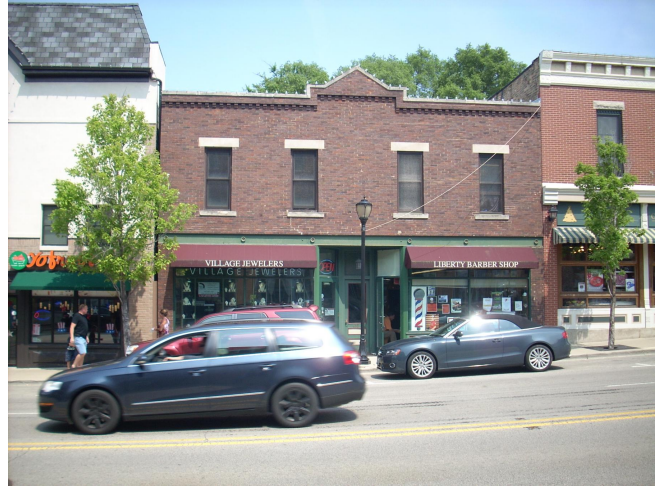
Photo Id: 614-618NMilwaukee

| Good | - |
| Minor alterations | - |

Brick facade; stone-capped brick parapet with center flanged triangular pediment; corbeled brick cornice below parapet; ashlar stone lintels and sills on 2nd story window; historic storefront configuration with center 2nd story entry and flanking storefronts with angled entry doors; metal storefront frieze with tiebacks

Replacement 2nd story windows in original openings; replacement storefront windows and doors; awnings
