# Historic Libertyville

| STREET NAME | W. Park Avenue |

Ramsey Historic Consultants

Downtown Libertyville

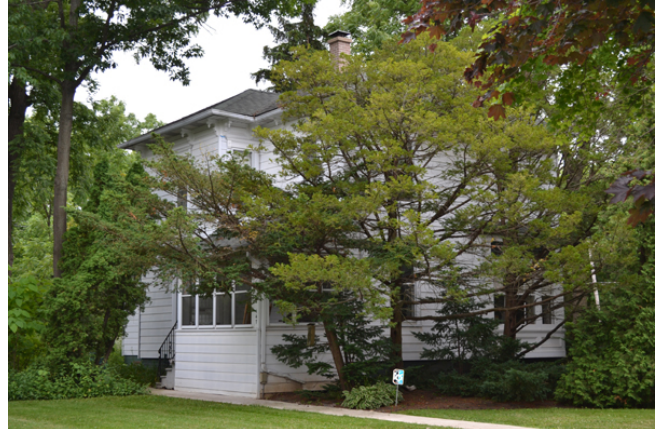
Photo Id: ParkAveW147(3)

Hipped roof; wood cornice with paneled frieze and brackets with drop pendants; square front oriel bay with classical surround and historic wood windows; 1/1 wood windows on all facades with classical surrounds

Replacement siding (1976); Two-story rear addition; replacement front porch (later enclosed)

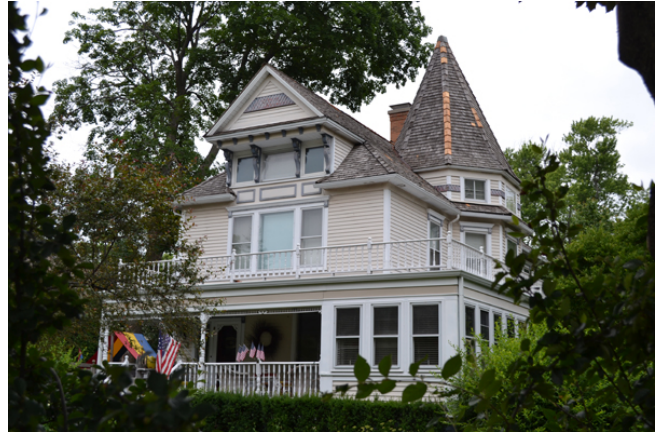
Photo Id: ParkAveW208(1)

Despite alterations, this Queen Anne residence may be eligible for local landmark designation.

Hipped main roof with projecting front-gable through-the-cornice dormer on south facade (dormer features overhang supported by scrolled brackets); 2.5-story east side polygonal tower with pointed roof; wraparound front porch structure (not original, but historic--dates from between 1924 and 1933; partially enclosed)

Replacement siding (1991); wood-shingle roofing; east end of wraparound porch enclosed (post-1948); replacement railings on porch; one-story rear addition; replacement windows in original openings

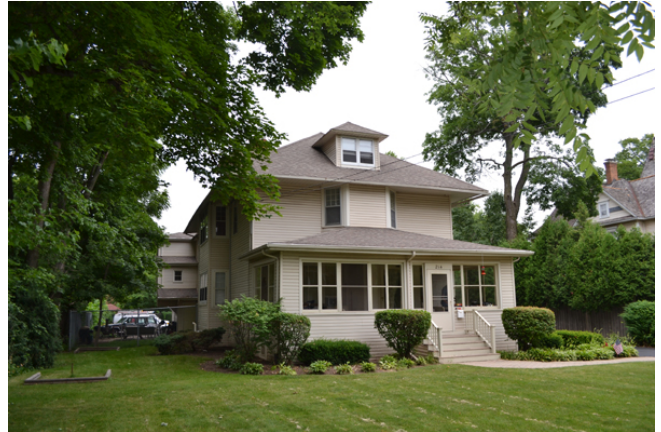
Photo Id: ParkAveW214

Hipped roof with overhanging eaves; hipped-roof front and side dormers; three-sided west bay; hipped-roof front porch; center three-sided bay above porch; original stucco cladding visible under porch

Large two-story rear addition (1953, 1982); front porch enclosed, with replacement front steps and railing; replacement siding (1994)

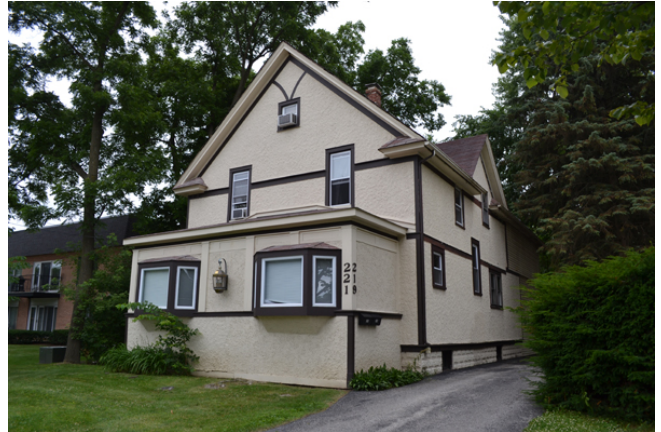
Photo Id: ParkAveW219-221(1)

Front gable roof; stucco with wood corner boards, string courses, and minimal decorative half-timbering; three-sided east window bay; east and west gables; some historic wood windows on side facades

Front porch enclosed

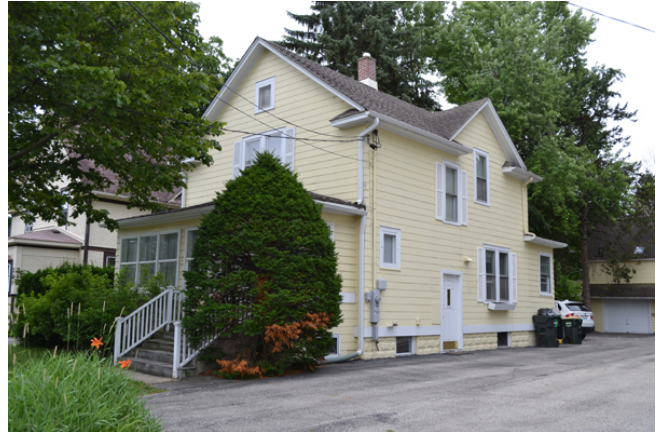
Photo Id: ParkAveW225(1)

Replacement windows in original openings; front porch enclosed with aluminum/vinyl windows (1970); fixed shutters; concrete steps (1970)

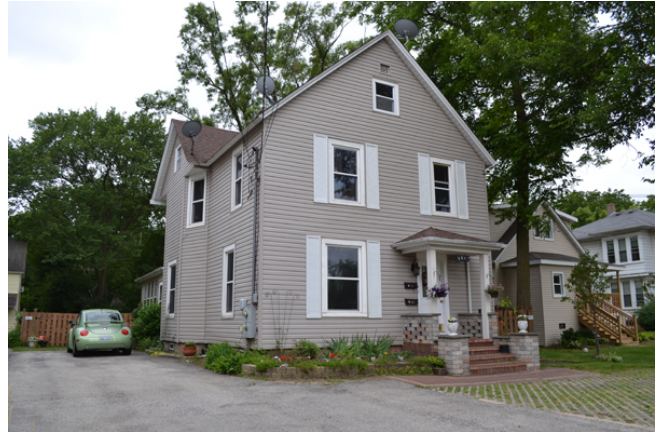
Photo Id: ParkAveW301

Replacement siding; replacement windows in downsized openings; fixed shutters; replacement front porch (post-1948); replacement door; one-story rear addition (may have originally been rear porch that was enclosed)

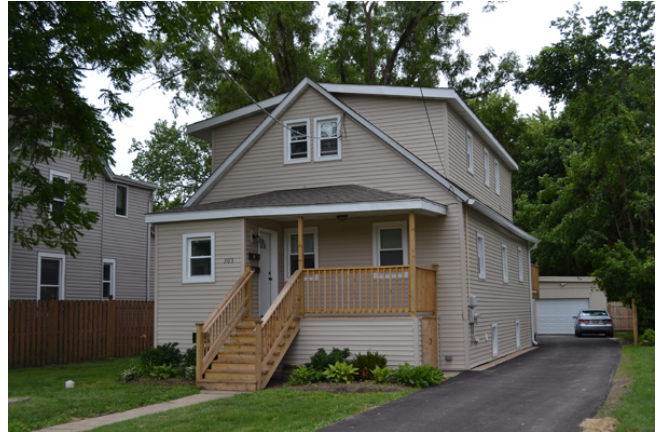
Photo Id: ParkAveW305

Replacement siding (1970); replacement windows in original openings; wrought iron railings on porch; large shed-roof side dormer additions (1970); rear deck addition

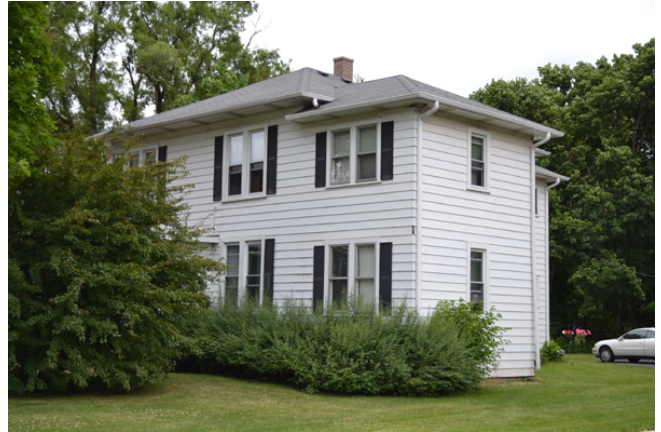
Photo Id: ParkAveW311(3)

Replacement siding (1990); replacement windows in original openings (not historic); front entry bay addition (open porch addition built c. 1930 and later enclosed); fixed shutters; two-story west addition that is flush with front facade (historic addition--c. 1930)
