Historic Libertyville

BEGINNING STREET NUMBER	118-124
END STREET NUMBER	-
STREET # SUFFIX	-
STREET NAME	Broadway Avenue
PIN	
<u>LOCAL</u>	
WITHIN LOCAL DISTRICT?	No
LOCAL DIST CONTRIB/NON-CONTRIB?	C
LOCAL LANDMARK?	No
YEAR	-
LOCAL LANDMARK ELIGIBLE?	No
CRITERIA	-

Ramsey Historic Consultants

May-June 2016

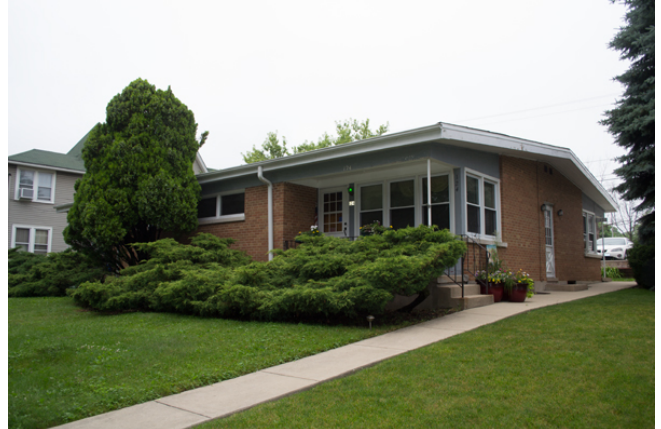
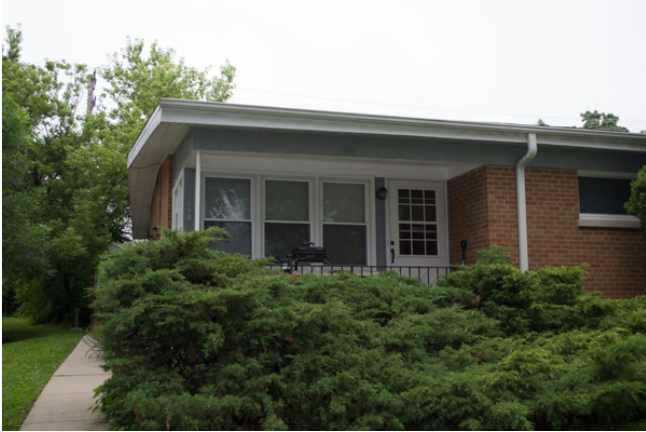
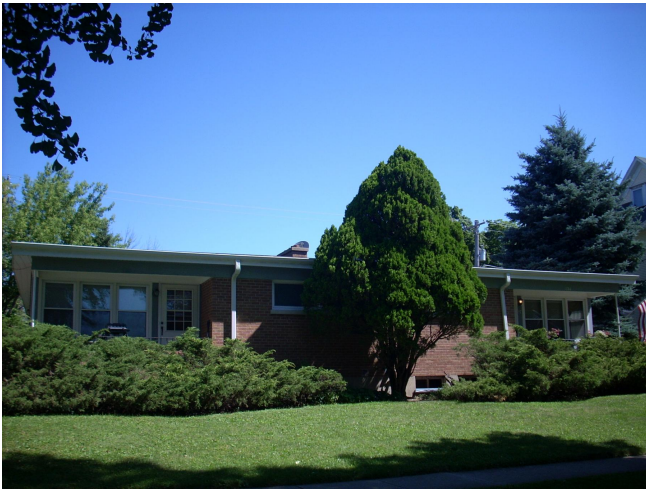
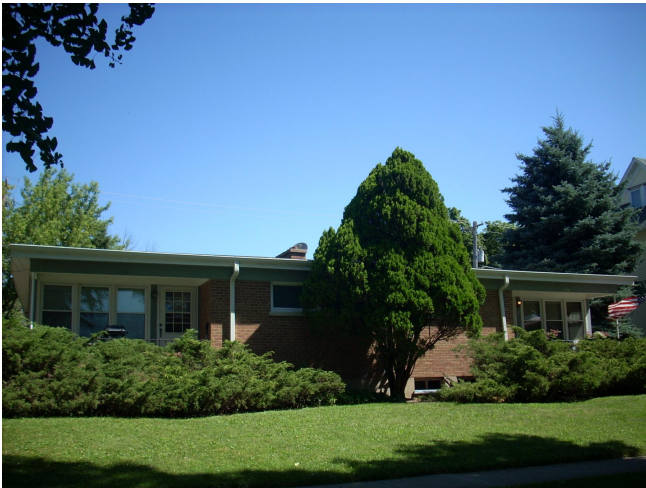
Photo Id: BroadwayAve118-124(1)

CATEGORY	HISTORIC USE
Building	Domestic - multiple dwelling
CONDITION	SECONDARY STRUCTURE
Good	-
INTEGRITY	NR SECOND
Minor alterations	-
CURRENT USE	
Domestic - multiple dwelling

Horizontal massing and flat roof; inset corner entry porches for each unit, with wrought iron railings

Replacement windows in original openings; replacement doors

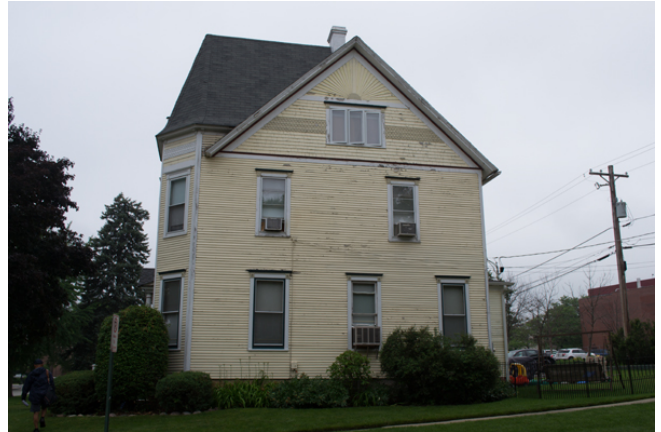
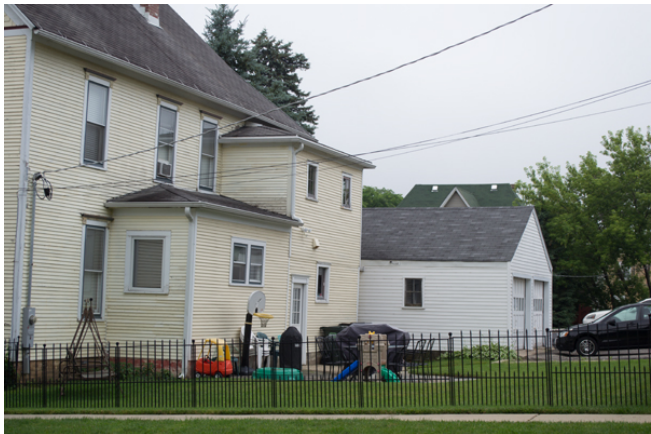
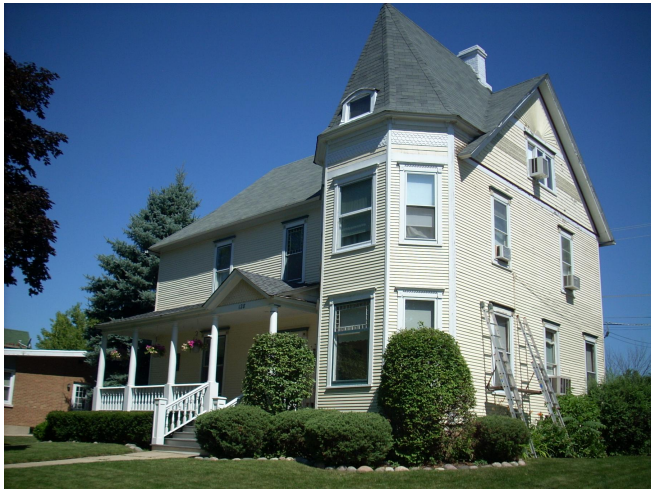
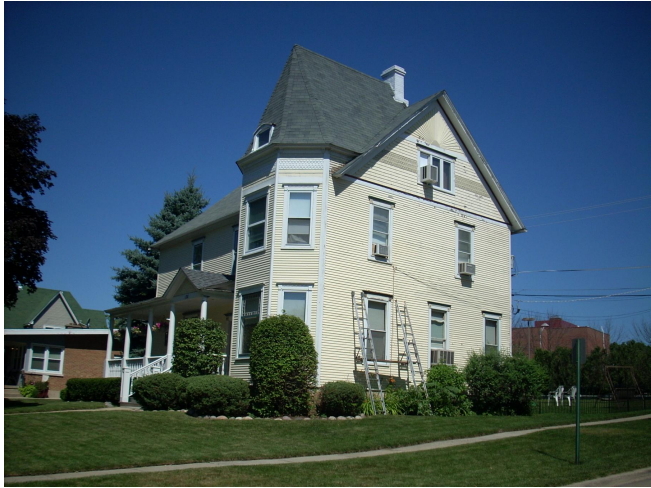
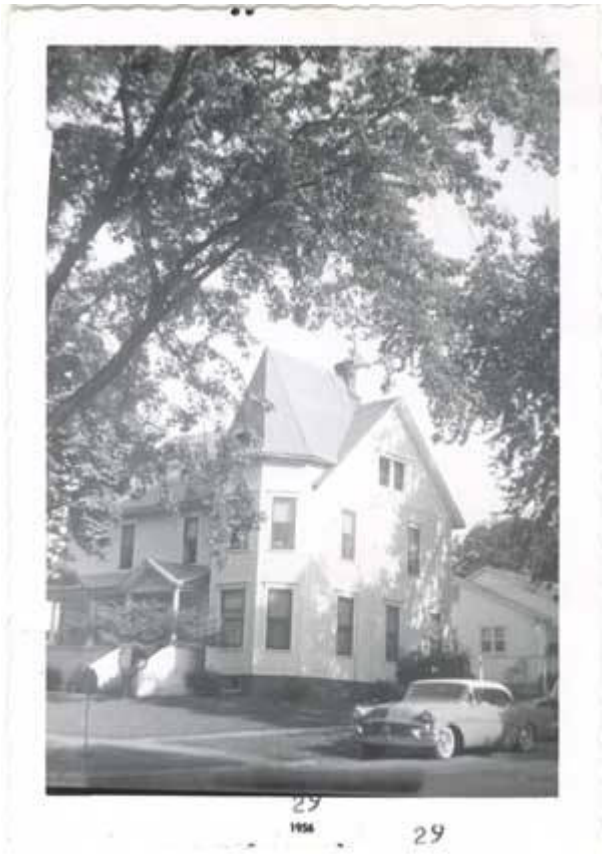
Photo Id: BroadwayAve128(1)

CATEGORY	Building	HISTORIC USE	Domestic - single dwelling
CONDITION	Good	SECONDARY STRUCTURE	Detached garage
INTEGRITY	Minor alterations	NR SECOND	NC
CURRENT USE	Domestic - single dwelling

This 1890s Queen Anne house may be eligible for local landmark designation as the home of Dr. John L. Taylor, a physician who served as Lake County coroner for 43 years.

Steeply pitched side gable roof; fishscale shingles and sunburst motif on gable walls; polygonal full-height bay with pointed roof at southeast corner of facade; full-front porch structure with triangular pediment over entry; historic wood windows, some with Queen Anne-style upper sash

Replacement floor, railings on front porch; 1-story rear addition and 2nd story rear addition (post-1948); some replacement windows in original openings on west elevation

93-474 (8/30/1993)--repairs and replacement to the base and deck of roofed porch

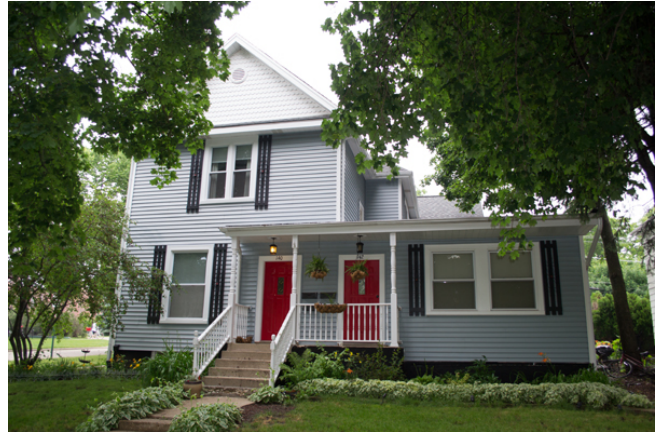
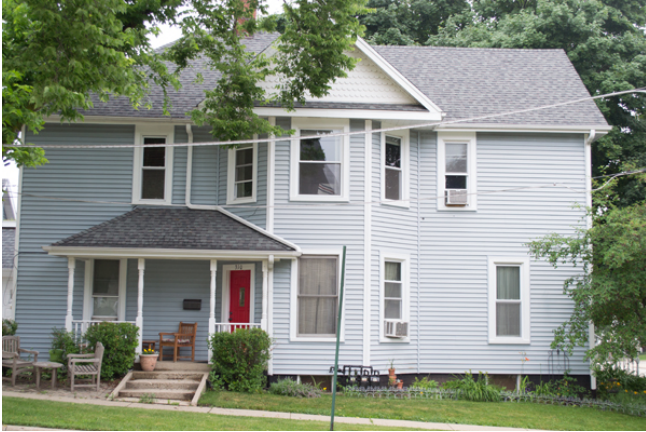
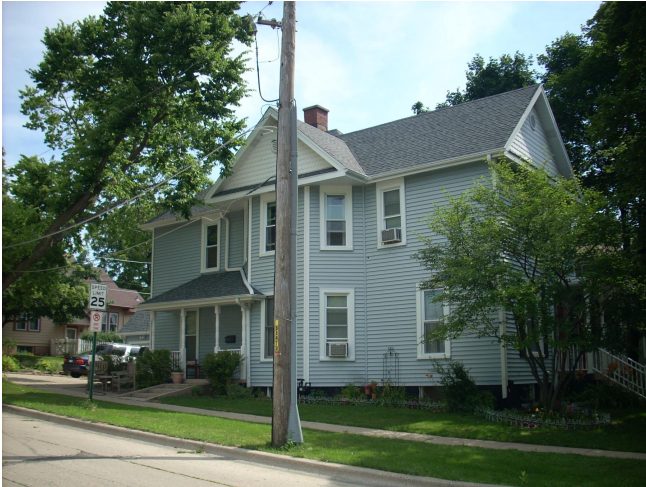
Photo Id: BroadwayAve140-142(2)

CATEGORY	HISTORIC USE
Building	Domestic - single dwelling
CONDITION	SECONDARY STRUCTURE
Good	[attached garage]
INTEGRITY	NR SECOND
Minor alterations and additions	-
CURRENT USE	
Domestic - multiple dwelling

Front gable roof; full-height polygonal bay on west facade; front porch structure on front facade; secondary porch structure on west facade

Replacement siding (2000); replacement windows in original openings (2001); replacement columns, railings, and steps on front porch; replacement columns and railings on west porch; rear attached garage addition (2003)

PB-01-0706 (7/25/2001)--replacement windows, door trim, fascia, and soffit; 00413 (5/23/2000)--vinyl siding house and garage; JRA-01-0066 (3/24/2003)--addition, siding, & roof deck

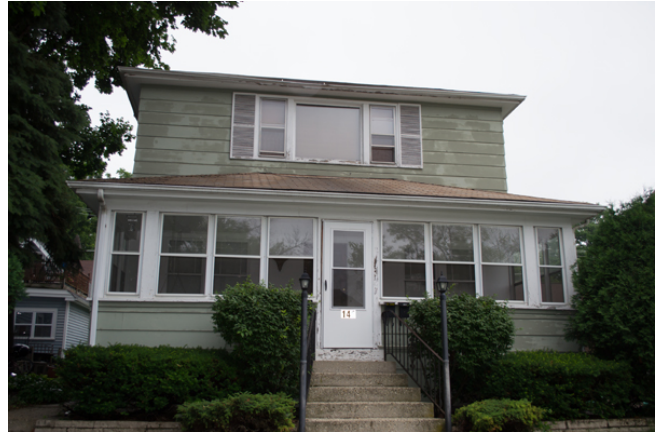
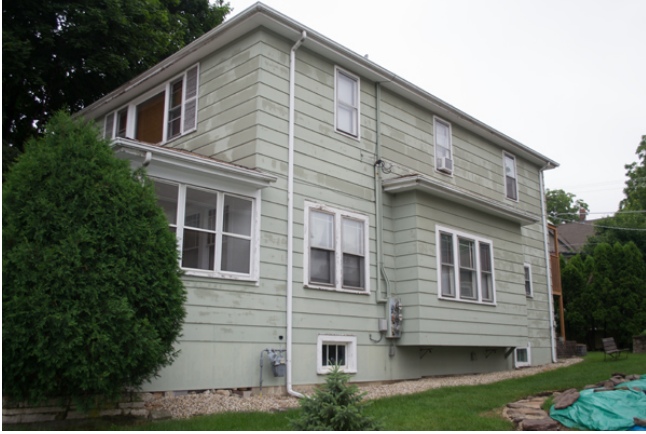
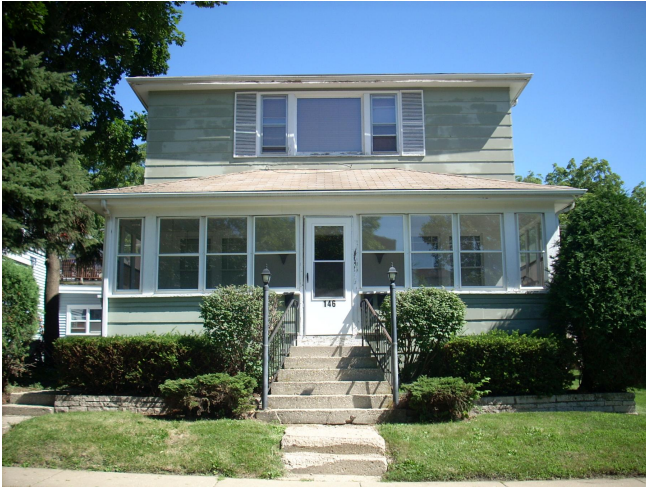
Photo Id: BroadwayAve146(1)

CATEGORY	HISTORIC USE
Building	Domestic - single dwelling
CONDITION	SECONDARY STRUCTURE
Good	-
INTEGRITY	NR SECOND
Minor alterations	-
CURRENT USE	
Domestic - single dwelling

Full front porch with hipped roof and solid knee walls; geometric/1 double hung windows; square oriel window bay on east facade

2nd story addition (1969); front porch enclosed; front steps and railing replaced; replacement siding

JD-12-0001 (3/13/2012)--replace exterior stairway; 4971
(8/19/1969)--raise roof 8 feet

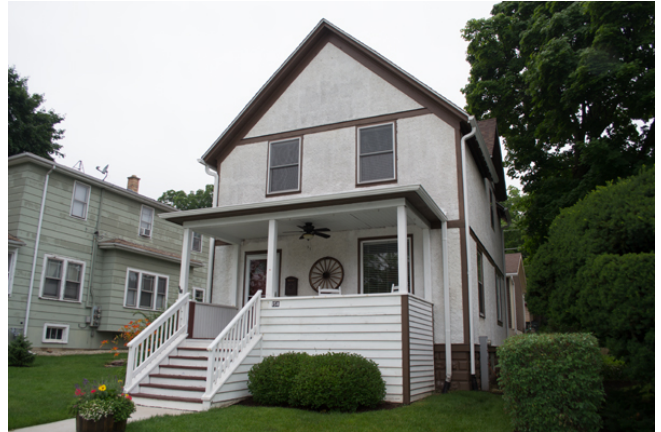
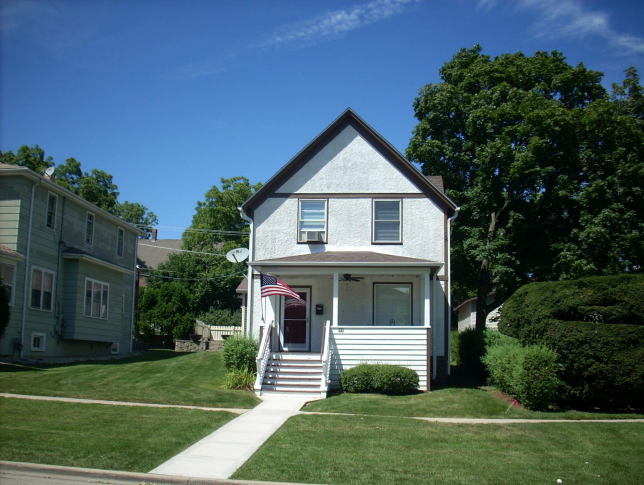
Photo Id: BroadwayAve150(2)

CATEGORY	HISTORIC USE
Building	Domestic - single family
CONDITION	SECONDARY STRUCTURE
Good	Detached garage
INTEGRITY	NR SECOND
Minor alterations	NC
CURRENT USE	
Domestic - single family

Front gable roof; rectangular massing; north side gable

Replacement front porch columns; replacement windows in original openings; replacement front door; picture window under porch

75-392 (9/27/1975)--addition (\$3,000); 6313 (5/4/1971)--enclose front porch on three sides; 867 (6/7/1954)--new steps and straighten up porch, patch stucco; 92-147 (3/24/1992)--opening up and repairing existing closed in front porch

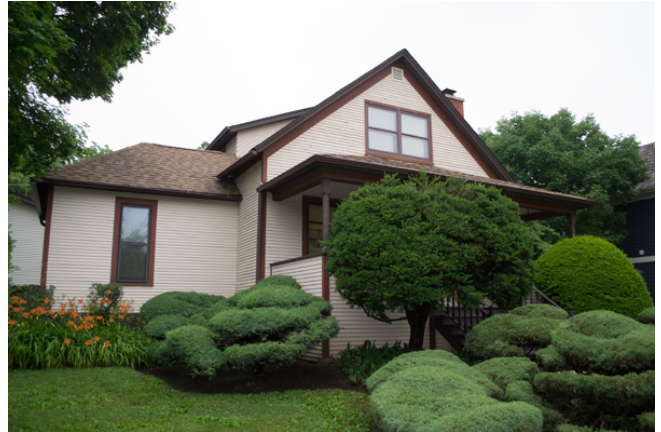
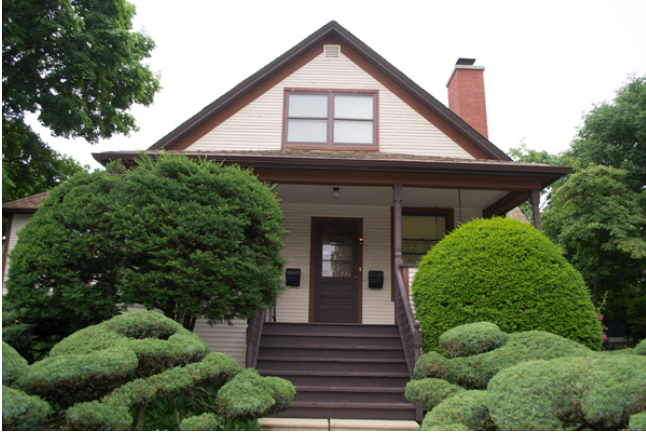
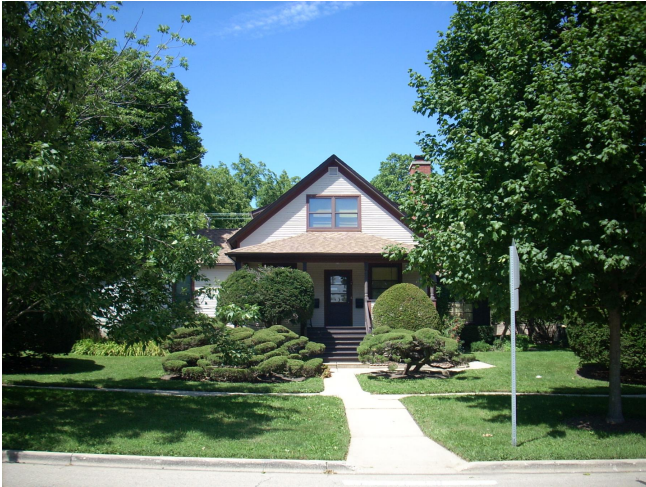
Photo Id: BroadwayAve154(1)

CATEGORY	HISTORIC USE
Building	Domestic - single dwelling
CONDITION	SECONDARY STRUCTURE
Good	-
INTEGRITY	NR SECOND
Minor alterations and additions	-
CURRENT USE	
Domestic - single dwelling

Front gable roof and rectangular massing of original structure; front porch structure; west and rear (north) additions appear to be early (pre-1925)

Some replacement windows in original openings.

00-66 (2/21/2000)--rebuilt front porch, leaving roof in place;
2573 (2/2/1960)--interior work, 2nd floor; 2 rooms and kitchen,
2 dormers, exterior stairway

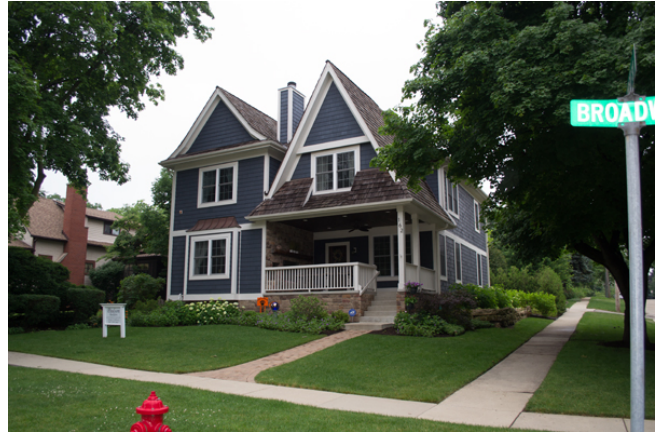
Photo Id: BroadwayAve162

CATEGORY	HISTORIC USE
Building	Domestic - single dwelling
CONDITION	SECONDARY STRUCTURE
Excellent	[attached garage]
INTEGRITY	NR SECOND
Not altered	-
CURRENT USE	
Domestic - single dwelling

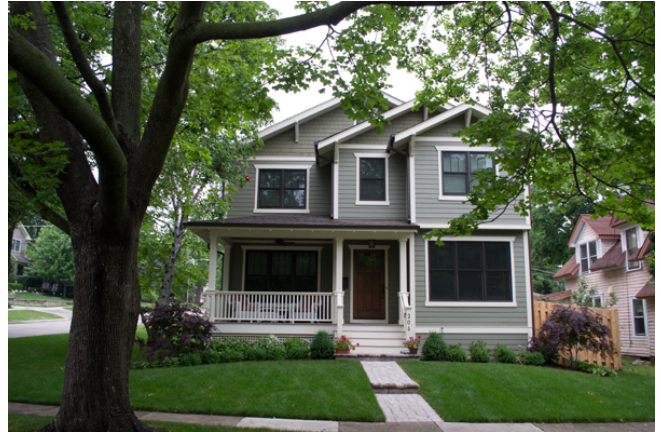
Photo Id: BroadwayAve204(1)

CATEGORY	Building	HISTORIC USE	Domestic - single dwelling
CONDITION	Good	SECONDARY STRUCTURE	Detached garage
INTEGRITY	Not altered	NR SECOND	NC
CURRENT USE	Domestic - single dwelling

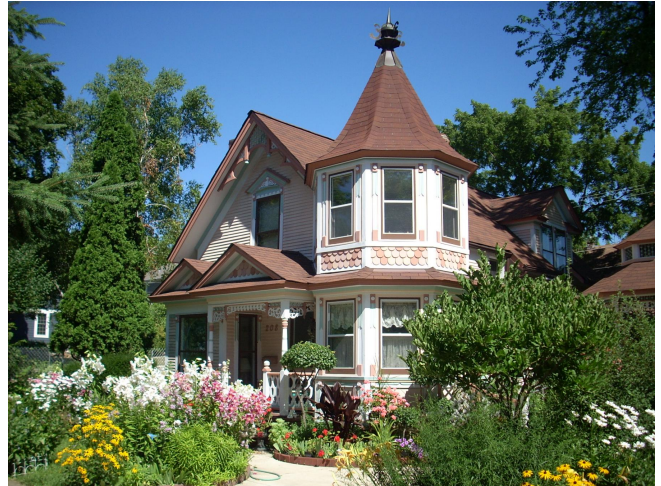
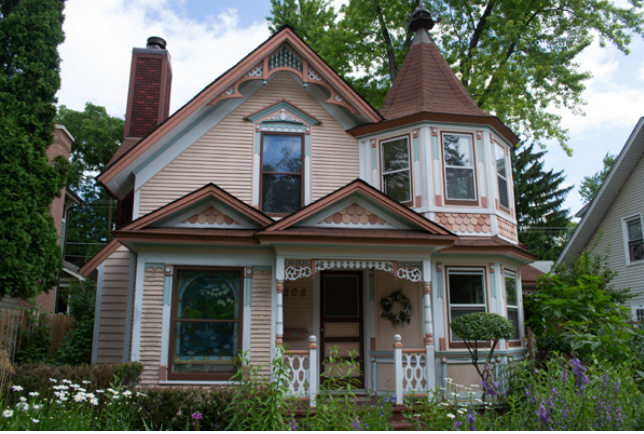
Photo Id: Broadway208

CATEGORY	HISTORIC USE
Building	Domestic - single dwelling
CONDITION	SECONDARY STRUCTURE
Good	Detached garage
INTEGRITY	NR SECOND
Major alterations and additions	NC
CURRENT USE	
Domestic - single dwelling

Original house obscured by extensive alterations and additions--
turret addition; front porch addition; 1-story rear addition;
Queen Anne trim throughout

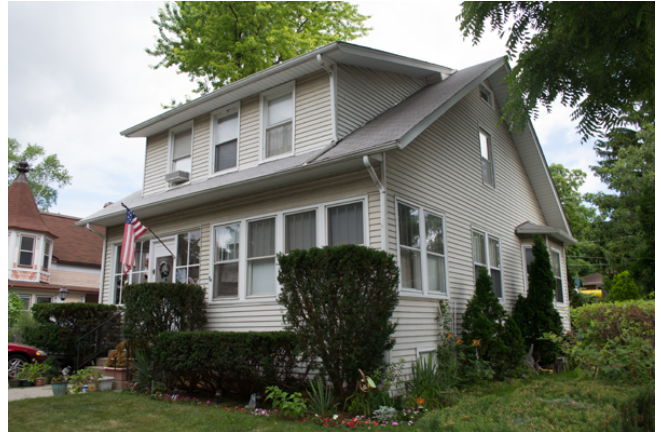
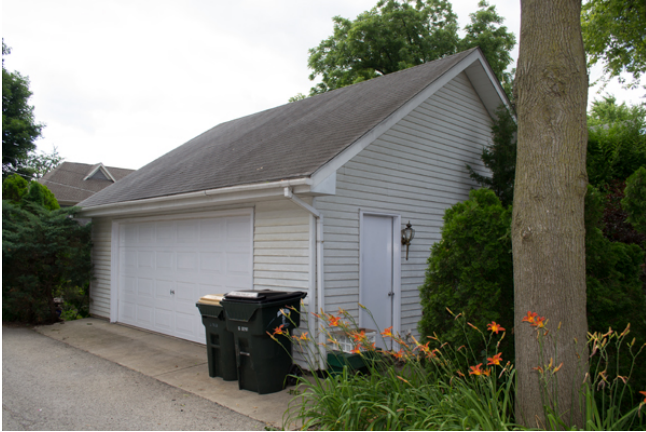
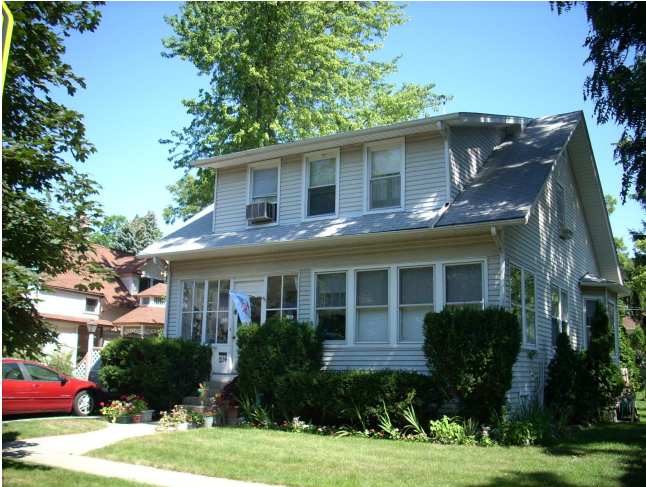
Photo Id: BroadwayAve214(1)

CATEGORY	HISTORIC USE
Building	Domestic - single dwelling
CONDITION	SECONDARY STRUCTURE
Good	Detached garage
INTEGRITY	NR SECOND
Minor alterations	NC
CURRENT USE	
Domestic - single dwelling

Replacement siding; replacement windows in dormer; entry porch enclosed
