Historic Libertyville

| STREET NAME | First Street |

Ramsey Historic Consultants

Downtown Libertyville

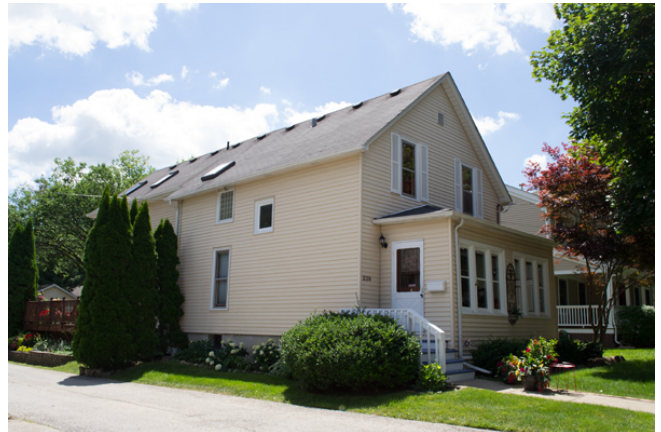
Photo Id: FirstSt228(1)

| Good | Detached garage |
| Major alterations and additions | NC |

Front gable roof; rectangular massing

Non-historic alterations include replacement siding; replacement windows in original openings; front porch enclosed; wood steps to front porch entrance; 2-story rear addition; rear deck addition

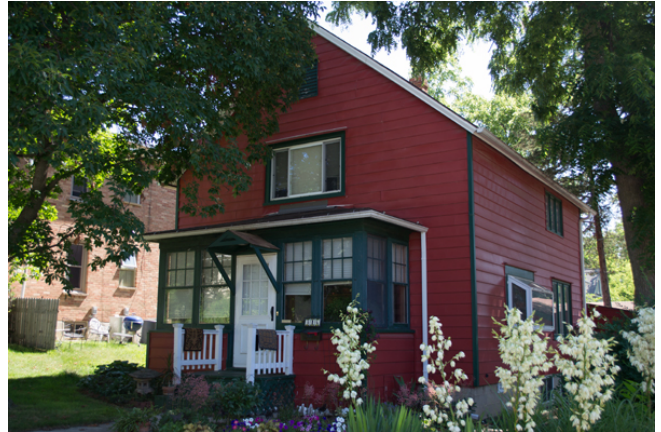
Photo Id: FirstSt316(1)

| Good | Detached garage |
| Minor alterations | C |

Front gable roof; rectangular massing; hipped-roof porch (enclosed)

Front porch enclosed (post-1948); replacement windows in original openings (casement and fixed); replacement siding (1978)

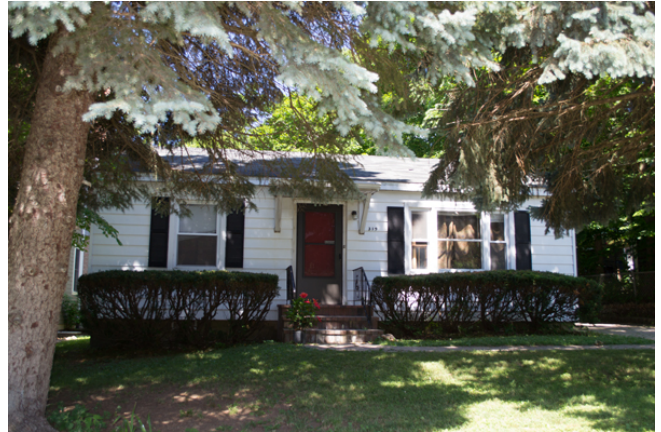
Photo Id: FirstSt319(1)

| Good | Shed |
| minor alterations | NC |

Shallow side gable roof and rectangular massing of original house; center entry; center wood window at north window bay on front facade

Aluminum siding (1980); 1-story rear addition (1966); replacement front door; replacement front stoop; most windows are 1/1 replacement windows

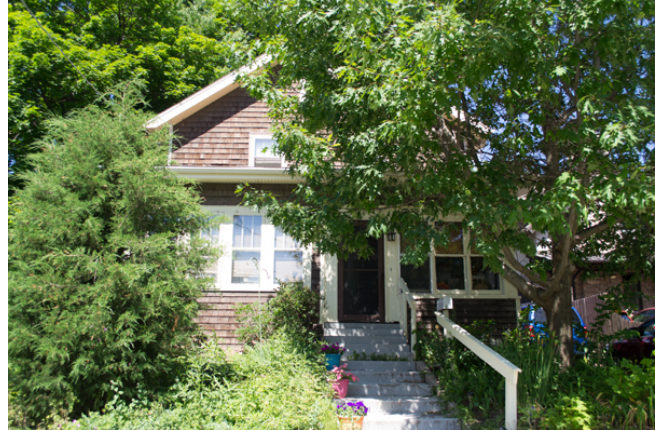
Photo Id: FirstSt321(1)

| Good | Detached garage |
| Minor alterations | C |

Well-preserved example of the Gable Front vernacular type, with Craftsman-style detailing.

Front gable roof and rectangular massing; wood shingle siding; south end of porch structure is original (Sanborn map, 1924); historic 3/1 wood windows

Sanborn maps show north end of porch was built as an open porch some time between 1924 and 1933--enclosed later with 1/1 windows; aluminum soffits

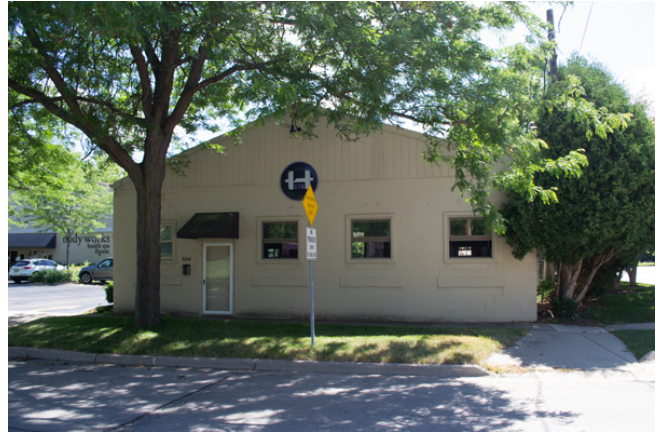
Photo Id: FirstSt504(1)

Gable roof replacing original flat roof; replacement windows in downsized openings; replacement front door; awning over entry; 1 story rear addition (1985)

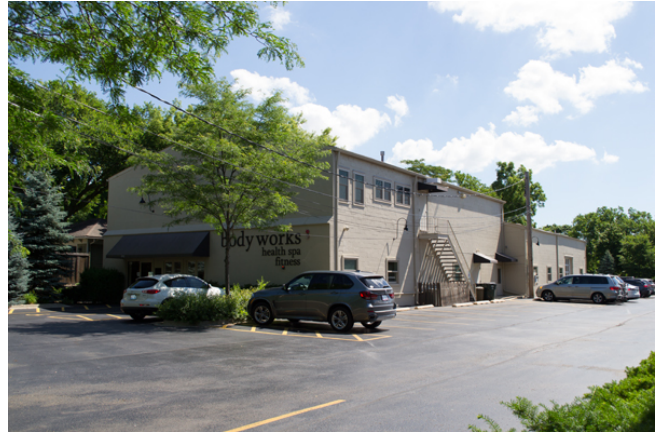
Photo Id: FirstSt510

Multiple rear additions that are substantially larger than original building (last addition dates from 1984); front facade stuccoed; non-historic front entrance with awning; replacement windows in altered openings

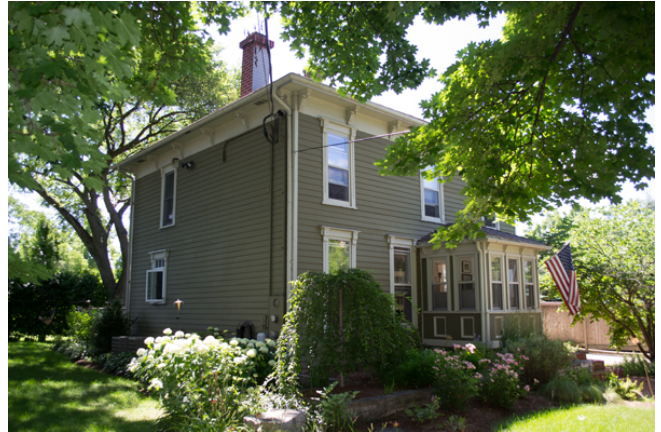
Photo Id: FirstSt518(2)

Front porch addition (not historic); original north side sun porch removed and replaced with small entry porch (not historic)
