Historic Libertyville

BEGINNING STREET NUMBER	130
END STREET NUMBER	-
STREET # SUFFIX	-
STREET NAME	W. Maple Avenue
PIN	
<u>LOCAL</u>	
WITHIN LOCAL DISTRICT?	No
LOCAL DIST CONTRIB/NON-CONTRIB?	C
LOCAL LANDMARK?	No
YEAR	-
LOCAL LANDMARK ELIGIBLE?	No
CRITERIA	-

Ramsey Historic Consultants

May-June 2016

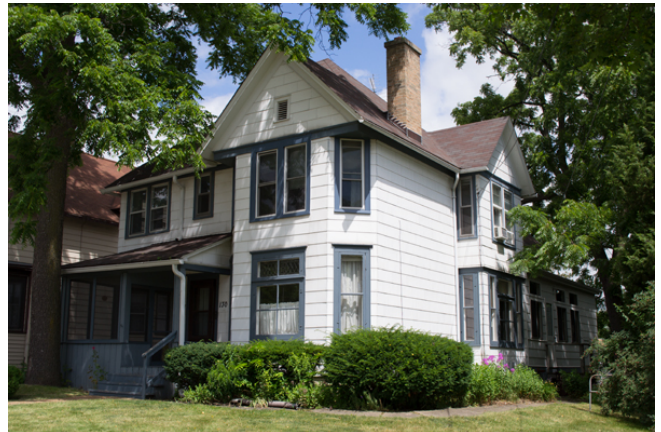
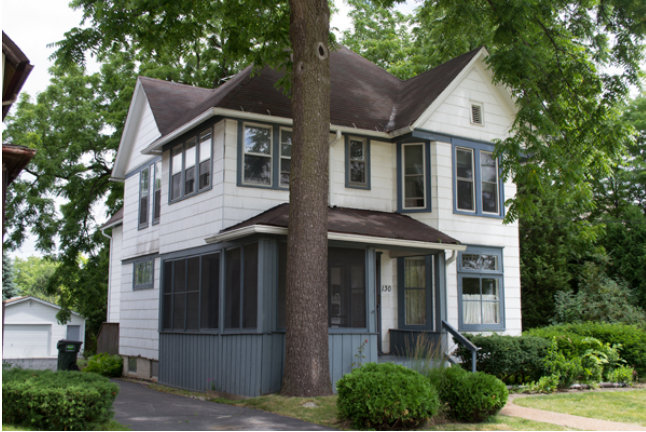
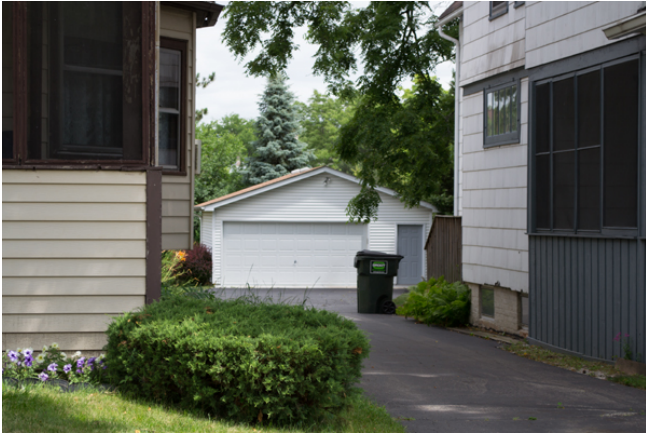
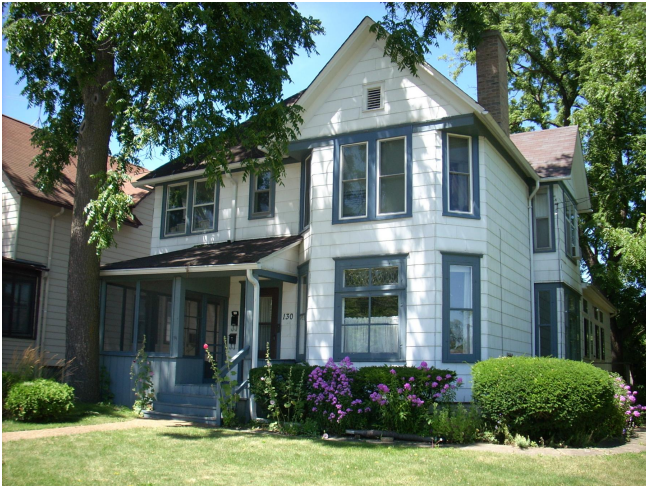
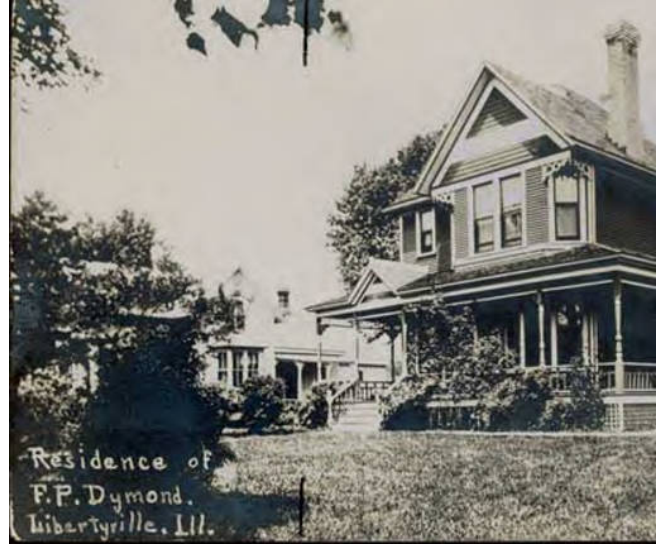
Photo Id: MapleAveW130(4)

CATEGORY	Building	HISTORIC USE	Domestic - single dwelling
CONDITION	Good	SECONDARY STRUCTURE	Detached garage
INTEGRITY	Moderate alterations and additions	NR SECOND	NC
CURRENT USE	Domestic - multiple dwelling

Hipped roof; three-sided 2-story front bay with pent roof; 2-story square pend roof bay on east elevation; east side hipped roof porch structure north of bay (enclosed); wood windows on first story; classical lintels over window openings; beveled glass transom over window on 1st story of front bay

Replacement siding; wraparound front porch removed and replaced with smaller entry and west side porch (post-1948); east side porch enclosed (post-1948); 2nd story replacement windows in original openings

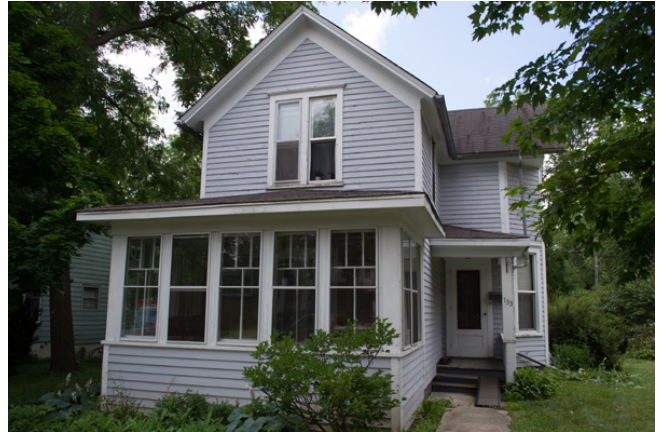
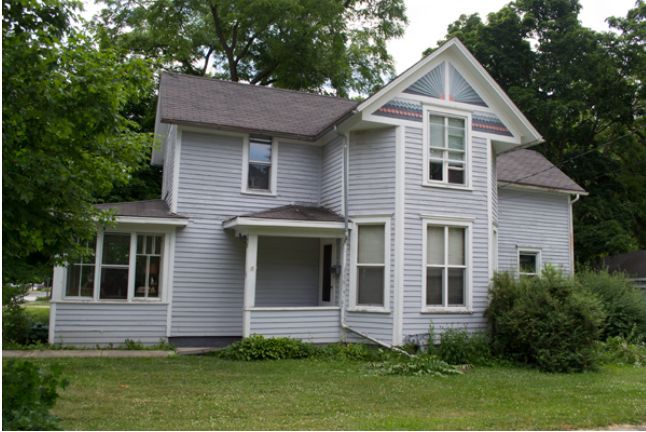
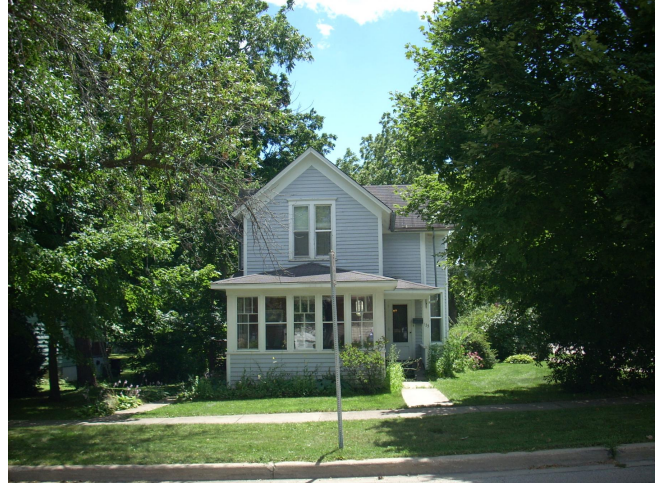
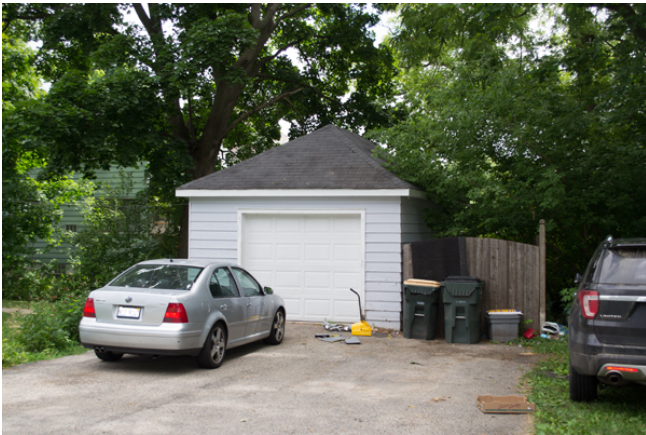
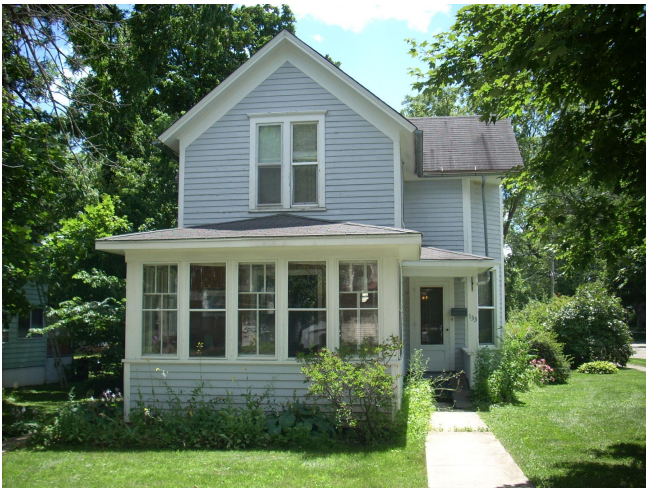
Photo Id: MapleAveW133(1)

CATEGORY	HISTORIC USE
Building	Domestic - single dwelling
CONDITION	SECONDARY STRUCTURE
Good	Detached garage
INTEGRITY	NR SECOND
Minor alterations	C
CURRENT USE	
Domestic - single dwelling

Front gable bay intersected by west-side gable ell; with cutaway corners and sunburst ornament under gable; 2-story square gable bay on east facade; historic wood surrounds and lintels on window openings

Hipped roof front entry porch and front sun porch are historic alterations (replaced original wraparound front porch some time between 1924 and 1933); 1/1 replacement windows in original openings (not historic)

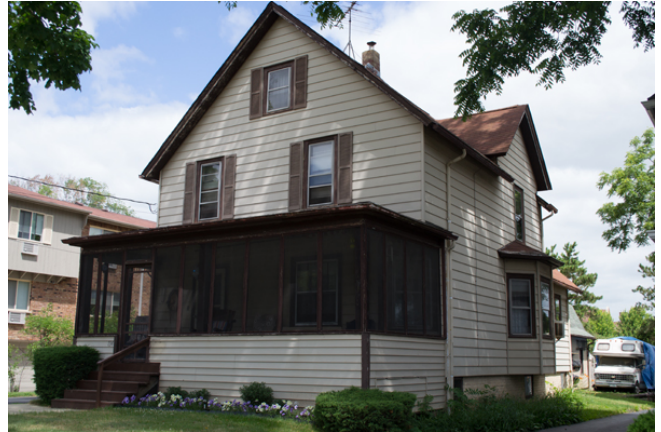
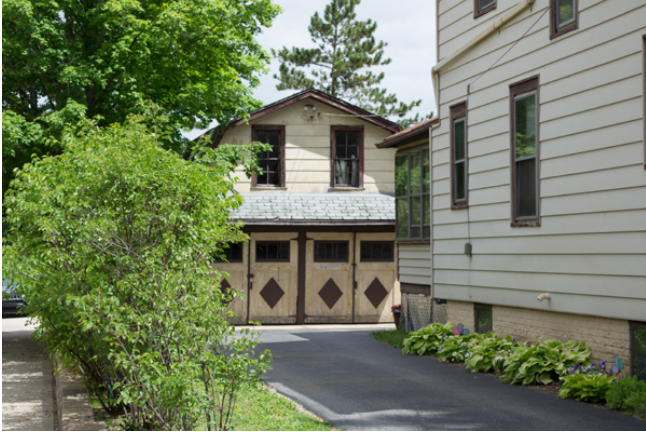
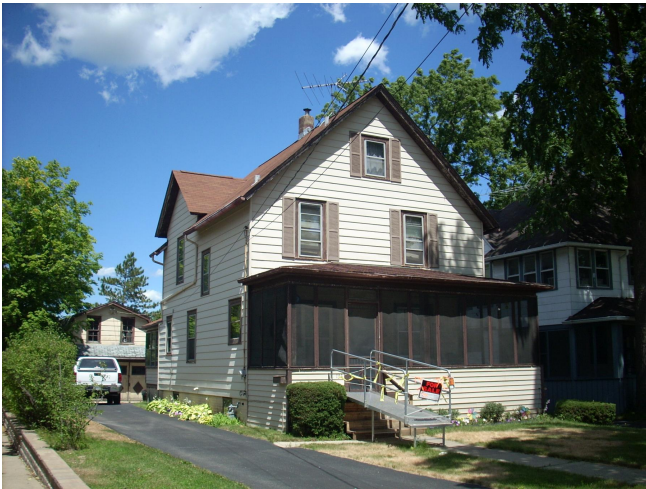
Photo Id: MapleAveW134(3)

CATEGORY	HISTORIC USE
Building	Domestic - single dwelling
CONDITION	SECONDARY STRUCTURE
Good	Detached garage
INTEGRITY	NR SECOND
Minor alterations	C
CURRENT USE	
Domestic - single dwelling

Front gable roof and rectangular massing; east and west gables; east side three-sided window bay; wood windows

Replacement siding; front porch screened; shutters

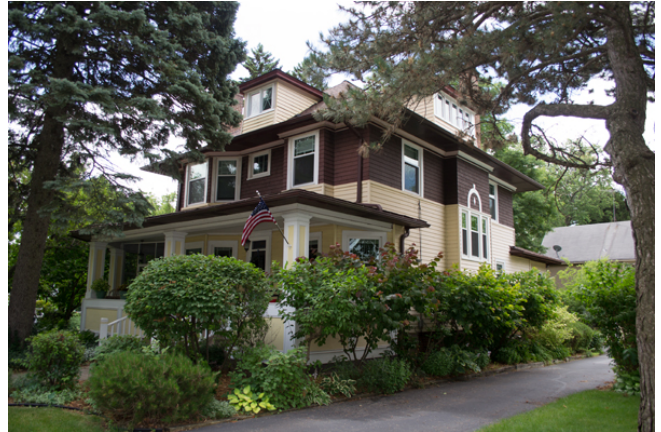
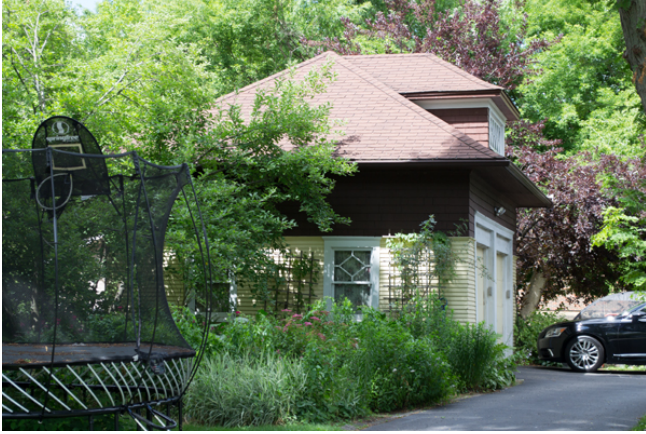
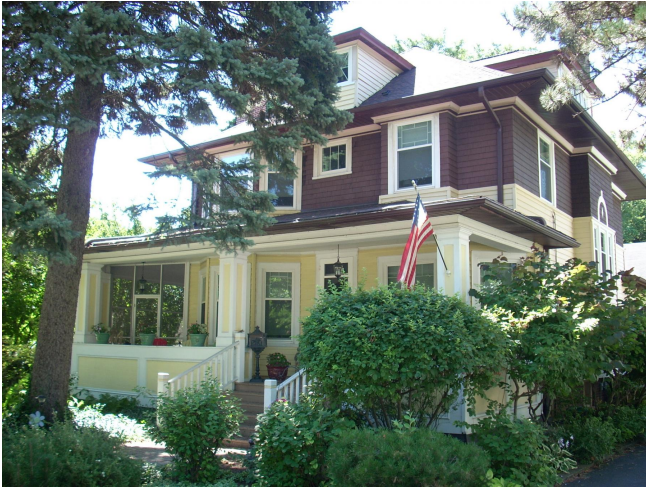
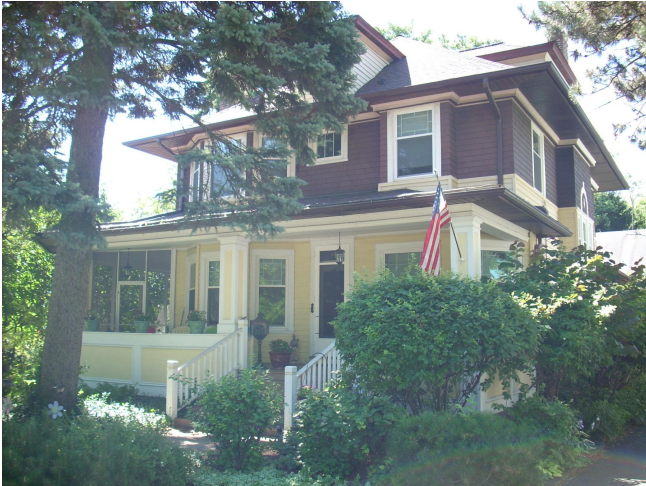
Photo Id: MapleAveW205(1)

CATEGORY	HISTORIC USE
Building	Domestic - single dwelling
CONDITION	SECONDARY STRUCTURE
Good	Detached garage
INTEGRITY	NR SECOND
Minor alterations and additions	C
CURRENT USE	
Domestic - single dwelling

Although altered, this turn-of-the-century Queen Anne with Colonial Revival detailing may be eligible for local landmark designation.

Flared hipped roof with overhanging eaves; front and side hipped roof dormers; hipped roof wraparound porch structure; three-sided and square window bays on front facade above porch; east side square oriel bay; 2-story three-sided bay on west elevation

Replacement windows in original openings; rear deck addition; one-story rear addition; east end of porch screened; replacement porch piers and front steps/railing on porch

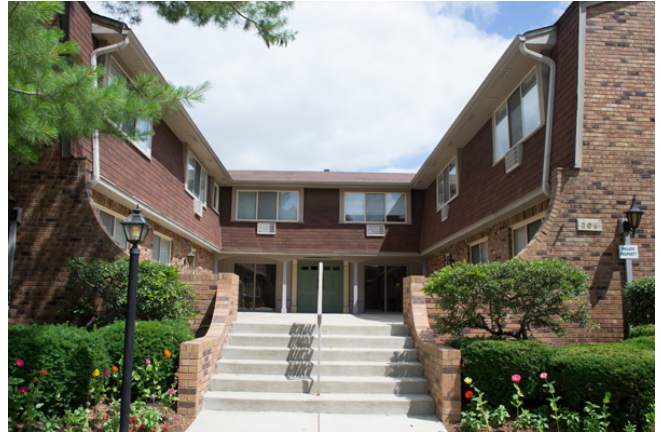
Photo Id: MapleAveW206(2)

CATEGORY	HISTORIC USE
Building	Domestic - multiple dwelling
CONDITION	SECONDARY STRUCTURE
Good	[underground garage]
INTEGRITY	NR SECOND
Minor alterations	-
CURRENT USE	
Domestic - multiple dwelling

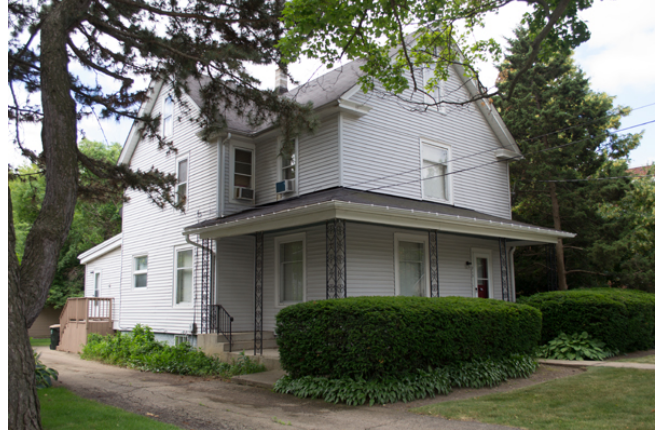
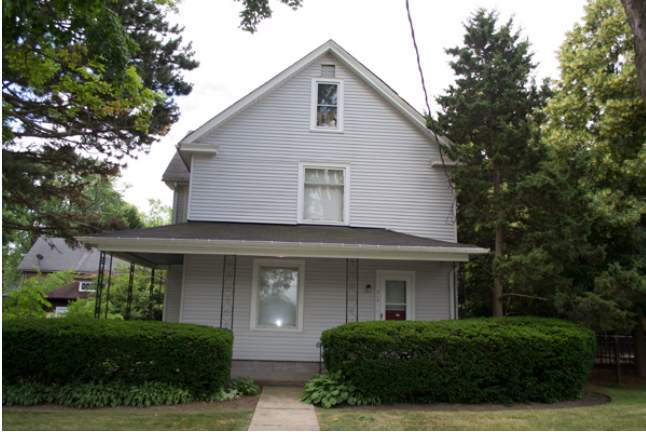
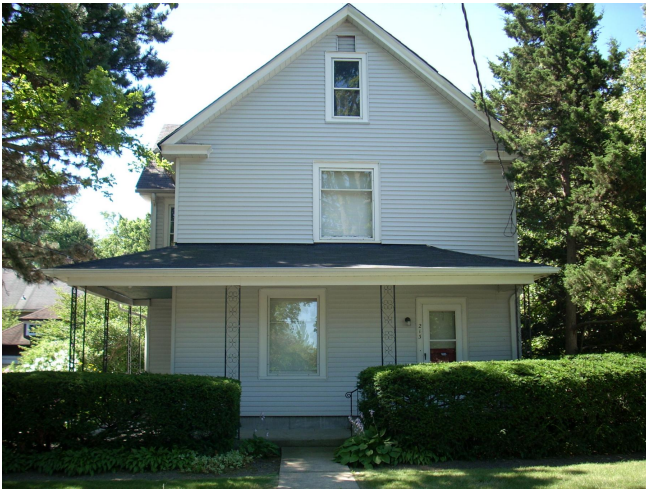
Photo Id: MapleAveW213(1)

CATEGORY	Building	HISTORIC USE	Domestic - single dwelling
CONDITION	Good	SECONDARY STRUCTURE	-
INTEGRITY	Minor alterations and additions	NR SECOND	-
CURRENT USE	Domestic - single dwelling

Front gable roof and rectangular massing; 2-story east side gable bay; some historic windows (1st and 2nd stories of front facade

Replacement siding; some replacement windows in original openings on side elevation; new window under front gable; extensive alterations to porch (concrete base and steps, wrought iron railings); 1 story rear addition (1980); rear deck addition (1980)

#2901 (7/19/1961)--repair front porch (new floor, ceiling, cornice boards, railing and columns), remove side door, install window; 79-185 (8/15/1980)--addition; JB-05-0029 (5/2/2006)-shed

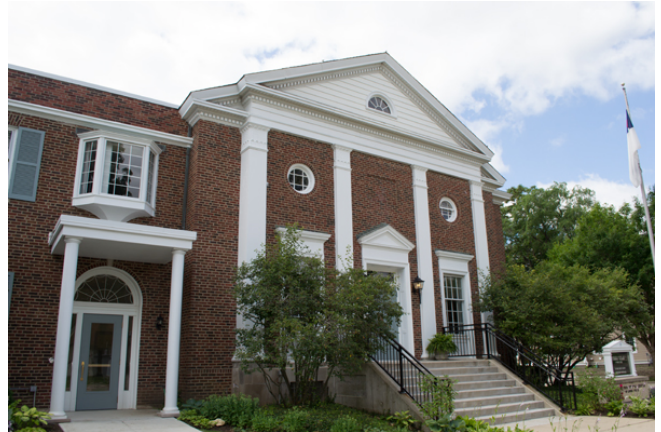
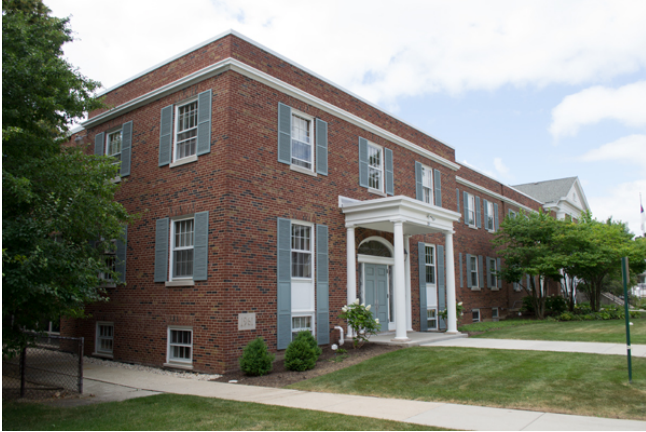
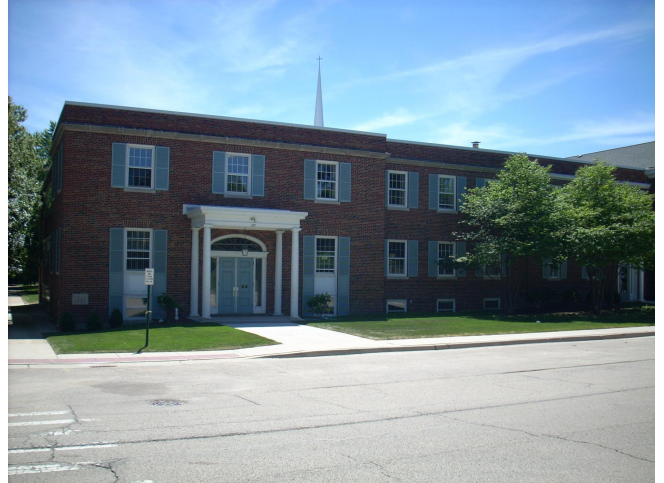
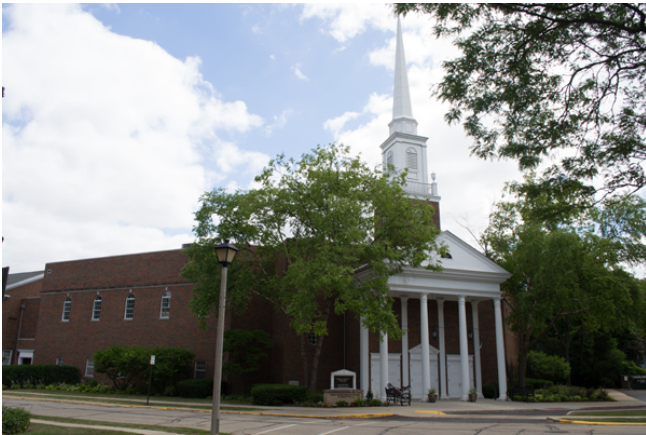
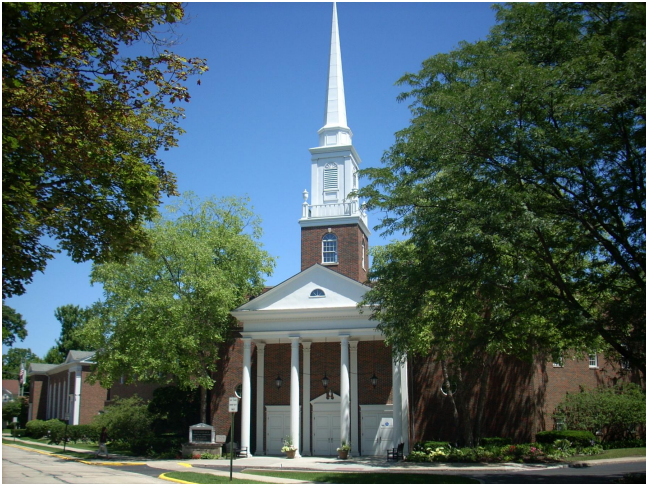
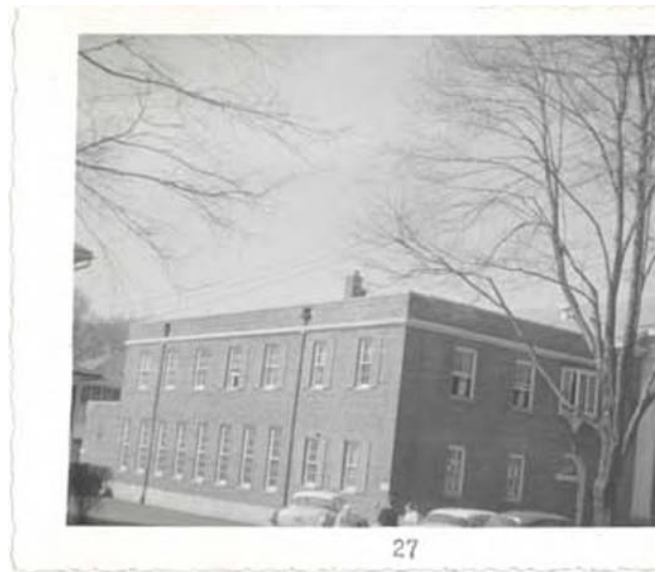
Photo Id: MapleAveW219(7)

CATEGORY	Building	HISTORIC USE	Religion - religious facility
CONDITION	Good	SECONDARY STRUCTURE	-
INTEGRITY	Major alterations and/or additions	NR SECOND	-
CURRENT USE	Religion - religious facility

2-story educational building addition at east end of original building (1961); 2-story addition south of original church building (larger than original building and 1961 addition combined), with new sanctuary and offices--addition features a new main entrance with front portico and steeple along Douglas Avenue

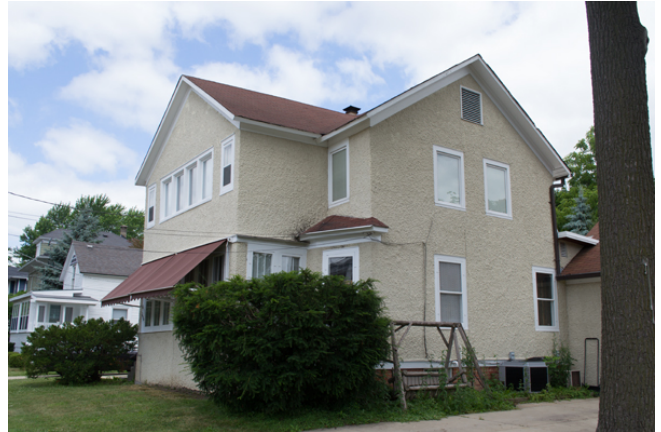
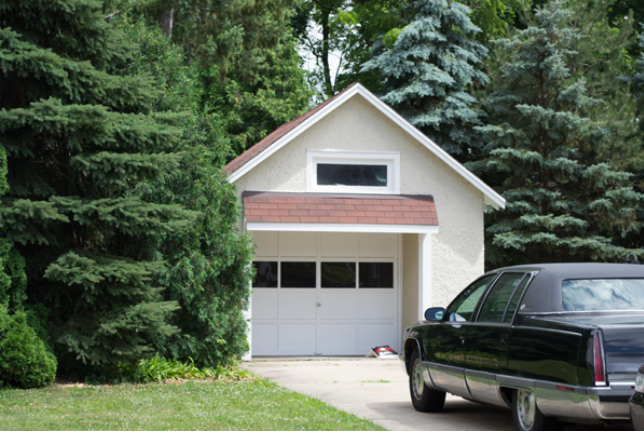
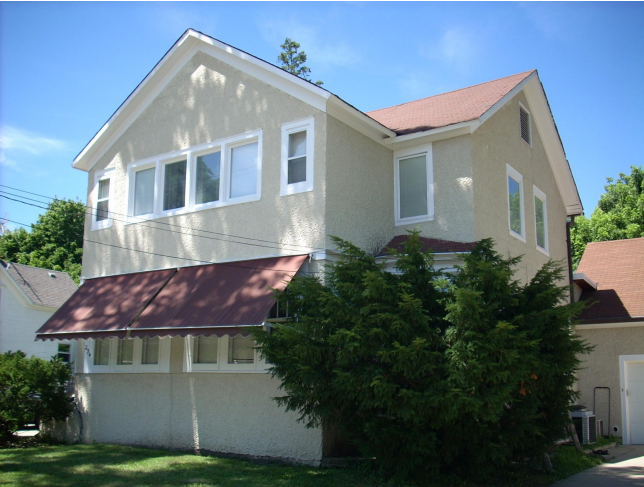
Photo Id: MapleAveW234(1)

CATEGORY	Building	HISTORIC USE	Domestic - single dwelling
CONDITION	Good	SECONDARY STRUCTURE	[attached garage]
INTEGRITY	Historic alterations and additions	NR SECOND	-
CURRENT USE	Domestic - single dwelling

2-story enclosed front porch addition (1920s--foundation is different than side gable section) with 3/1 windows on front facade; stucco cladding (1920s); single-light wood replacement windows throughout (not historically compatible type or configuration); 1-story rear addition and garage addition (2001)

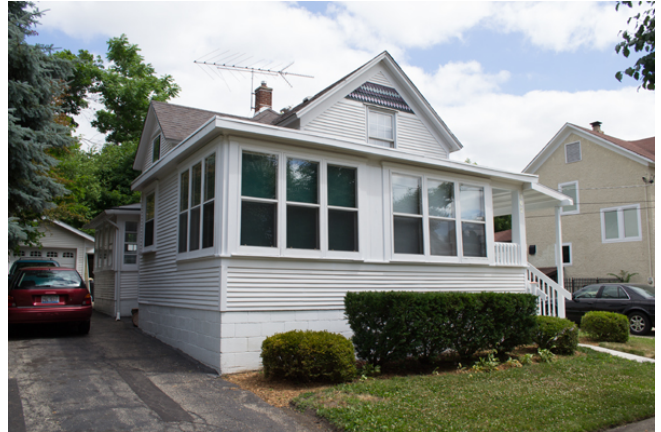
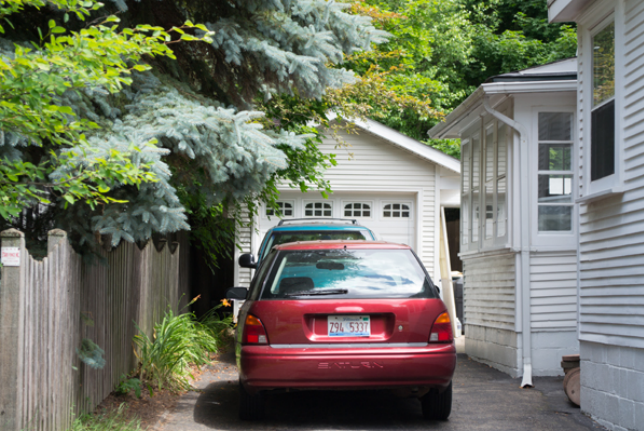
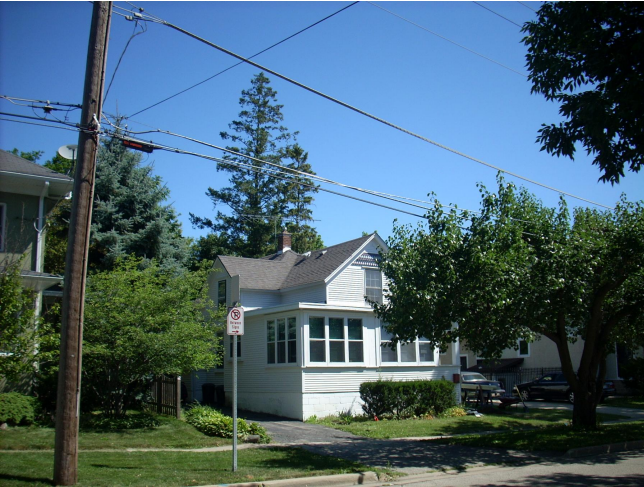
Photo Id: MapleAveW302(3)

CATEGORY	HISTORIC USE
Building	Domestic - single dwelling
CONDITION	SECONDARY STRUCTURE
Good	Detached garage
INTEGRITY	NR SECOND
Historic additions/minor alterations	NC
CURRENT USE	
Domestic - single dwelling

Replacement front sun porch (historic--pre-1933); non-historic shed-roof entry porch at east end of front sun porch; northwest corner sun porch (historic--pre-1933); non-historic replacement windows in original openings on front and side elevations of house; one-story rear addition (historic--pre-1933)

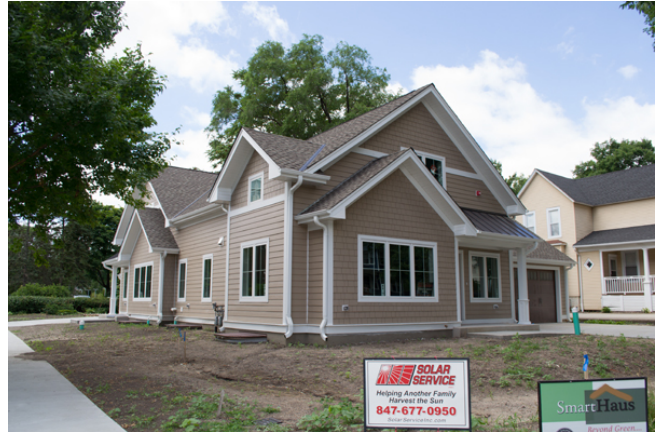
Photo Id: MapleAveW305(1)

CATEGORY	HISTORIC USE
Building	Domestic - single dwelling
CONDITION	SECONDARY STRUCTURE
Good	[attached garage]
INTEGRITY	NR SECOND
Minor alterations and additions	-
CURRENT USE	
Domestic - single dwelling
