Historic Libertyville

BEGINNING STREET NUMBER	136
END STREET NUMBER	-
STREET # SUFFIX	-
STREET NAME	Newberry Avenue
PIN	
<u>LOCAL</u>	
WITHIN LOCAL DISTRICT?	No
LOCAL DIST CONTRIB/NON-CONTRIB?	C
LOCAL LANDMARK?	No
YEAR	-
LOCAL LANDMARK ELIGIBLE?	Potentially Eligible
CRITERIA	A

Downtown Libertyville

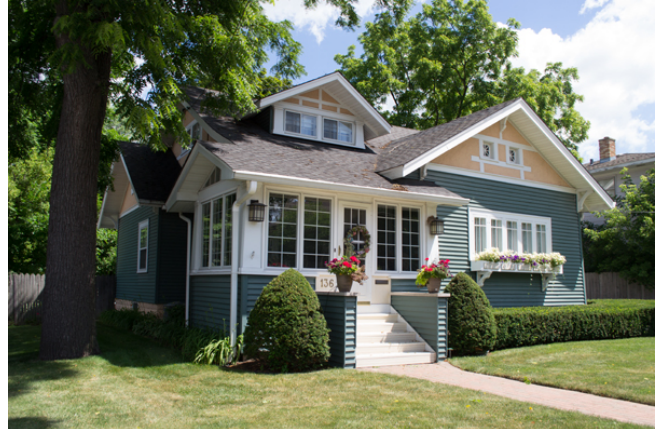
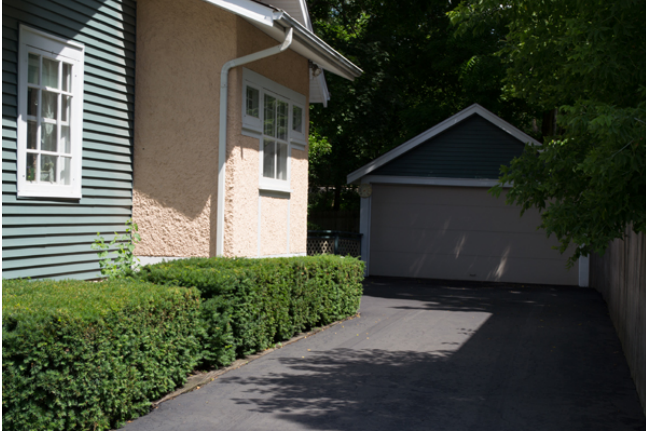
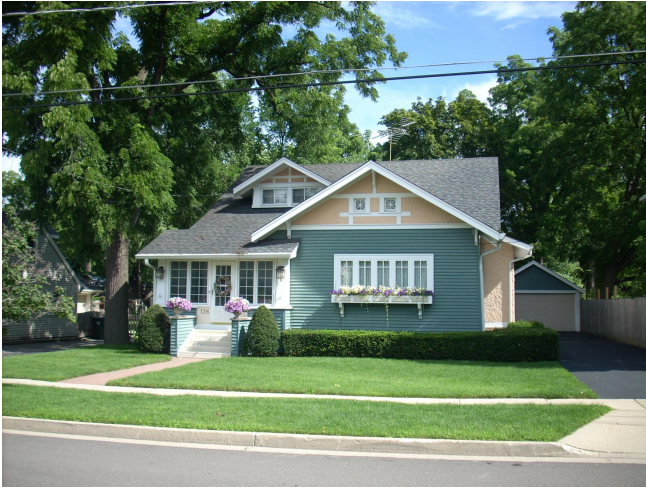
Photo Id: NewberryAve136(1)

CATEGORY	HISTORIC USE
Building	Domestic - single dwelling
CONDITION	SECONDARY STRUCTURE
Good	Detached garage
INTEGRITY	NR SECOND
Minor alterations	NC
CURRENT USE	
Domestic - single dwelling

Craftsman Bungalow

Despite some alterations, this Craftsman Bungalow may be eligible for local landmark designation.

Side gable roof with L brackets under eaves; front gable bay with battered corners, decorative half timbering; east side oriel window bay; corner entry porch with battered square columns; gable front dormer

Replacement siding on sections of exterior; front porch enclosed; alterations to rear porch (replaced 1956, alterations 1970)

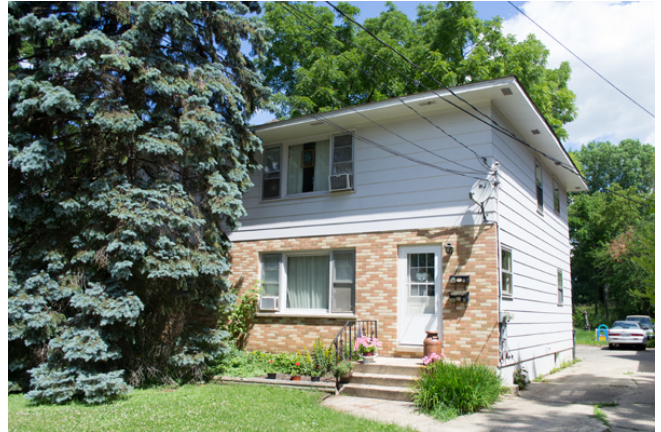
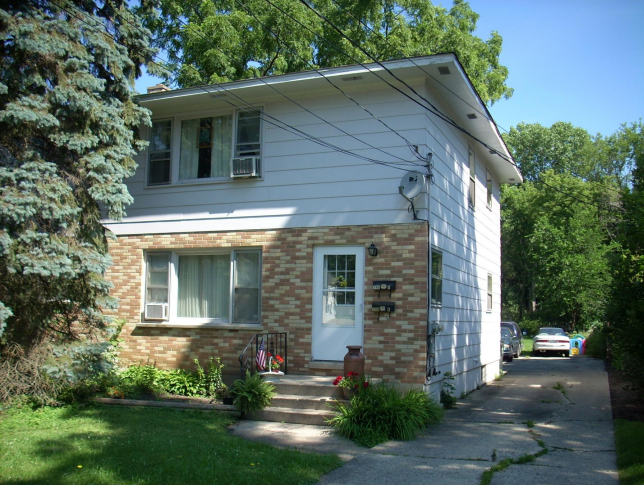
Photo Id: NewberryAve140

CATEGORY	HISTORIC USE
Building	Domestic - multiple dwelling
CONDITION	SECONDARY STRUCTURE
Good	-
INTEGRITY	NR SECOND
Minor alterations	-
CURRENT USE	
Domestic - multiple dwelling

Contemporary

Replacement siding; replacement front door

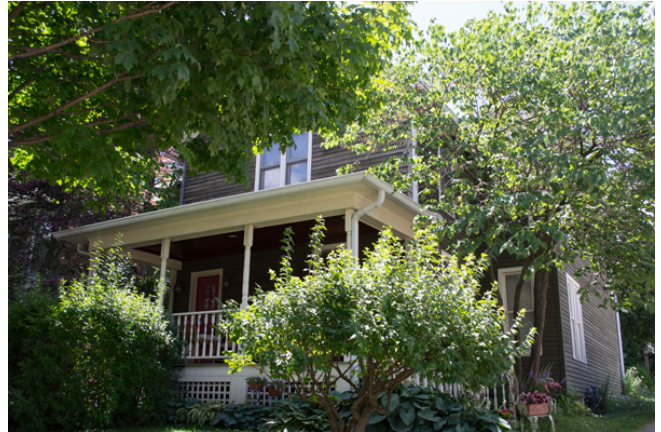
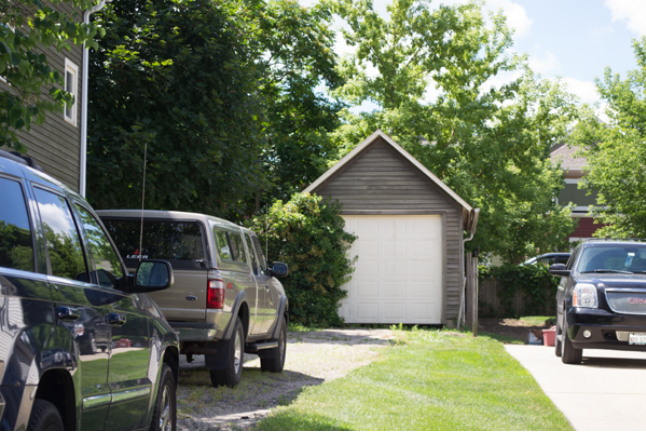
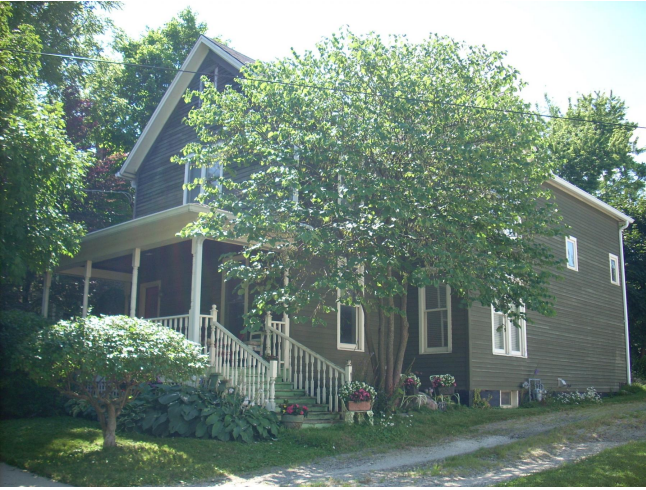
Photo Id: NewberryAve143(1)

CATEGORY	Building	HISTORIC USE	Domestic - single dwelling
CONDITION	Good	SECONDARY STRUCTURE	Detached garage
INTEGRITY	Moderate alterations	NR SECOND	NC
CURRENT USE	Domestic - single dwelling

Front gable roof; hipped full-front porch structure (historic, but not original-see 1912 and 1924 Sanborn maps); two-story west gable bay (altered)

Wood siding is replacement; replacement windows in original openings; replacement railings and columns on front porch; two-story rear and west addition (1993); replacement front door

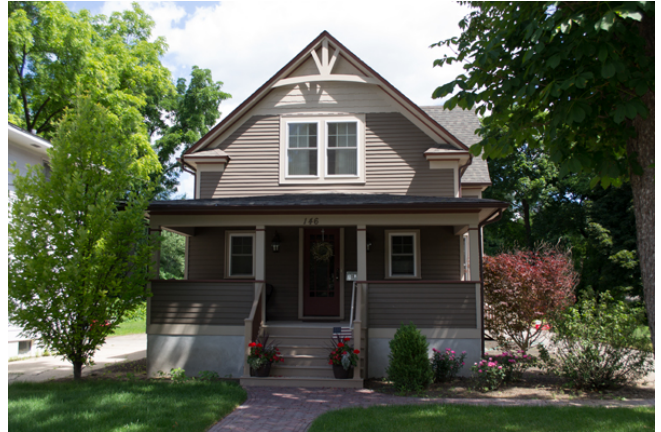
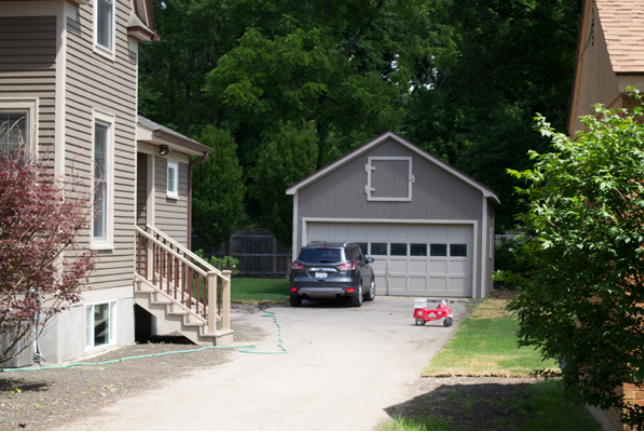
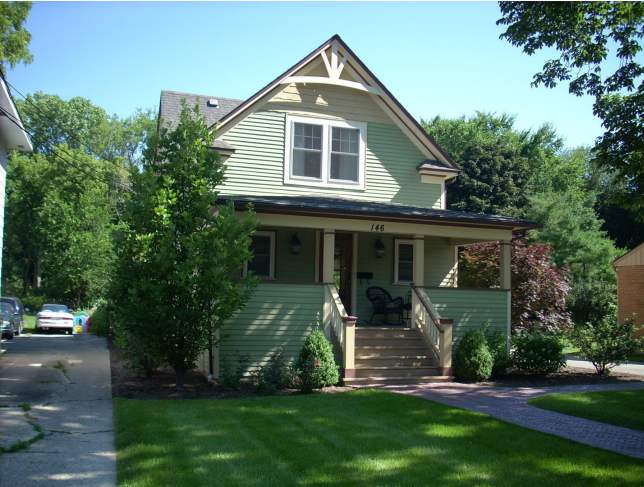
Photo Id: NewberryAve146(1)

CATEGORY	HISTORIC USE
Building	Domestic - single dwelling
CONDITION	SECONDARY STRUCTURE
Good	Detached garage
INTEGRITY	NR SECOND
Moderate alterations	NC
CURRENT USE	
Domestic - single dwelling

Front gable roof; east-side gable bay; front porch structure with hipped roof

Exterior remodeling in 2012--replacement siding; replacement windows in original openings; replacement porch columns and step railings; rear porch enclosed (post-1948)

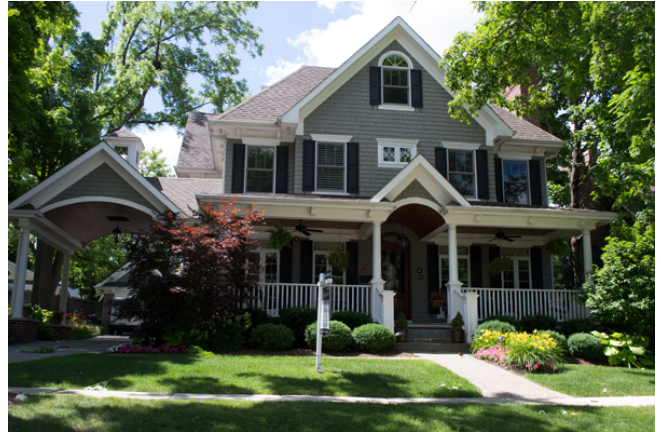
Photo Id: NewberryAve149(1)

CATEGORY	HISTORIC USE
Building	Domestic - single dwelling
CONDITION	SECONDARY STRUCTURE
Excellent	Detached garage
INTEGRITY	NR SECOND
Not altered	NC
CURRENT USE	
Domestic - single dwelling

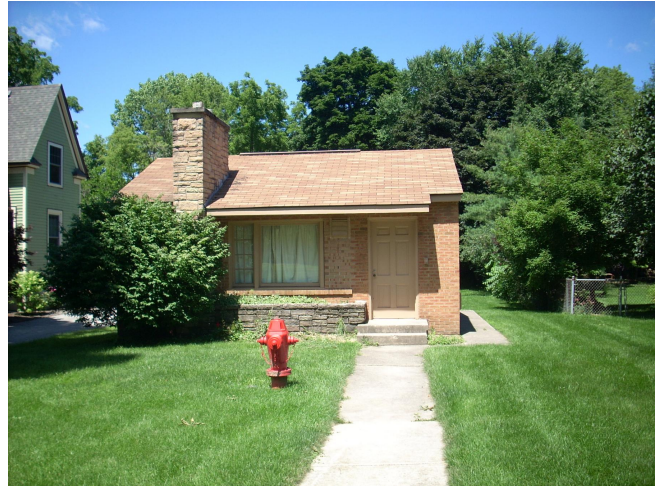
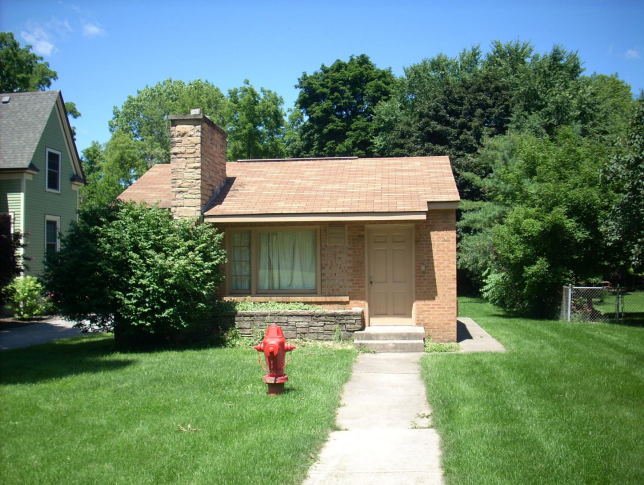
Photo Id: NewberryAve150

CATEGORY	HISTORIC USE
Building	Domestic - single dwelling
CONDITION	SECONDARY STRUCTURE
Good	-
INTEGRITY	NR SECOND
Minor alterations	-
CURRENT USE	
Domestic - single dwelling

Materials (siding, windows, door) all appear original; stone chimney and front planter box

One casement windows on front facade bricked in

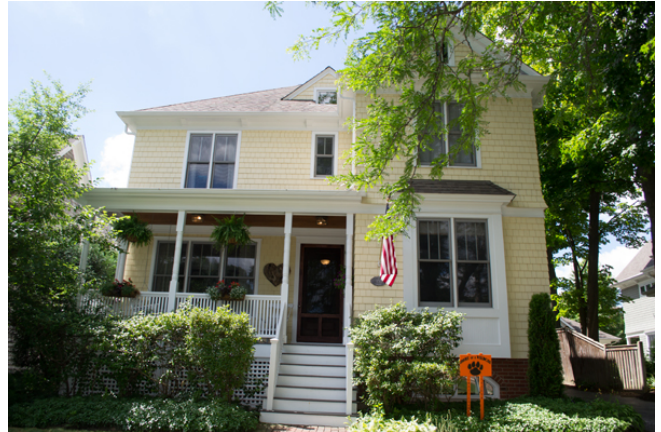
Photo Id: NewberryAve155(1)

CATEGORY	HISTORIC USE
Building	Domestic - single dwelling
CONDITION	SECONDARY STRUCTURE
Excellent	Detached garage
INTEGRITY	NR SECOND
Not altered	NC
CURRENT USE	
Domestic - single dwelling

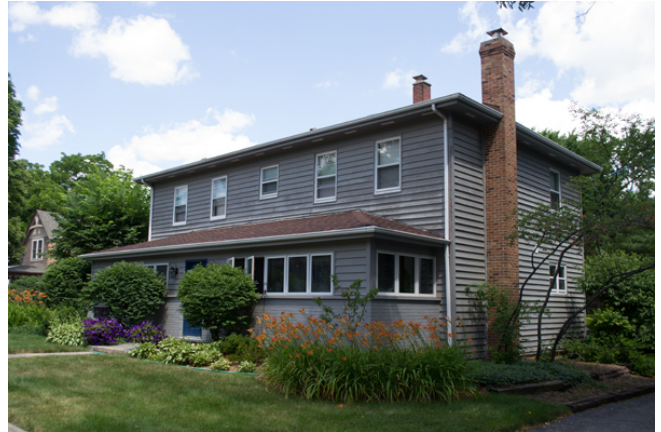
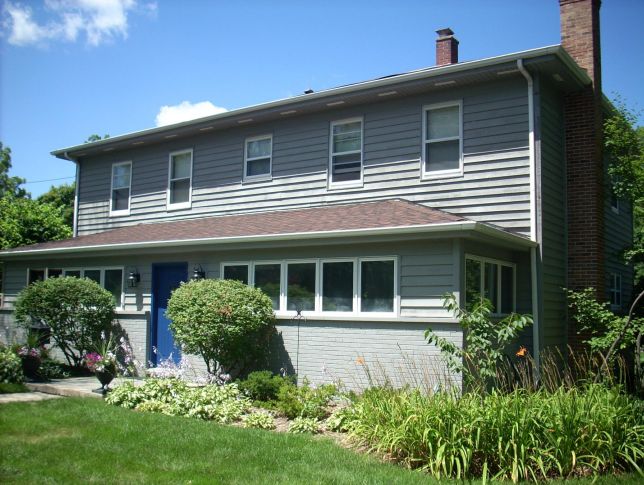
Photo Id: NewberryAve158(1)

CATEGORY	HISTORIC USE
Building	Domestic - single dwelling
CONDITION	SECONDARY STRUCTURE
Good	-
INTEGRITY	NR SECOND
Major alterations and additions	-
CURRENT USE	
Domestic - single dwelling

Original massing and roofline of house obscured by large, 2-story west side addition built in 1986; original porch removed and replaced with new enclosed porch; replacement siding; replacement windows in original openings

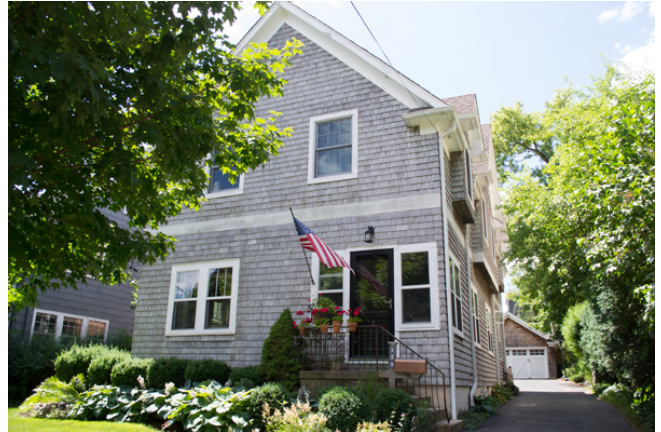
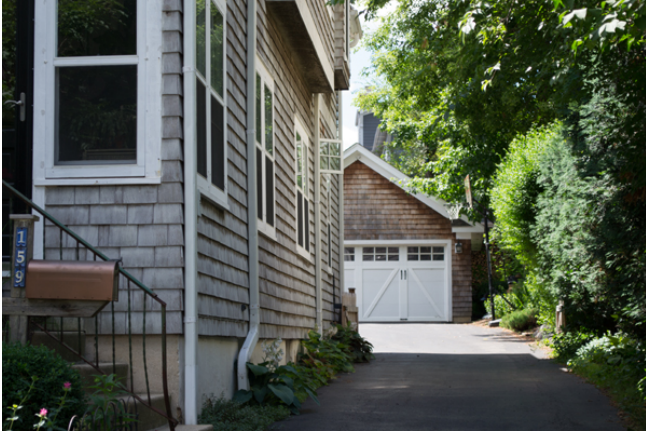
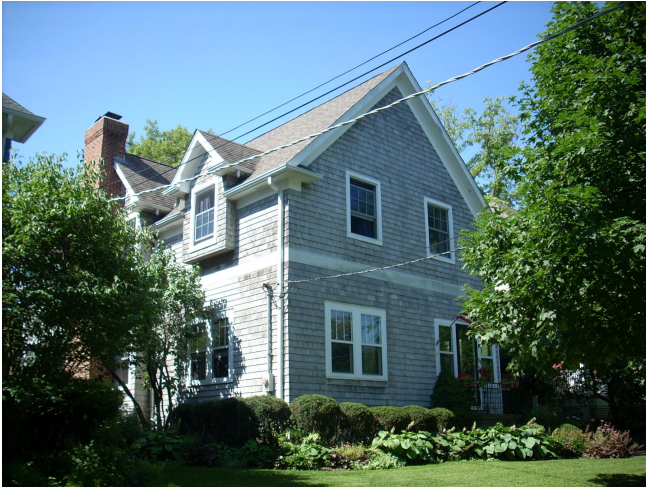
Photo Id: NewberryAve159(1)

CATEGORY	HISTORIC USE
Building	Domestic - single dwelling
CONDITION	SECONDARY STRUCTURE
Good	Detached garage
INTEGRITY	NR SECOND
Major alterations and additions	NC
CURRENT USE	
Domestic - single dwelling

Second story is non-historic addition (see 1948 Sanborn map); replacement siding

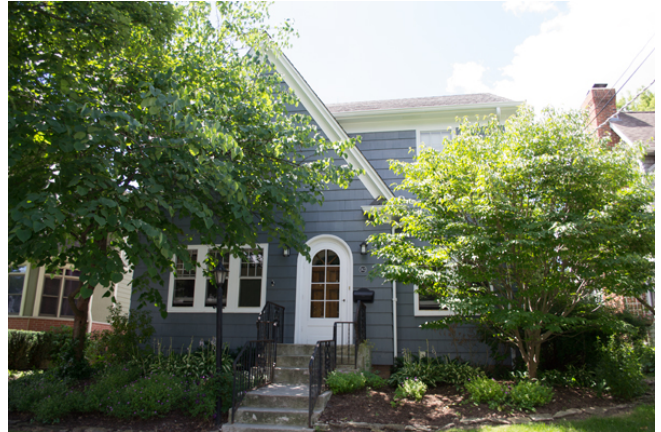
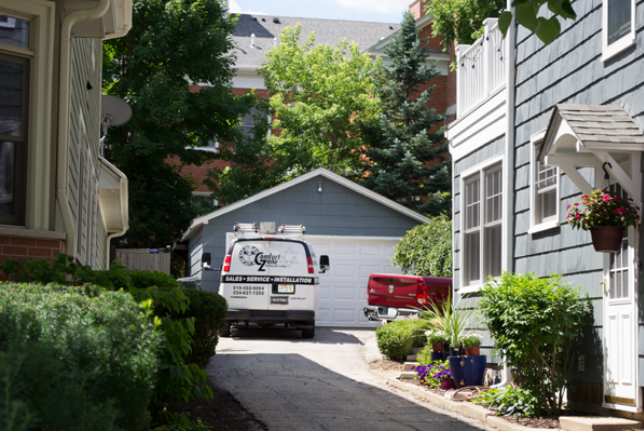
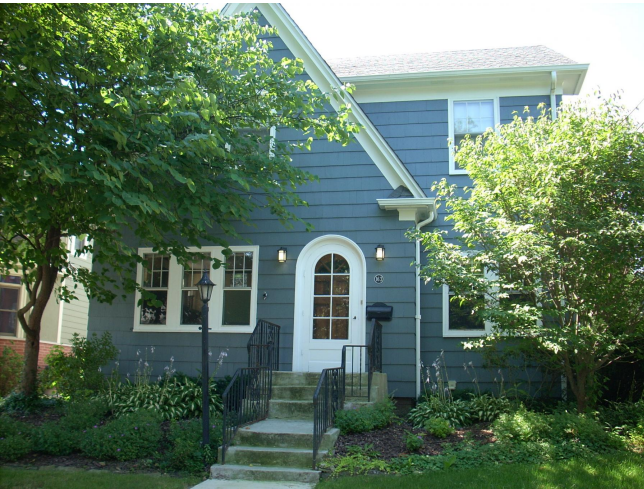
Photo Id: NewberryAve163(1)

CATEGORY	HISTORIC USE
Building	Domestic - single dwelling
CONDITION	SECONDARY STRUCTURE
Good	Detached garage
INTEGRITY	NR SECOND
Minor alterations	NC
CURRENT USE	
Domestic - single dwelling

Replacement front door; rear porch enclosed (1955)
