Historic Libertyville

Ramsey Historic Consultants

May-June 2016

Downtown Libertyville

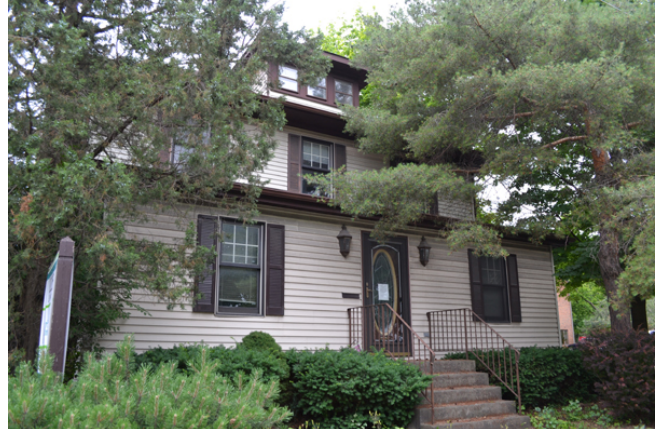
Photo Id: ParkAveE225

CATEGORY	HISTORIC USE
Building	Domestic - single dwelling
CONDITION	SECONDARY STRUCTURE
Good	Detached garage
INTEGRITY	NR SECOND
Minor alterations	NC
CURRENT USE	
Commerce/Trade

American Foursquare

Hipped roof with overhanging eaves; front hipped-roof dormer; hipped-roof front porch structure (enclosed)

Replacement siding; replacement windows in original openings; 2 story rear addition; front porch enclosed (non-historic porch door and concrete steps)

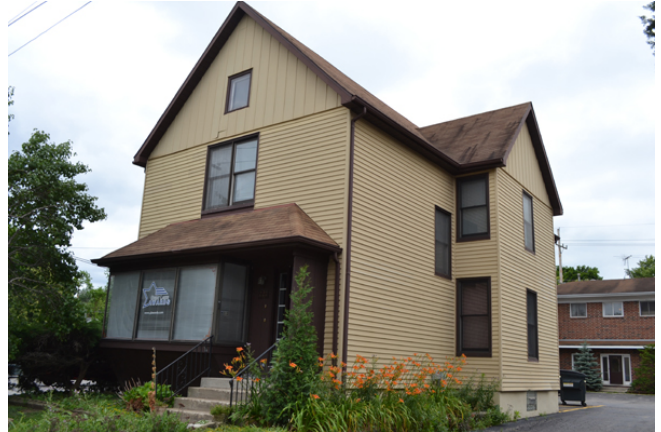
Photo Id: ParkAveE227(1)

CATEGORY	HISTORIC USE
Building	Domestic - single dwelling
CONDITION	SECONDARY STRUCTURE
Good	-
INTEGRITY	NR SECOND
Minor alterations	-
CURRENT USE	
Commerce/Trade - office

Gable Front

Front gable roof; 2-story square gable-roof bay on west facade;
2-story gable-roof bay with cutaway corners on east facade

Replacement siding; replacement windows in original openings;
2nd-story rear addition; Front porch replaced with enclosed bay
(1976)

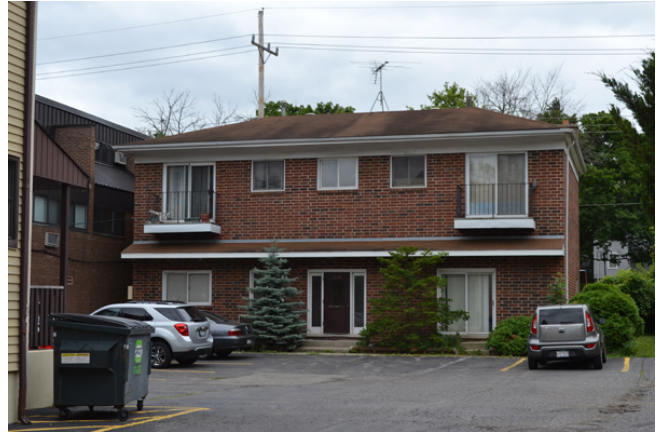
Photo Id: ParkAveE229

CATEGORY	HISTORIC USE
Building	Domestic - multiple dwelling
CONDITION	SECONDARY STRUCTURE
Good	-
INTEGRITY	NR SECOND
Minor alterations	-
CURRENT USE	
Domestic - multiple dwelling

Neo-Colonial

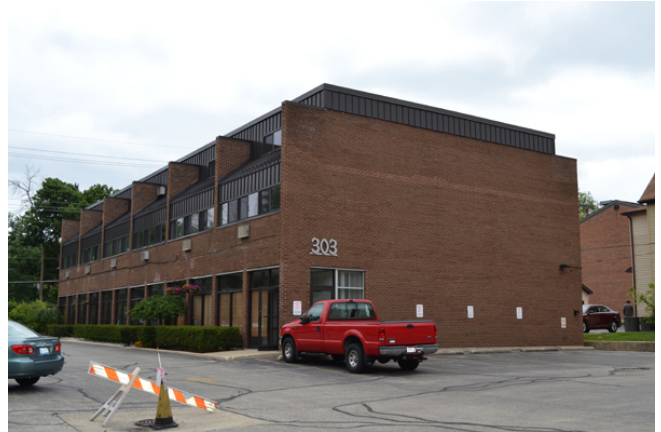
Photo Id: ParkAveE303

CATEGORY	HISTORIC USE
Building	Commerce/Trade
CONDITION	SECONDARY STRUCTURE
Good	-
INTEGRITY	NR SECOND
Minor alterations	-
CURRENT USE	
Commerce/Trade

Contemporary

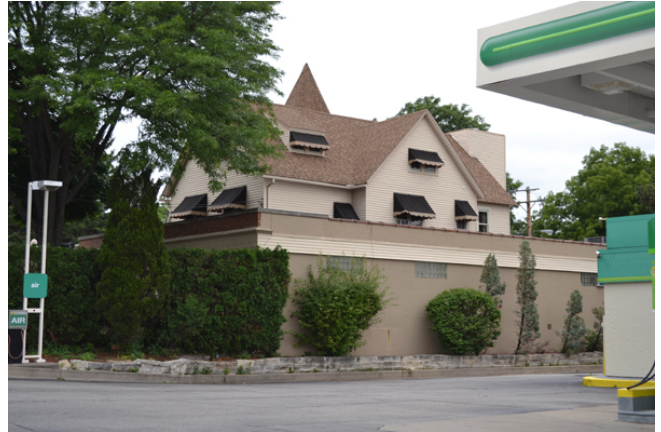
Photo Id: ParkAveW120(1)

CATEGORY	Building
CONDITION	Good
INTEGRITY	Major alterations and additions
CURRENT USE	Funerary--mortuary
HISTORIC USE	Domestic - single dwelling
SECONDARY STRUCTURE	Detached garage
NR SECOND	NC

Queen Anne (altered)

Original Queen Anne house surrounded by additions dating from the 1970s--original roof line, west side polygonal tower, and 2nd-story elevations still extant

Aluminum siding on original house (1986); replacement windows in original openings; awnings over window openings on original house; multiple 1-story additions surrounding original structure along south, east, and west sides (1971)

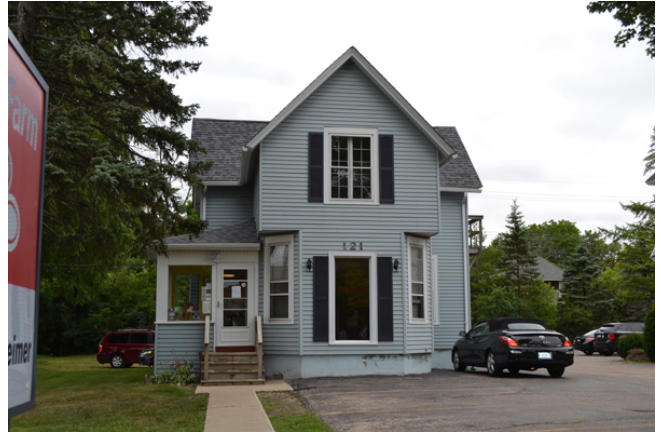
Photo Id: ParkAveW121(2)

CATEGORY	HISTORIC USE
Building	Domestic - single dwelling
CONDITION	SECONDARY STRUCTURE
Good	-
INTEGRITY	NR SECOND
Moderate alterations	-
CURRENT USE	
Commerce/Trade - office

Cross Gable

Two story front gable bay with east and west two-story cross-bays; cutaway corners on front bay; square, east-side oriel bay with historic wood windows

Replacement siding (2005); replacement windows in downsized openings (except in oriel bay); corner entry porch (historic alteration likely dating from the 1910s or 20s, enclosed later); fixed shutters; rear east-side addition; east deck addition; exterior staircase on west bay (2006)

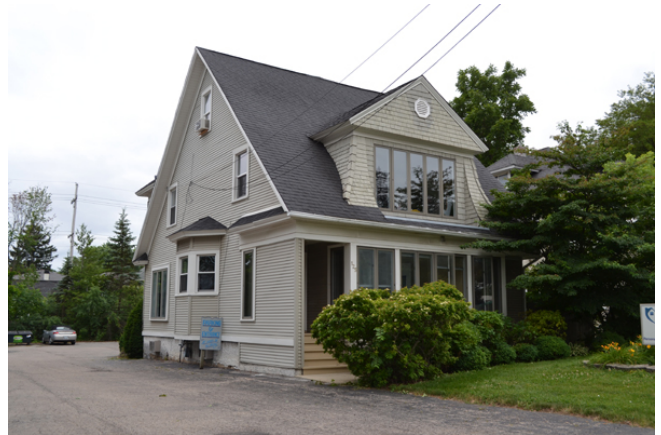
Photo Id: ParkAveW125(2)

CATEGORY	HISTORIC USE
Building	Domestic - single dwelling
CONDITION	SECONDARY STRUCTURE
Good	-
INTEGRITY	NR SECOND
Moderate alterations	-
CURRENT USE	
Commerce/Trade - office

Queen Anne/Shingle

Side gable roof with cornice returns; three-sided east oriel bay window; inset front porch structure (altered)

Sanborn maps from 1924-1948 show house with full-front, open porch--porch partially enclosed at center, removed at west end, with open entry porch at east end; replacement windows in original openings on side elevations; inset porch in front dormer enclosed with casement windows; replacement siding

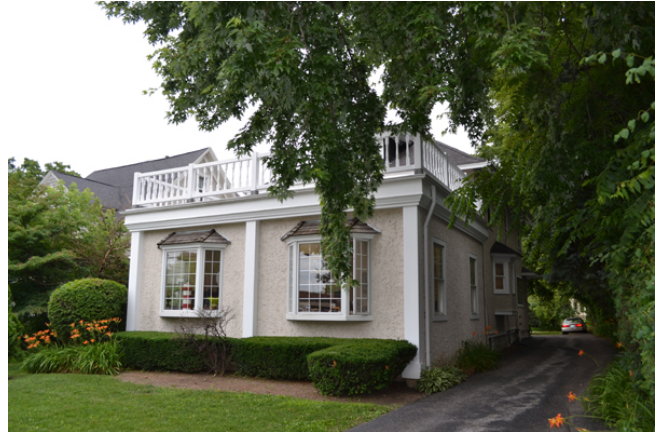
Photo Id: ParkAveW131(1)

CATEGORY	HISTORIC USE
Building	Domestic - single dwelling
CONDITION	SECONDARY STRUCTURE
Good	-
INTEGRITY	NR SECOND
Major alterations	-
CURRENT USE	
Commerce/Trade - office

One-story front addition to building obscures original facade (1989)

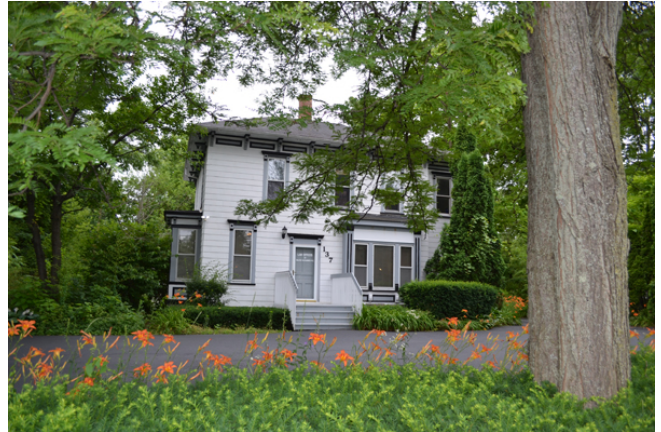
Photo Id: ParkAveW137(3)

CATEGORY	HISTORIC USE
Building	Domestic - single dwelling
CONDITION	SECONDARY STRUCTURE
Good	Detached garage
INTEGRITY	NR SECOND
Moderate alterations and additions	C
CURRENT USE	
Commerce/Trade - office

Replacement siding; replacement wood windows (may be historic, but not original); original full-front porch removed and replaced with wood stoop (post-1948); replacement front door; front window bay addition; 2-story west side addition (1988); second-story rear addition (1988)

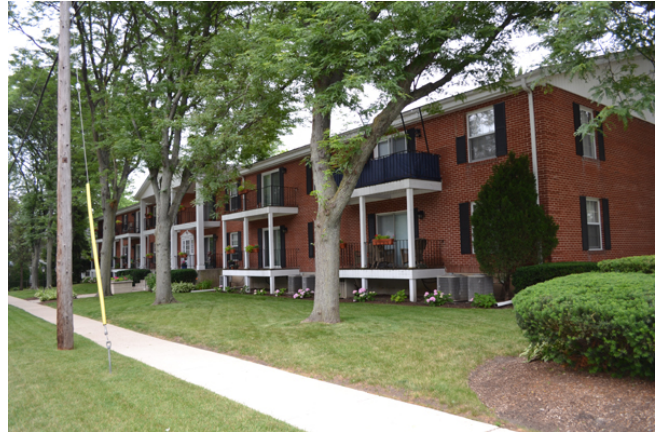
Photo Id: ParkAveW144(1)

CATEGORY	HISTORIC USE
Building	Domestic - multiple dwelling
CONDITION	SECONDARY STRUCTURE
Good	-
INTEGRITY	NR SECOND
Minor alterations	-
CURRENT USE	
Domestic - multiple dwelling
