Historic Libertyville

BEGINNING STREET NUMBER	215
END STREET NUMBER	-
STREET # SUFFIX	-
STREET NAME	Broadway Avenue
PIN	
<u>LOCAL</u>	
WITHIN LOCAL DISTRICT?	No
LOCAL DIST CONTRIB/NON-CONTRIB?	C
LOCAL LANDMARK?	No
YEAR	-
LOCAL LANDMARK ELIGIBLE?	Yes
CRITERIA	A

BUILDING NAME	Evilsizer, J. P. House	ZONING	R-6
GROUND FLOOR USE	Residence	NUMBER OF STORIES	2
UPPER FLOOR USE	Residential	PROPERTY INDEX NUMBER	1116422003
CURRENT OCCUPANT	-

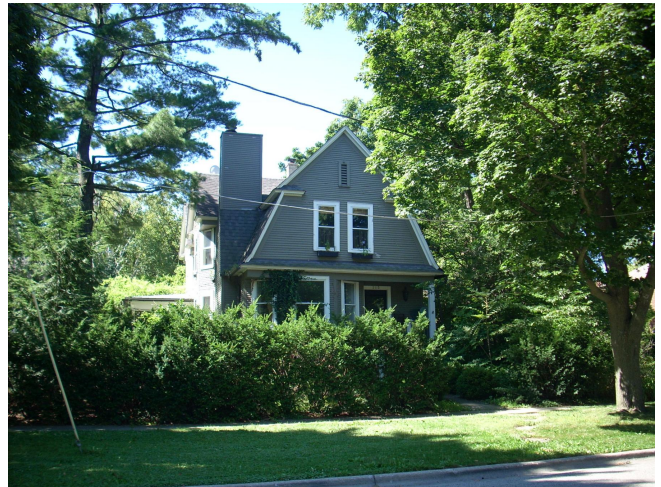
Photo Id: broadway215

Fine, early-20th-century example of the Dutch Colonial Revival Style, with characteristic front-facing gambrel roof .

Steeply pitched front gambrel roof; inset corner porch with corner wood support; polygonal window bay west of entry; full-height, east-side, gable-roof bay; historic windows

2-story rear and east addition (2000); 1-story rear addition; rear deck addition (1990); chimney addition (not historic)

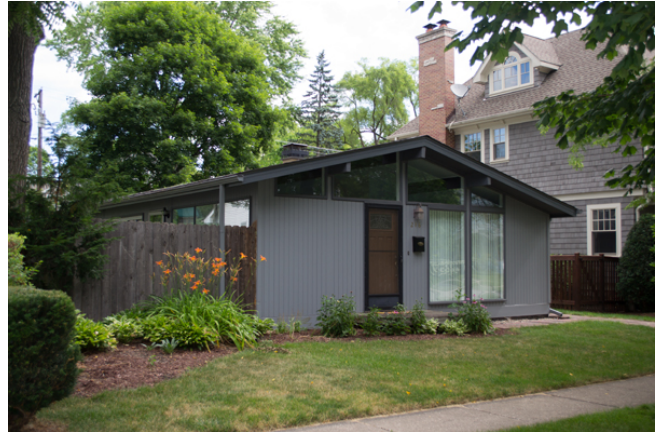
Photo Id: BroadwayAve216(1)

Low, pitched, broad front gable roof with overhanging eaves; vertical wood siding; single-light clerestory Windows on front facade

Replacement front door; replacement windows on east facade

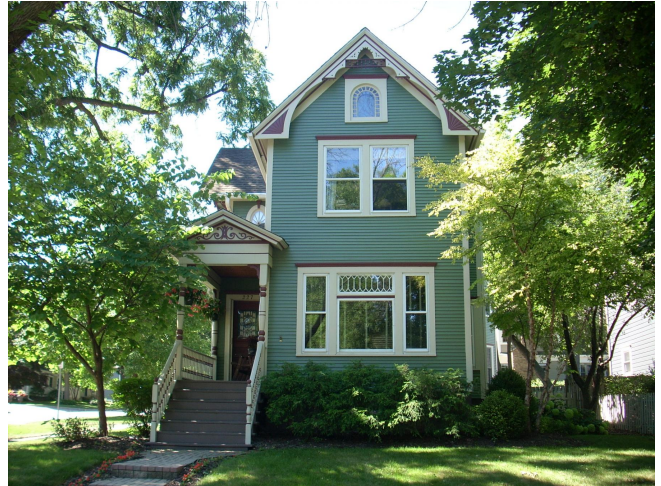
Photo Id: broadway227

Based on historic photograph of house in Libertyville Illustrated, the house has been extensively altered--large 2-story front and rear additions, front entry and porch moved, materials (wood siding, vergeboard, windows) appear to be new.

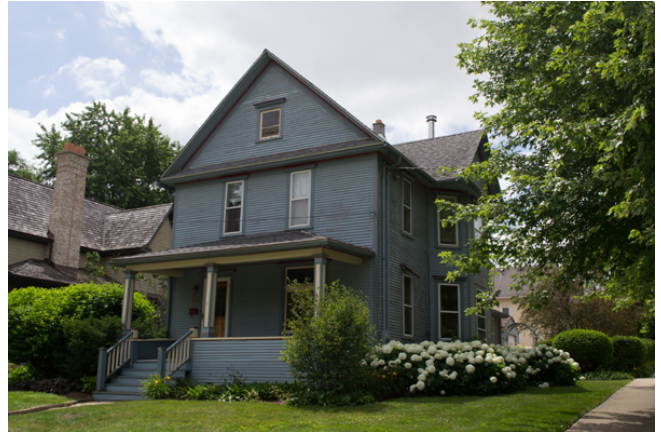
Photo Id: BroadwayAve303(1)

Simple but intact example of the Free-Classic variant of the Queen Anne style.

Front gable roof with pent enclosure; full-height gable bay on west facade with cutaway corners; wood double hung windows with classical wood lintels in openings; full front porch with square supports on solid knee walls

1-story rear porch addition; some non historic casement windows toward rear of west elevation

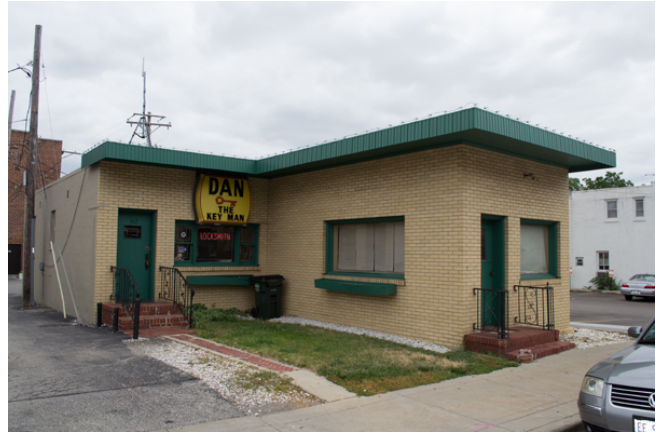
Photo Id: ChurchStE112(1)

Replacement doors; aluminum at eaves

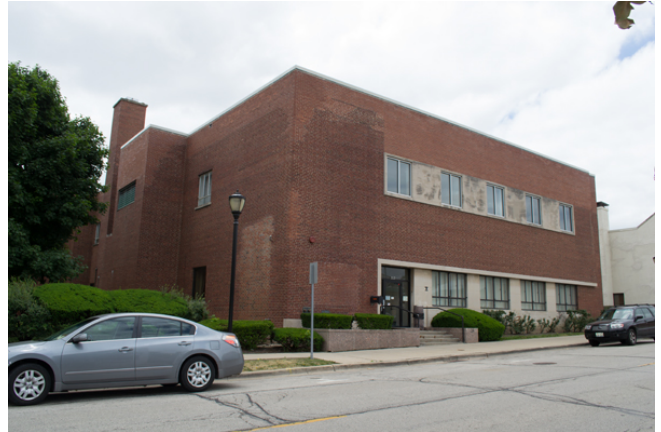
Photo Id: ChurchStE117(1)

Building may be eligible for local landmark designation for its associations with the history and development of communications in the Village of Libertyville. The building replaced an earlier office erected at the same location in 1923.

Two story rear additions (1956 and 1968); front window east of entry bricked in

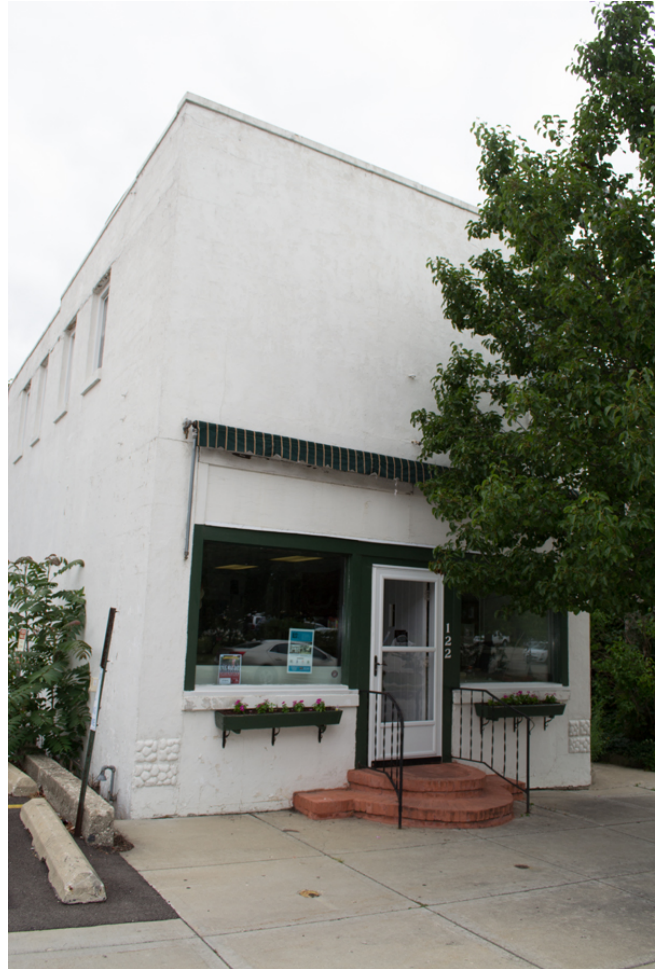
Photo Id: ChurchStE122(1)

Replacement double hung windows in original openings; replacement storefront window and door; 2-story rear addition (between 1933 and 1948); replacement stoop (2014); 2-story porch addition
