Historic Libertyville

BEGINNING STREET NUMBER	222-224
END STREET NUMBER	-
STREET # SUFFIX	-
STREET NAME	E. Church Street
PIN	
<u>LOCAL</u>	
WITHIN LOCAL DISTRICT?	No
LOCAL DIST CONTRIB/NON-CONTRIB?	NC
LOCAL LANDMARK?	No
YEAR	-
LOCAL LANDMARK ELIGIBLE?	No
CRITERIA	-

May-June 2016

Downtown Libertyville

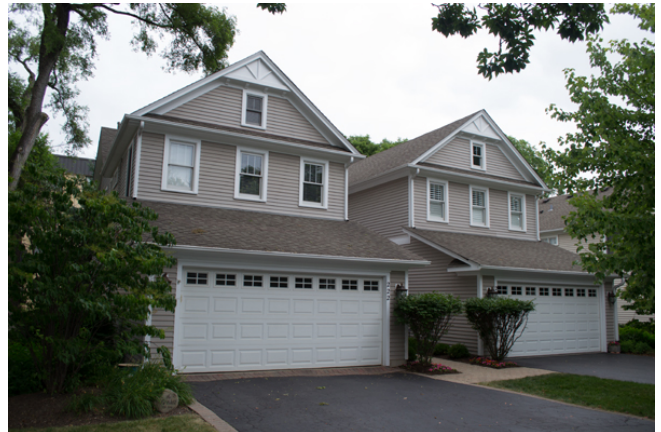
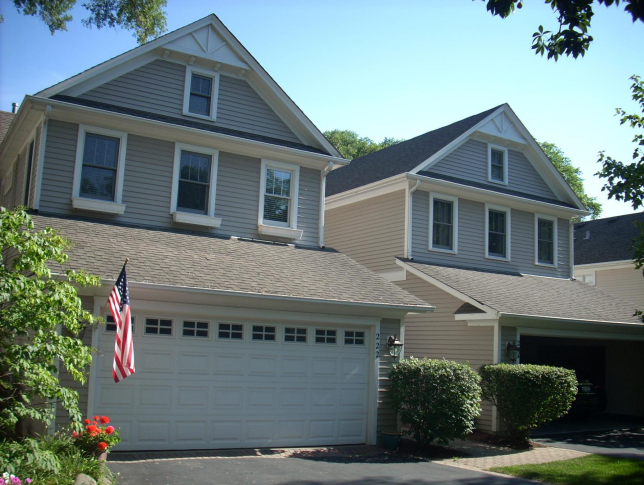
Photo Id: ChurchStE222-224(1)

CATEGORY	HISTORIC USE
Building	Domestic - multiple dwelling
CONDITION	SECONDARY STRUCTURE
Excellent	[attached garage]
INTEGRITY	NR SECOND
Not altered	-
CURRENT USE	
Domestic - multiple dwelling

New Traditional

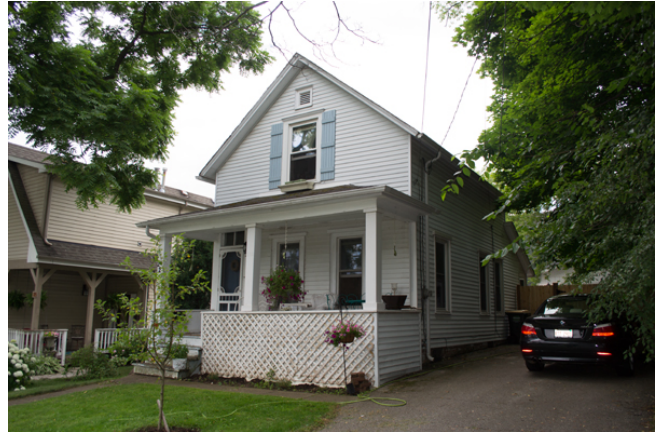
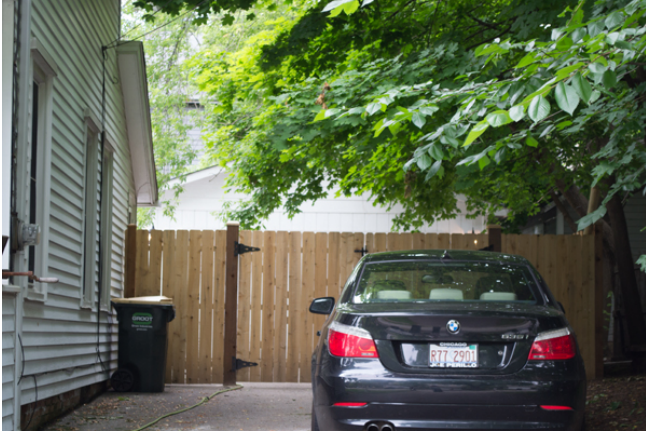
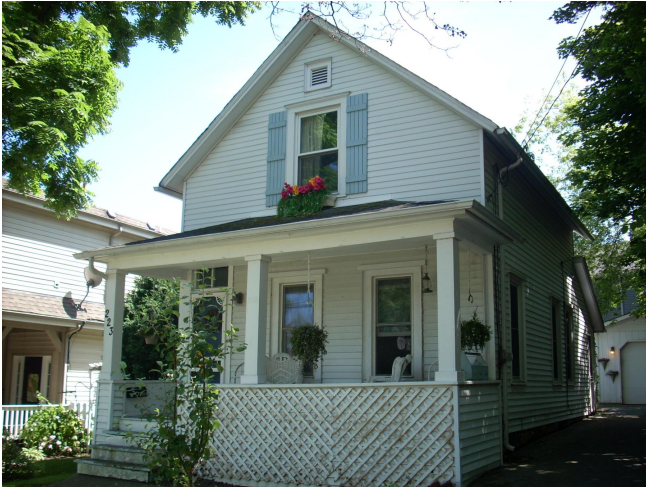
Photo Id: ChurchStE223(2)

CATEGORY	HISTORIC USE
Building	Domestic - single dwelling
CONDITION	SECONDARY STRUCTURE
Fair	Detached garage
INTEGRITY	NR SECOND
Moderate alterations and additions	NC
CURRENT USE	
Domestic - single dwelling

Gable Front

Front gable roof and rectangular massing; full front hipped-roof porch structure

Replacement siding; replacement windows in original openings; replacement columns on front porch; 1-story rear addition; fixed shutters

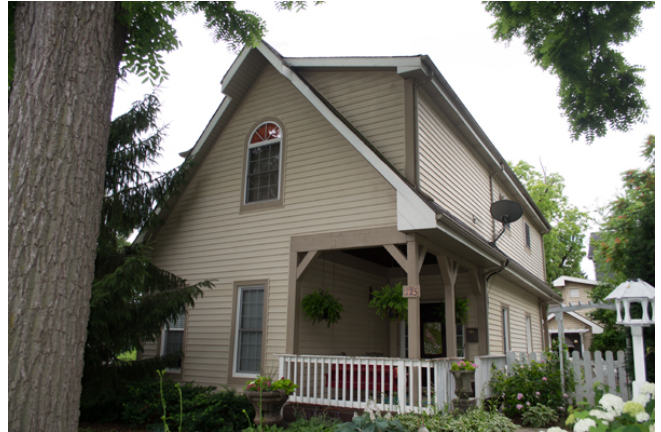
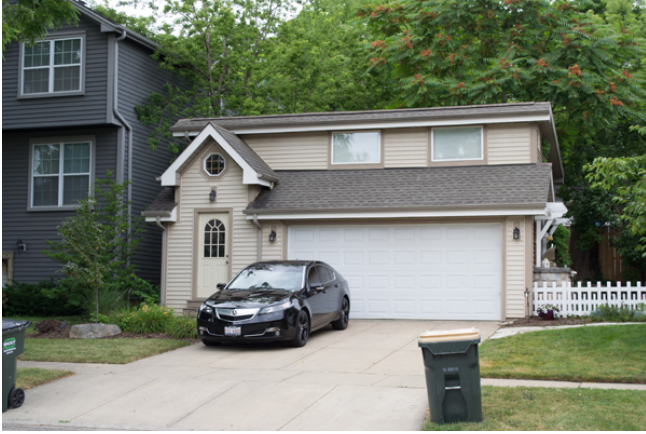
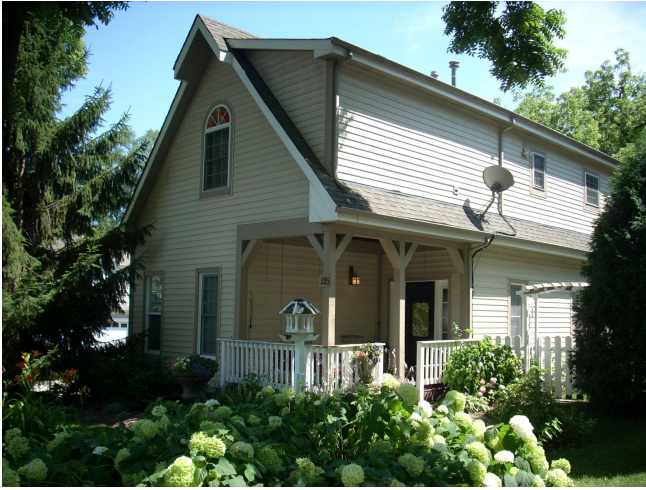
Photo Id: ChurchStE225(2)

CATEGORY	HISTORIC USE
Building	Domestic - single dwelling
CONDITION	SECONDARY STRUCTURE
Good	Detached garage
INTEGRITY	NR SECOND
Major alterations and/or additions	NC
CURRENT USE	
Domestic - single dwelling

Gable Front

Rectangular massing; corner porch structure added c. 1925

Major renovation in 1998--roof raised and pitch altered, and dormers added; replacement windows in original openings; round arch window added on front gable wall; replacement front porch supports and railing

98-170 (1998)--second story addition with alterations (\$61,600)

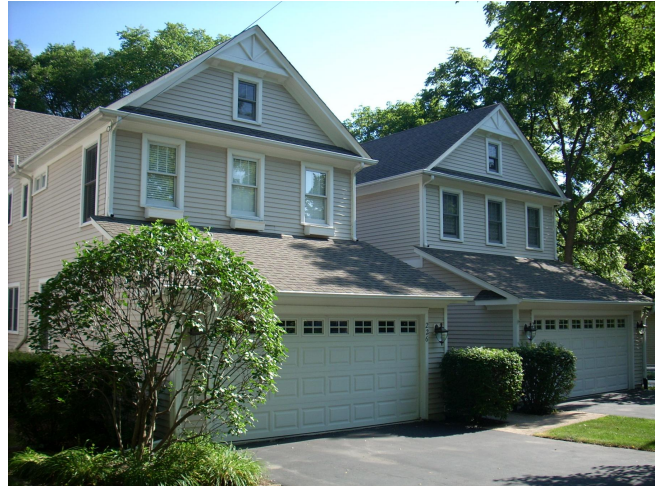
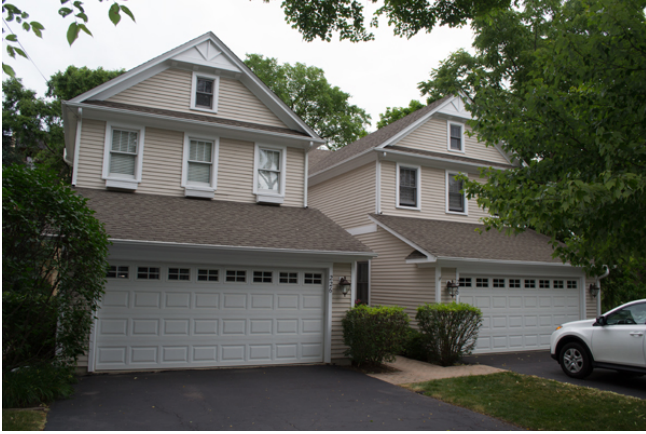
Photo Id: EChurch226228

CATEGORY	HISTORIC USE
Building	Domestic - multiple dwelling
CONDITION	SECONDARY STRUCTURE
Excellent	[attached garage]
INTEGRITY	NR SECOND
Not altered	-
CURRENT USE	
Domestic - multiple dwelling

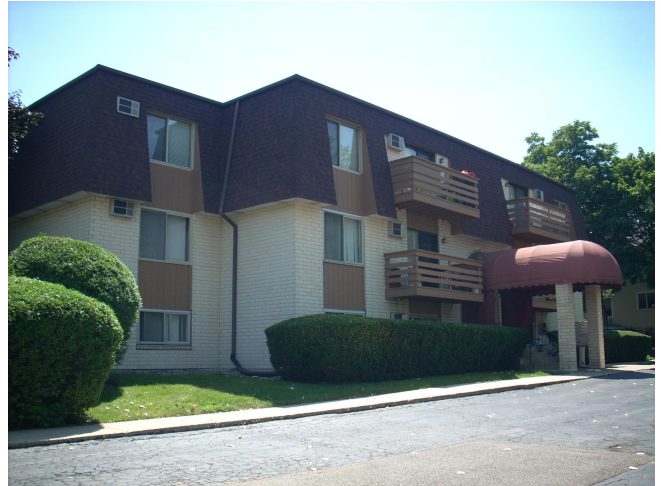
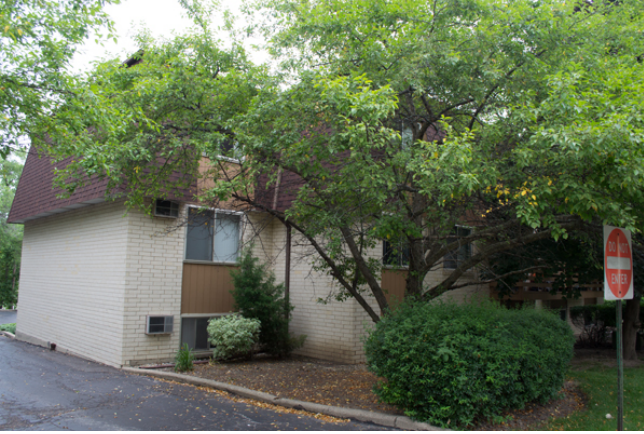
Photo Id: EChurch232

CATEGORY	HISTORIC USE
Building	Domestic - multiple dwelling
CONDITION	SECONDARY STRUCTURE
Good	-
INTEGRITY	NR SECOND
Minor alterations	-
CURRENT USE	
Domestic - multiple dwelling

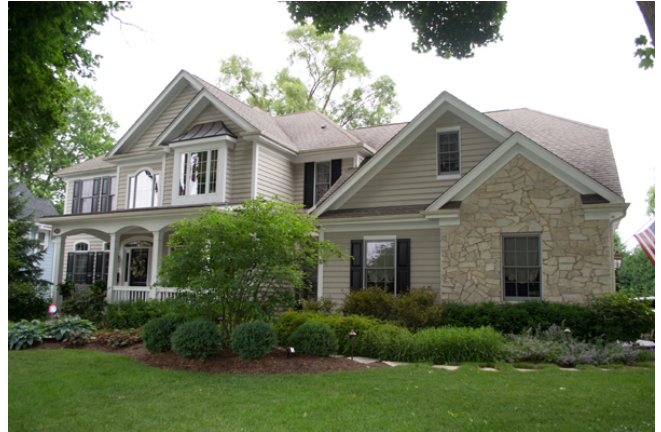
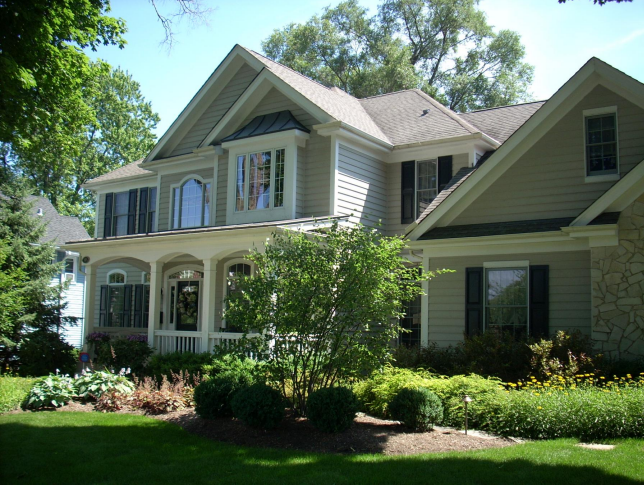
Photo Id: ChurchStE305(1)

CATEGORY	HISTORIC USE
Building	Domestic - single dwelling
CONDITION	SECONDARY STRUCTURE
Excellent	[attached garage]
INTEGRITY	NR SECOND
Not altered	-
CURRENT USE	
Domestic - single dwelling

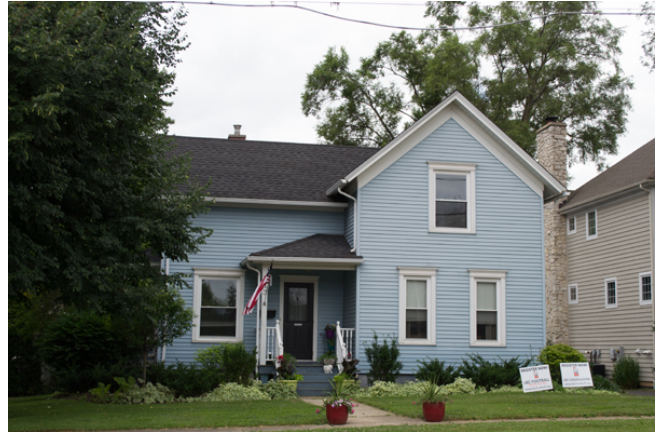
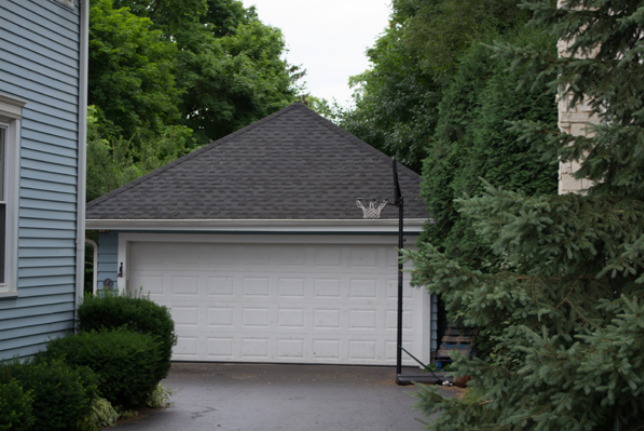
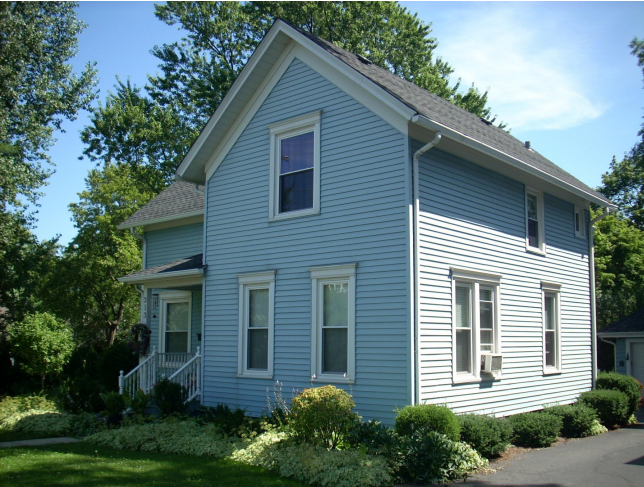
Photo Id: ChurchStE313(1)

CATEGORY	HISTORIC USE
Building	Domestic - single dwelling
CONDITION	SECONDARY STRUCTURE
Good	Detached garage
INTEGRITY	NR SECOND
Major alterations and additions	NC
CURRENT USE	
Domestic - single dwelling

L-Form

L-shaped massing, with front-gable bay intersected by 1.5-story side gable bay; 1-story square window bay at east facade

Replacement windows in original openings (2013); replacement siding (1991); replacement front porch (historic--1952); 2nd-story rear addition

JB-13-10147 (10/21/2013)--replacement windows; 2173 (8/18/1958)--remove front porch; 91-24 (1/22/1991)--vinyl siding and aluminum trim

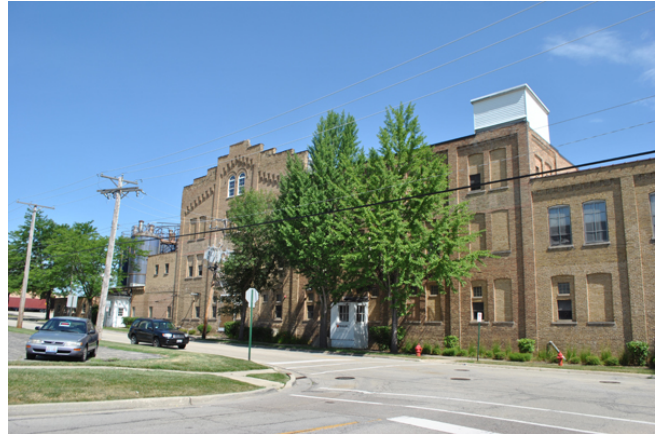
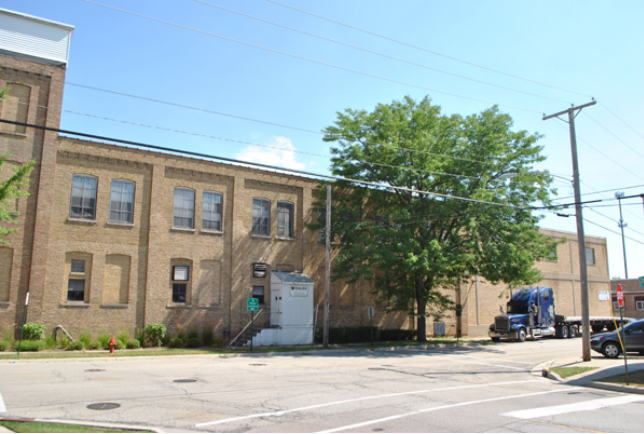
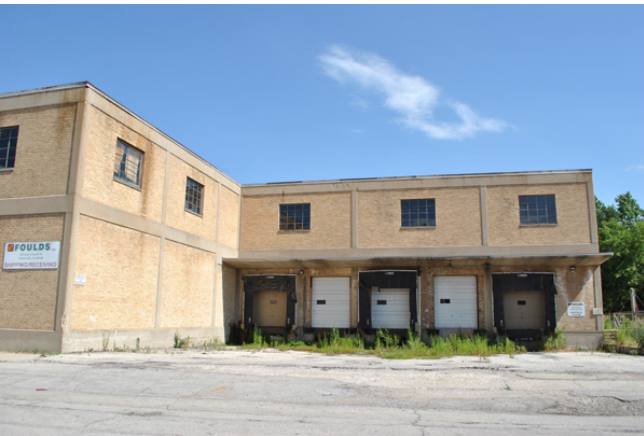
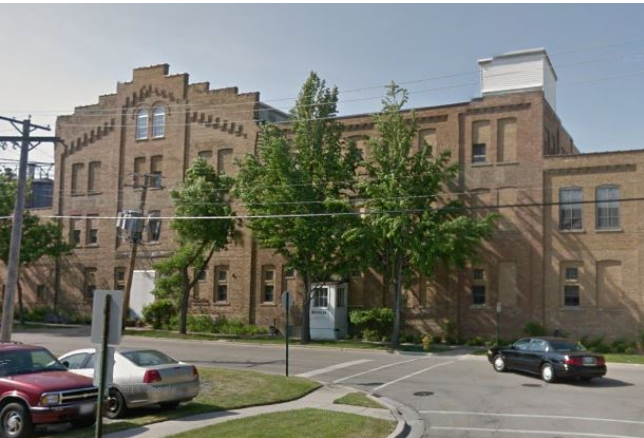
Photo Id: ChurchStE520(1)

CATEGORY	Building	HISTORIC USE	Industry/Processing/Extraction - manufacturing facility
CONDITION	Good	SECONDARY STRUCTURE	-
INTEGRITY	Moderate alterations and additions	NR SECOND	-
CURRENT USE	Industry/Processing/Extraction - manufacturing facility

Renaissance Revival

additions--1906 (c); 1920 (c); 1955 (c)

[see historic features for historic additions] 2-story east end addition dating from c. 1955-60 Wood shed-roof and hipped-roof entry bays along south (front) facade; most windows on building either replacement (glass block, metal, and vinyl) in downsized openings or bricked in

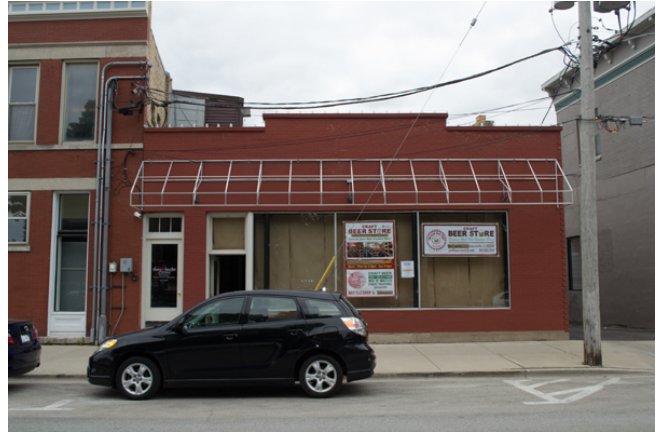
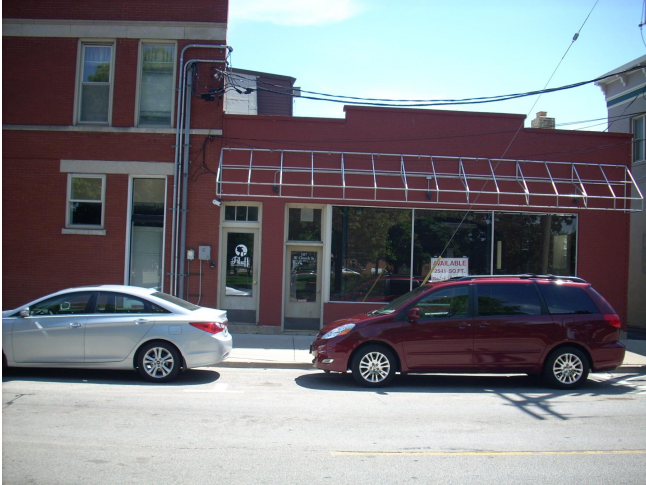
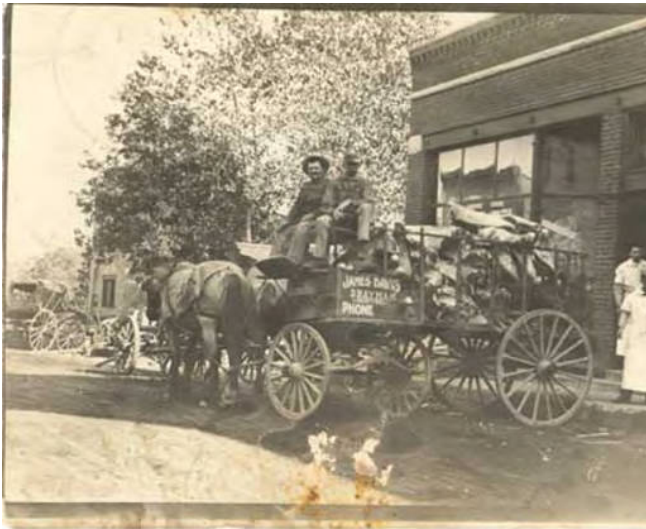
Photo Id: ChurchStW107(1)

CATEGORY	HISTORIC USE
Building	Commerce/Trade - business
CONDITION	SECONDARY STRUCTURE
Good	-
INTEGRITY	NR SECOND
Minor alterations	-
CURRENT USE	
Vacant

Storefront configuration altered (1949); awning (2008)

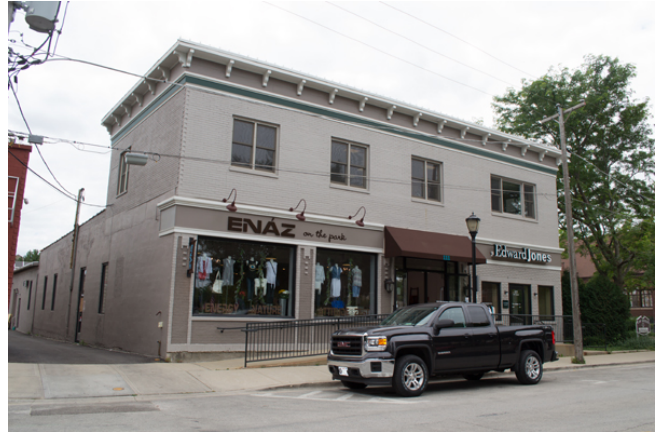
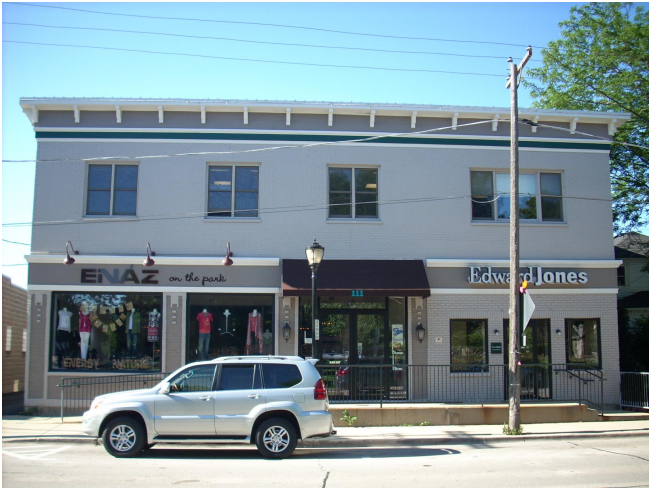
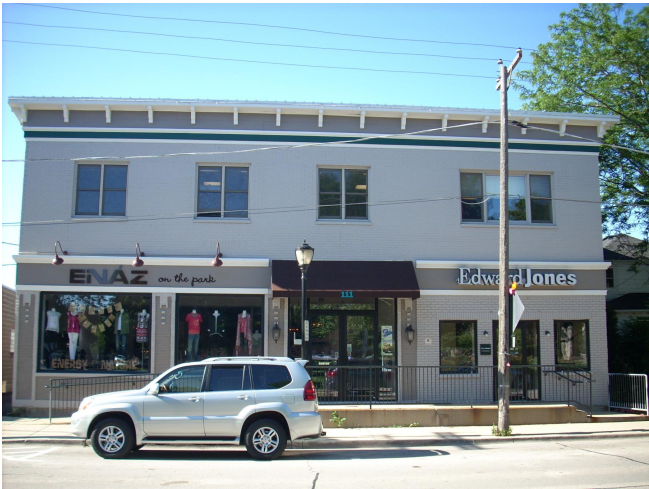
Photo Id: ChurchStW111-115(1)

CATEGORY	HISTORIC USE
Building	Commerce/Trade - business
CONDITION	SECONDARY STRUCTURE
Good	-
INTEGRITY	NR SECOND
Major alterations and additions	-
CURRENT USE	
Commerce/Trade - business

More recent alterations include replacement windows, in upper and storefront levels, faux cornice with brackets; storefront signage; center entry and awning
