Historic Libertyville

BEGINNING STREET NUMBER	121
END STREET NUMBER	-
STREET # SUFFIX	-
STREET NAME	W. Church Street
PIN	
<u>LOCAL</u>	
WITHIN LOCAL DISTRICT?	No
LOCAL DIST CONTRIB/NON-CONTRIB?	C
LOCAL LANDMARK?	No
YEAR	-
LOCAL LANDMARK ELIGIBLE?	No
CRITERIA	-

Ramsey Historic Consultants

Downtown Libertyville

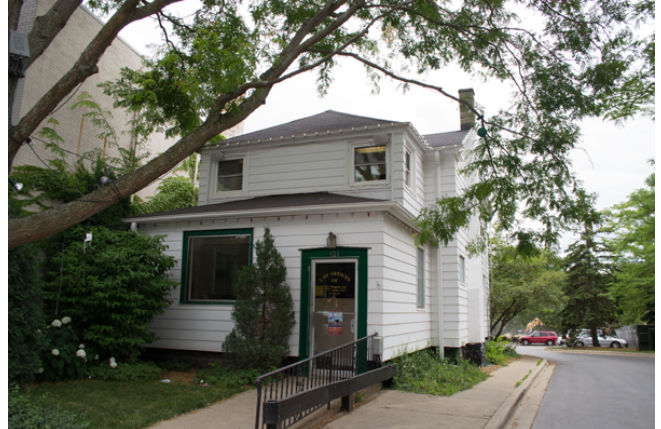
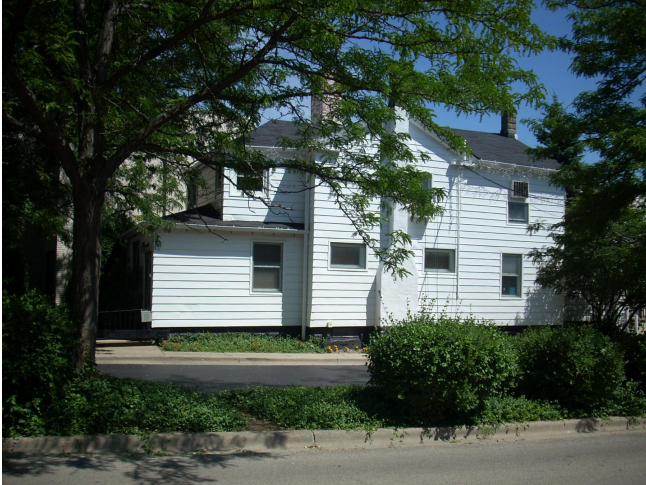
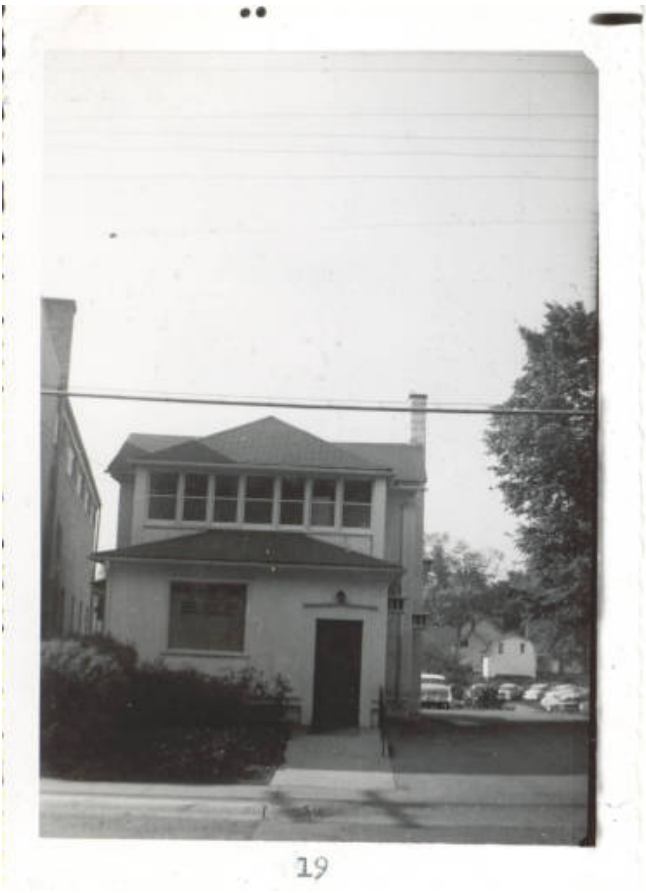
Photo Id: ChurchStW121(1)

CATEGORY	HISTORIC USE
Building	Domestic - single dwelling
CONDITION	SECONDARY STRUCTURE
Good	-
INTEGRITY	NR SECOND
Moderate alterations	-
CURRENT USE	
Commerce/Trade - business

Side Gable

Side gable roof with cornice returns; rectangular massing

Replacement siding (1970); replacement windows in original openings; rear porch enclosed; front porch enclosed (c. 1945) and expanded (post 1948); 2nd story front (north) addition above enclosed porch (post 1948)

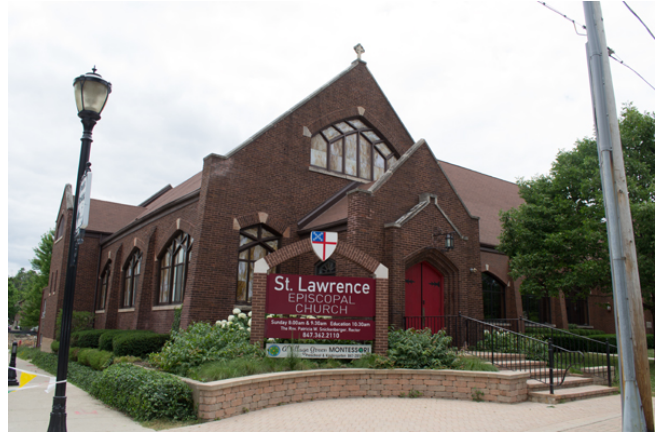
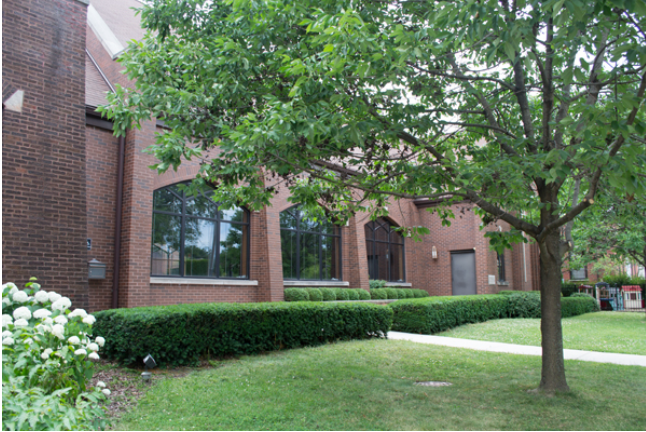
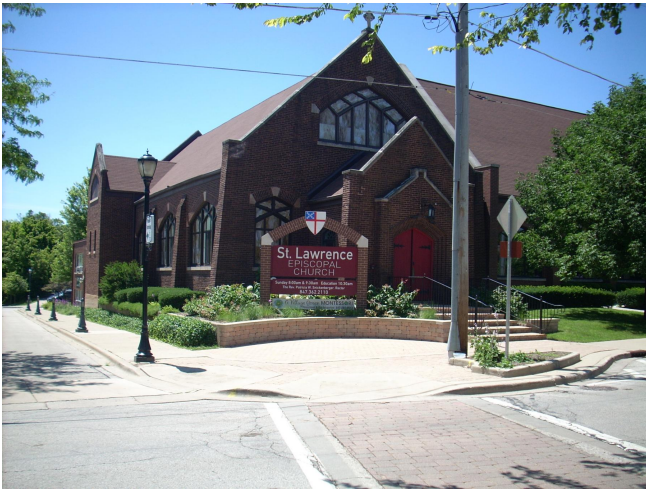
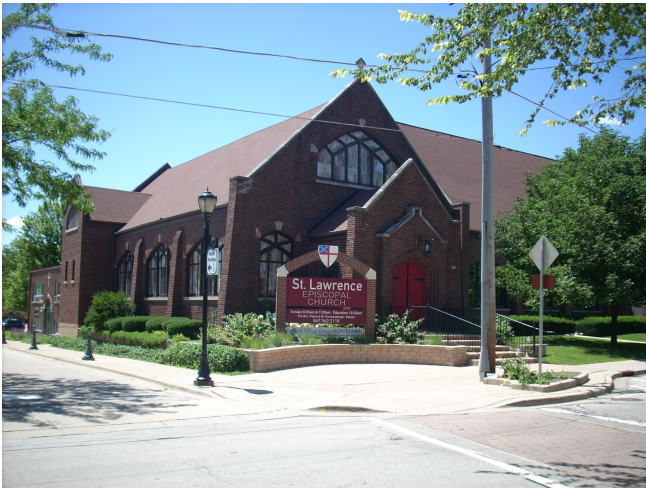
Photo Id: ChurchStW125(1)

CATEGORY	Building	HISTORIC USE	Religion - religious facility
CONDITION	Good	SECONDARY STRUCTURE	-
INTEGRITY	Additions	NR SECOND	-
CURRENT USE	Religion - religious facility

Gothic Revival

Sanctuary section of building features a broad, parapeted front gable roof; nested gable entry bay with double wood plank doors; side of sanctuary features decorative brick buttresses; multi-light pointed arch stained glass windows at original building

1-story addition behind sanctuary and original educational wing (1963-4); large 1.5-story east and north addition (2003)

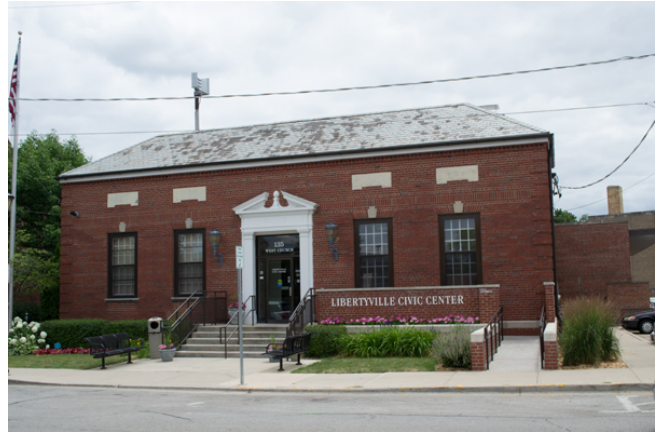
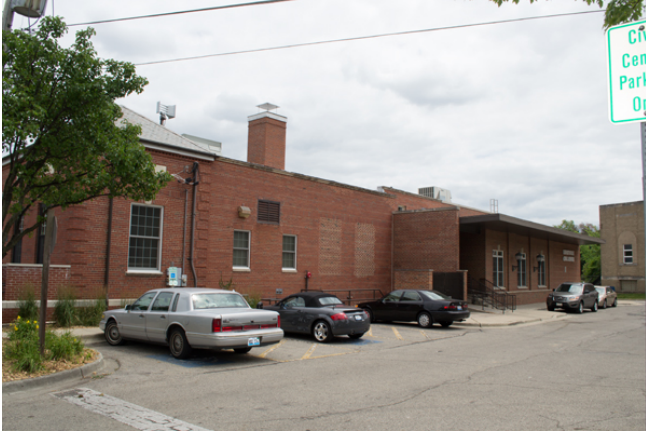
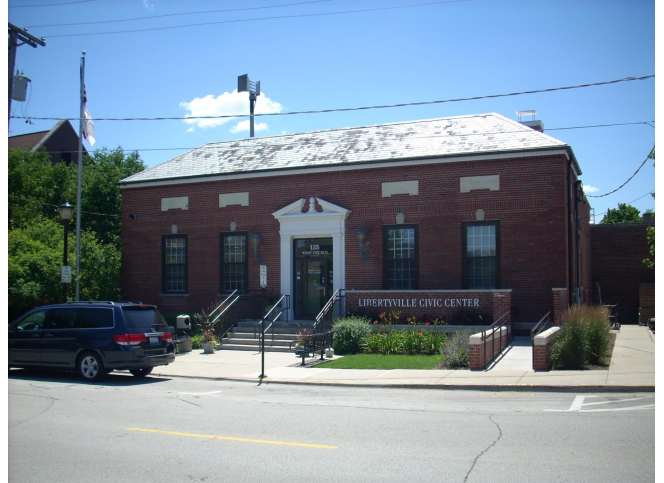
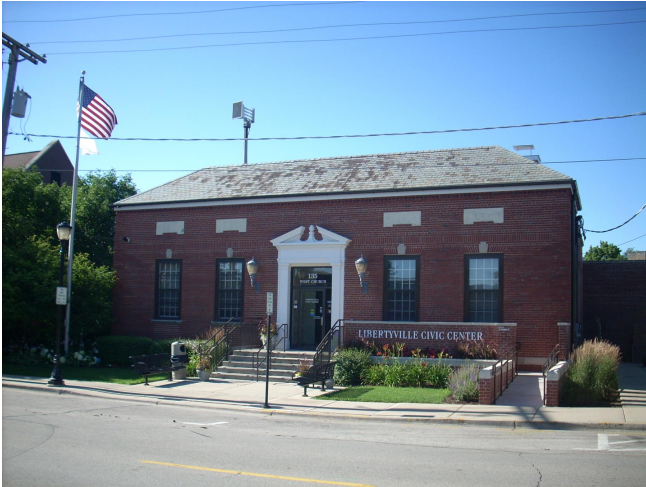
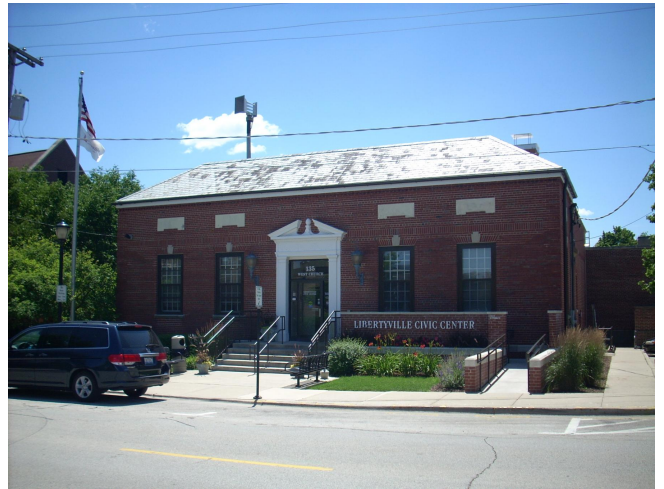
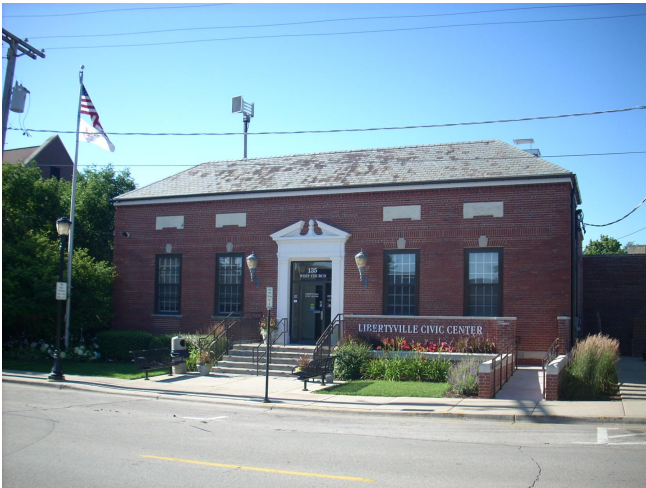
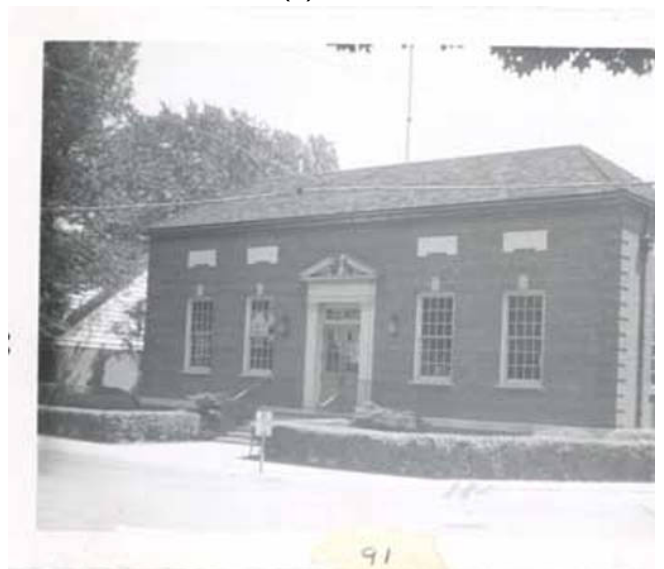
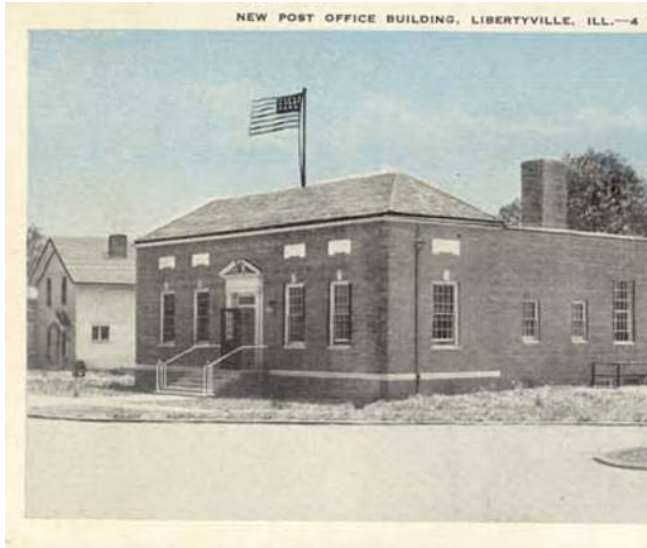
Photo Id: ChurchStW135(1)

CATEGORY	Building	HISTORIC USE	Government - post office
CONDITION	Good	SECONDARY STRUCTURE	-
INTEGRITY	Minor alterations and additions	NR SECOND	-
CURRENT USE	Social - civic

Colonial Revival

Low-pitched hipped roof and rectangular massing; symmetrical front facade with center entry; classical entry surround with broken pediment; center keystone window lintels; decorative stone panels above window openings

1-story rear addition; 1-story west loading dock addition; replacement windows in original openings; replacement front door; some windows on side elevations bricked in

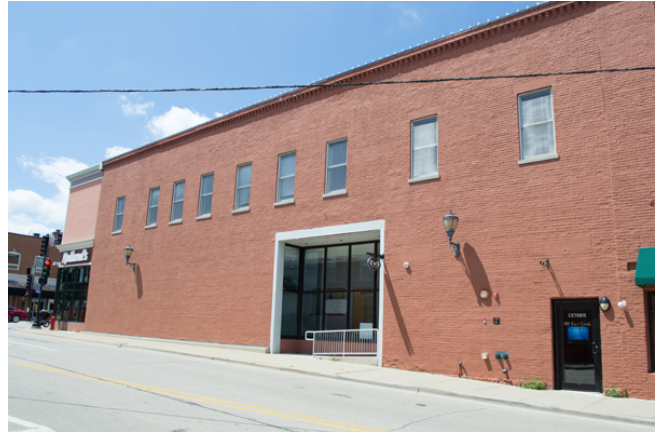
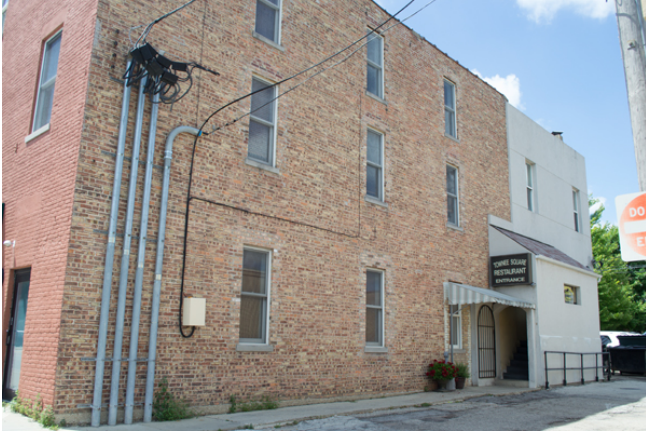
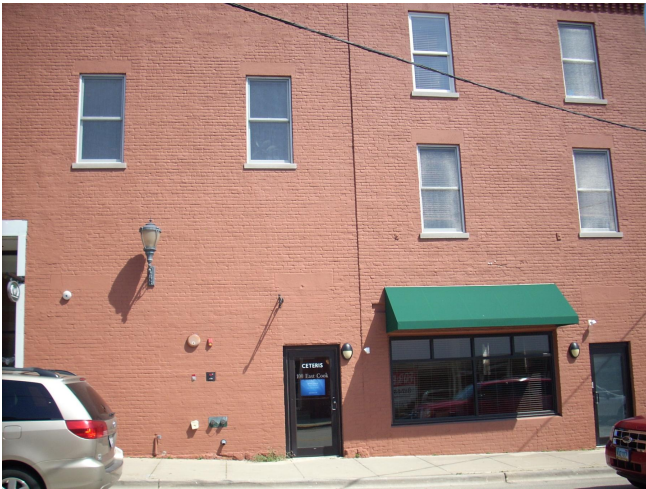
Photo Id: CookAveE100(1)

CATEGORY	HISTORIC USE
Building	Commerce/Trade
CONDITION	SECONDARY STRUCTURE
Good	-
INTEGRITY	NR SECOND
Moderate alterations	-
CURRENT USE	
Commerce/Trade

Two Part Commercial Block

corbelled brick cornice; original stone lintels visible on 2nd floor

Brick painted; replacement windows in downsized openings on upper floors; replacement storefront windows and door in altered/downsized openings

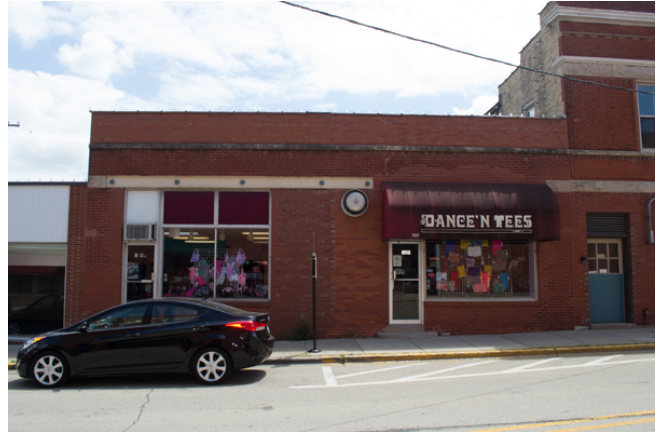
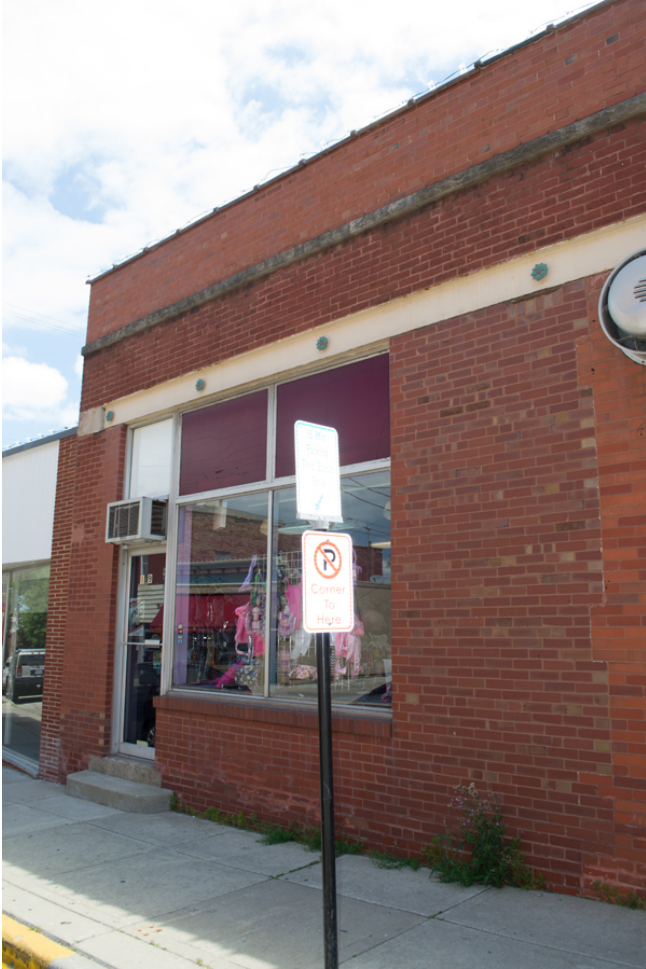
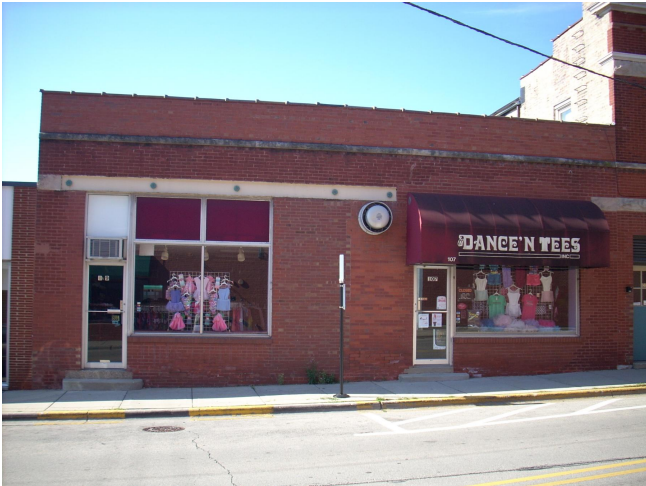
Photo Id: CookAveE107-109(1)

CATEGORY	HISTORIC USE
Building	Commerce/Trade
CONDITION	SECONDARY STRUCTURE
Good	-
INTEGRITY	NR SECOND
Major alterations	-
CURRENT USE	
Commerce/Trade - retail

One Part Commercial Block

Brick exterior; rectangular massing; metal lintel with tie backs over east storefront; stone stringcourse between storefront level and parapet wall

Replacement storefront windows and doors in altered openings; parapet wall appears rebuilt or added; awning over west storefront

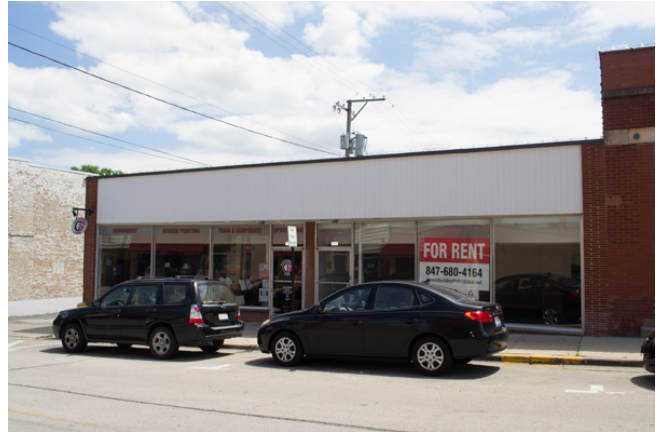
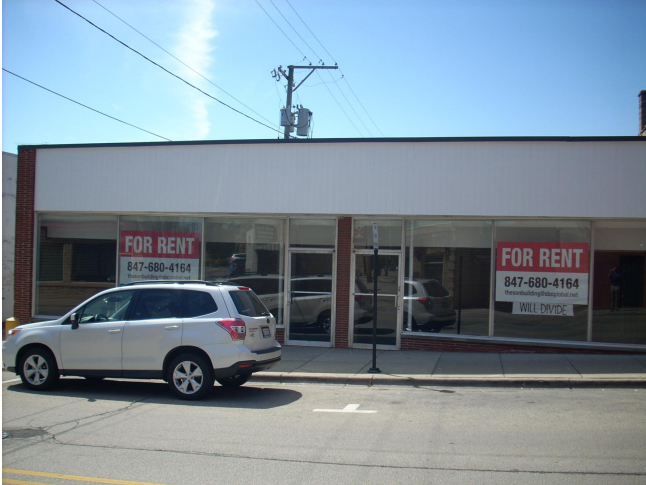
Photo Id: CookAveE111-113(1)

CATEGORY	HISTORIC USE
Building	Commerce/Trade
CONDITION	SECONDARY STRUCTURE
Good	-
INTEGRITY	NR SECOND
Not altered	-
CURRENT USE	
Vacant

One Part Commercial Block

Curving front facade with roman brick cladding; paired, mirror image storefronts with aluminum windows and doors

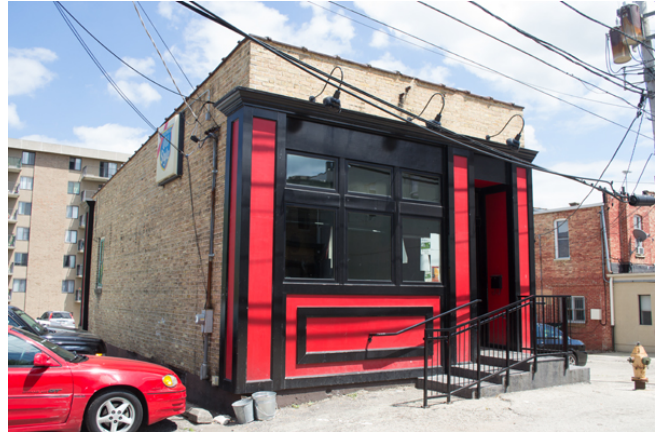
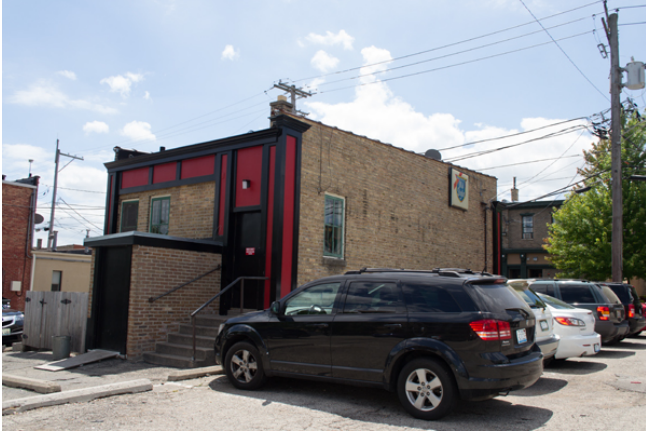
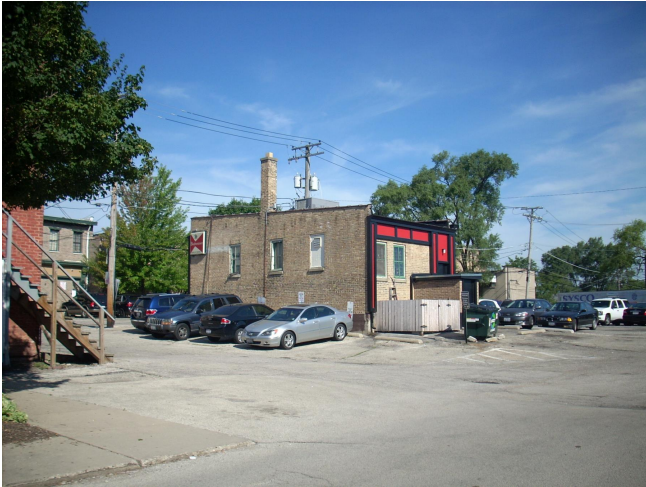
Photo Id: CookAveE112(1)

CATEGORY	HISTORIC USE
Building	Commerce/Trade
CONDITION	SECONDARY STRUCTURE
Good	-
INTEGRITY	NR SECOND
Major alterations	-
CURRENT USE	
Commerce/Trade - restaurant

One Part Commercial Block

Storefront configuration and materials are not historic; 1-story rear addition; rear concrete steps

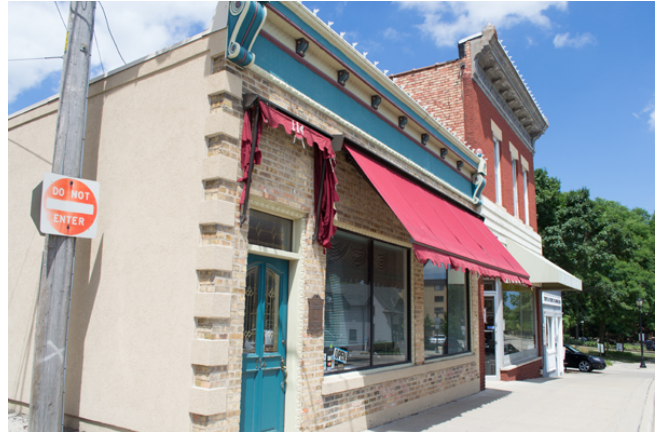
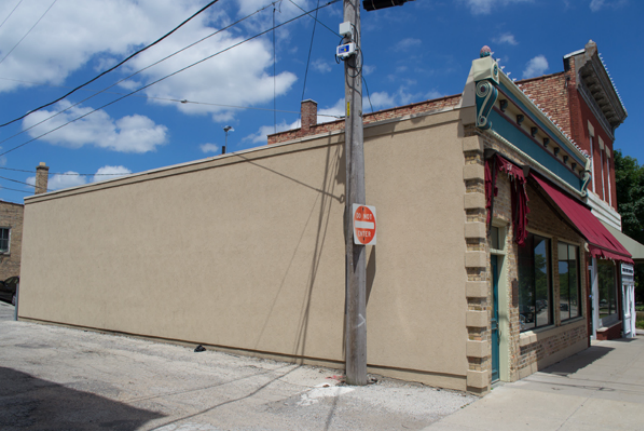
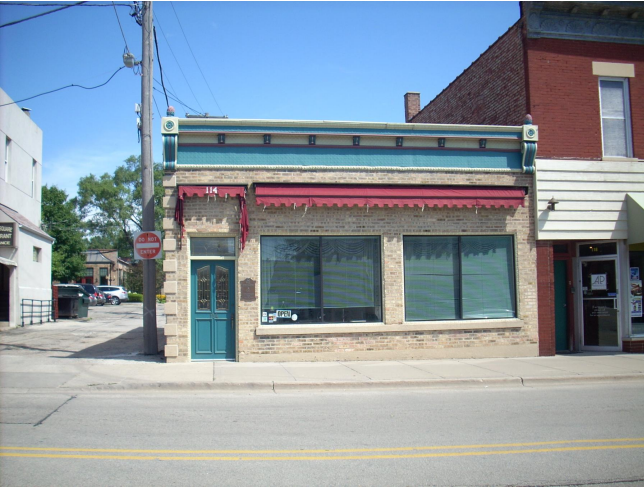
Photo Id: CookAveE114(1)

CATEGORY	HISTORIC USE
Building	Commerce/Trade
CONDITION	SECONDARY STRUCTURE
Good	-
INTEGRITY	NR SECOND
Major alterations	-
CURRENT USE	
Commerce/Trade

Building remodeled in 1992--cornice addition; replacement front door; stucco finish on concrete corner quoins; other alterations include replacement windows in original openings

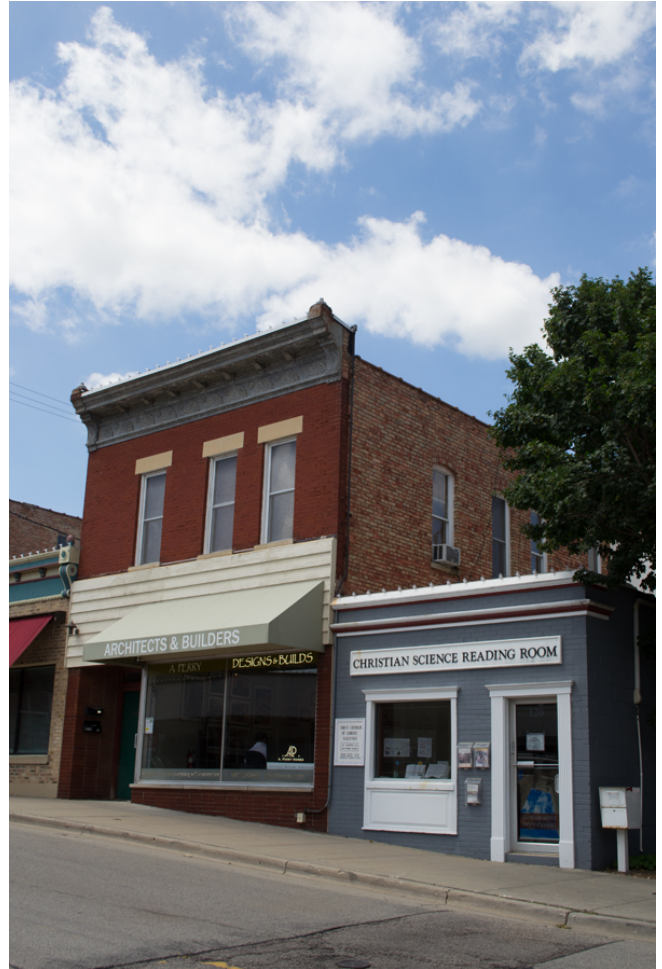
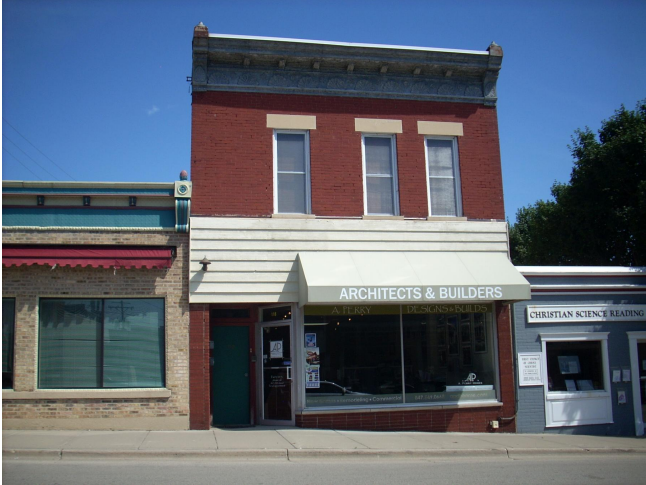
Photo Id: CookAveE116-118

Replacement windows on upper story; storefront level reconfigured with angled storefront entry, recessed 2nd story entry, and Roman brick bulkhead (1956); wood siding between 1st and 2nd stories on front facade; awning; 2nd story east side addition

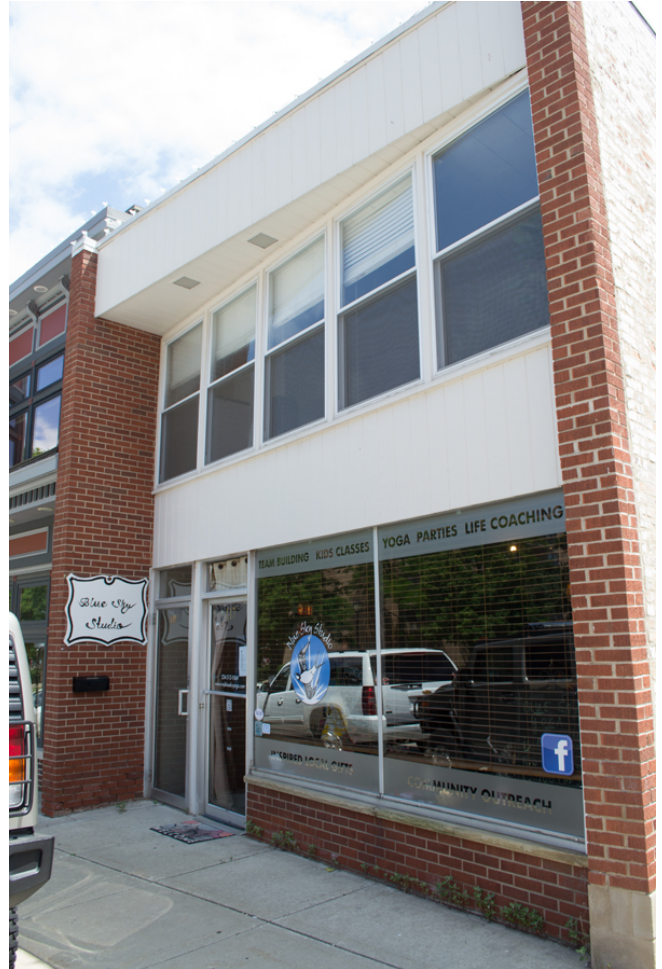
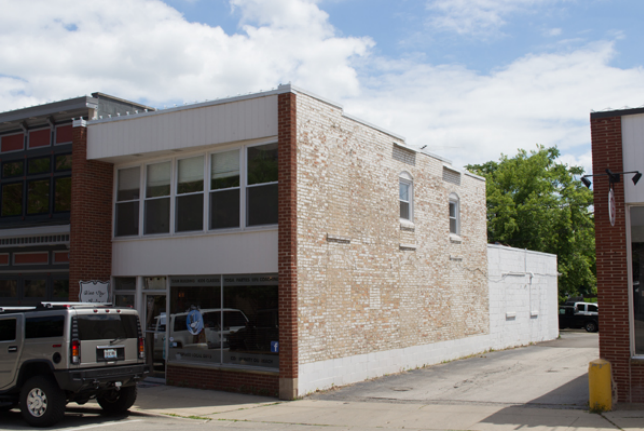
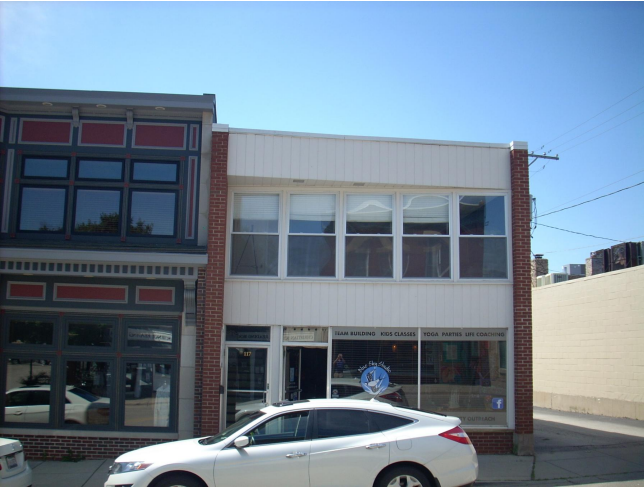
Photo Id: CookAveE117(1)

Front facade extensively remodeled in the 1958; non-historic replacement windows in original openings on 2nd story; replacement storefront windows and doors; segmental arch window openings bricked in on side
